**MINERALS MANAGEMENT SERVICE**

**POST MORTEM PLATFORM  
FAILURE EVALUATION STUDY**

**FINAL REPORT**

**PMB ENGINEERING INC.  
SAN FRANCISCO, CALIFORNIA**

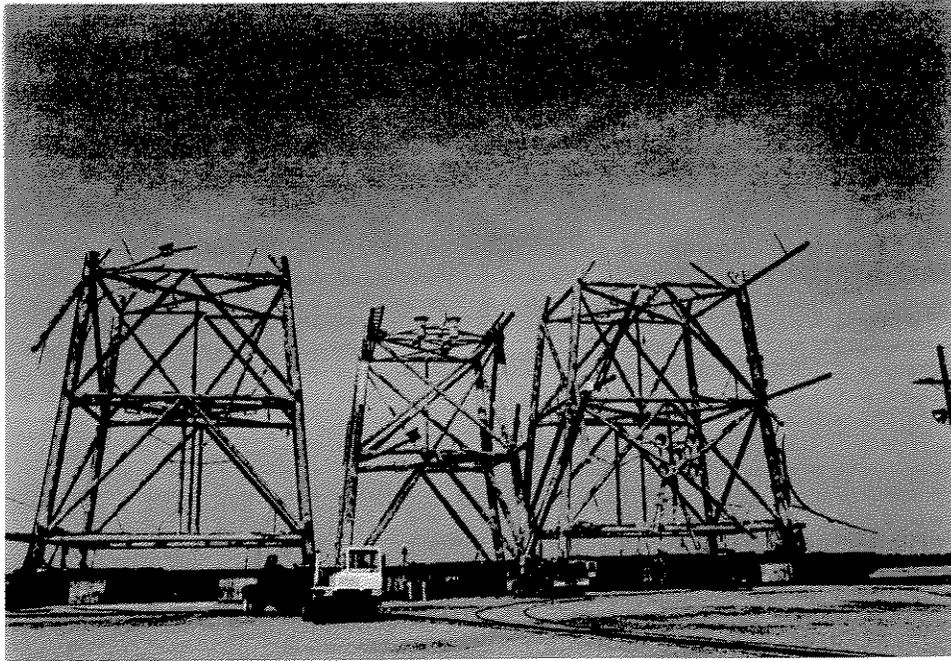
**Photo 2-2** Broadside View of Platform Sections

A closer look at Photo 2-2 reveals clearly damaged K joints on the BN (left side) and BS (right side). Closer inspection showed even more damage to the X and K joints on the TN (center) and other K and KT joints of the bottom section. Several of the mudline joints on the bottom sections were sandblasted clean and inspected for possible fatigue damage.

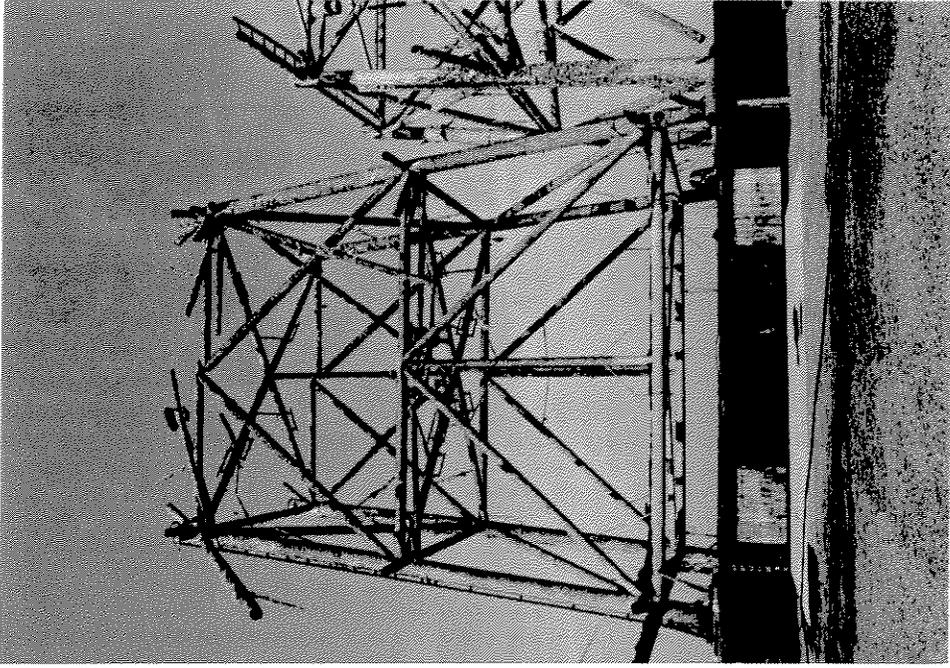
**Photo 2-4 Closeup view of Section BN (Bottom North)**

The upper K joints of BN (Photo 2-4) showed the same type of failures, with both the interior and the exterior joints completely severed at the chord.

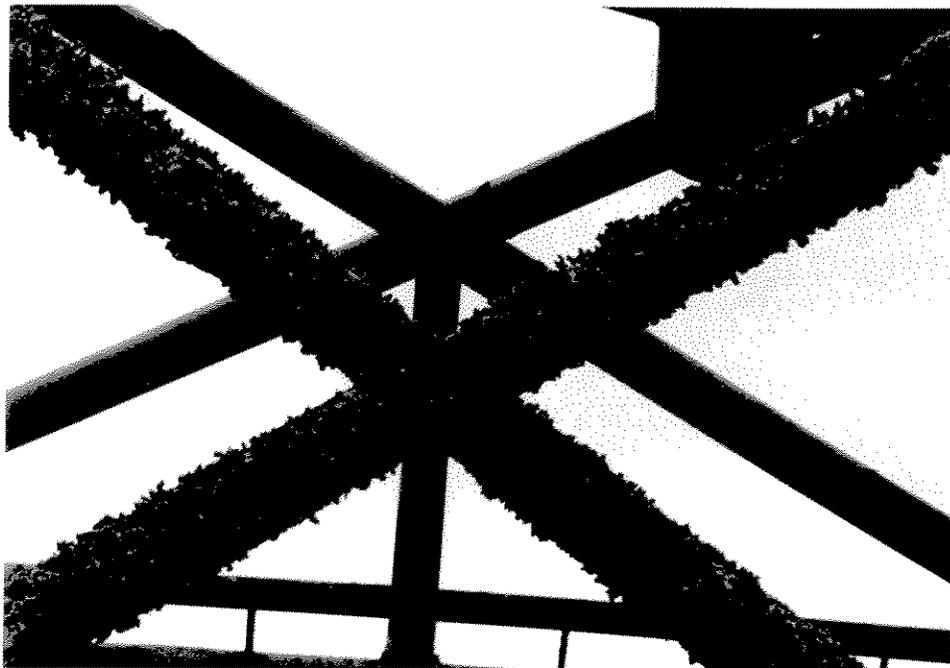
Photo 2-7 Damaged X Joint Row 2

The X joints were located in the upperbays of the platform just below the water line of TN (Photo 2-5). Photo 2-7 shows a closeup of the BN X joint in the transverse frame Row 2. The through brace (and coincidentally the tension brace) extends from the bottom right side to the upper left side. The most severe Andrew waves moved basically from right to left of the photo. A crack is clearly seen at the intersection of the braces along the tension brace.

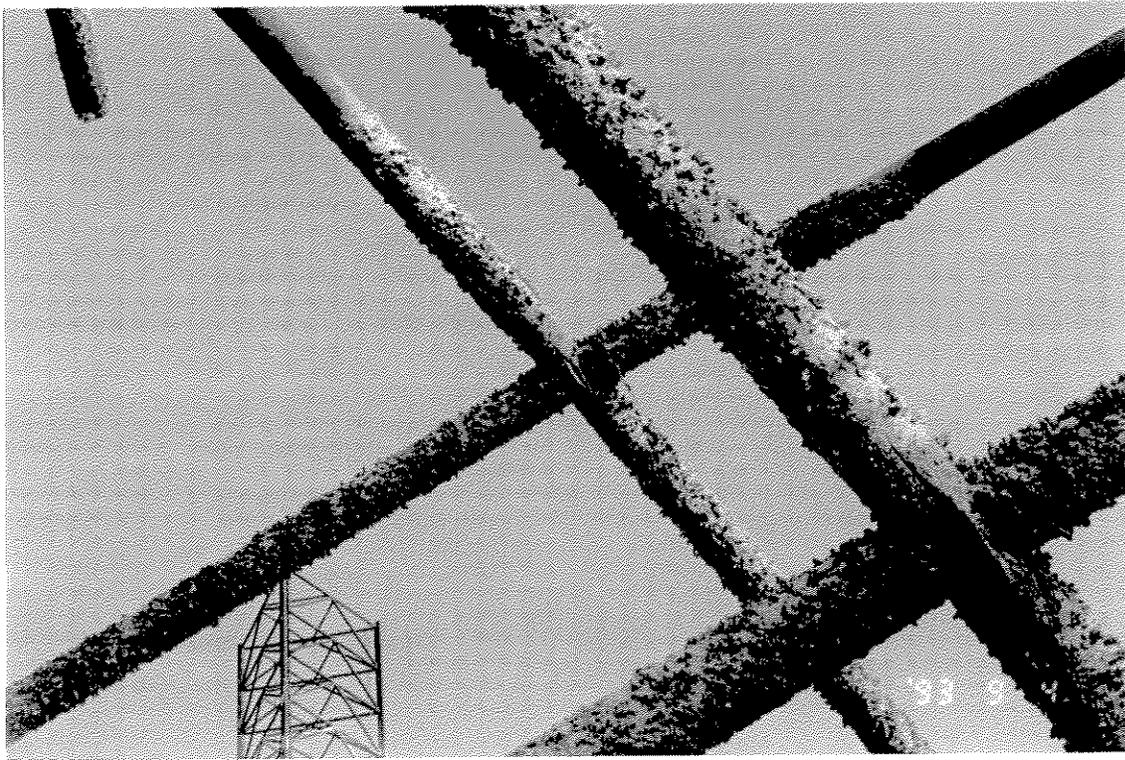
Photo 2-10 B AUX X Joint Crack

The X joints contained a 2+ ft crack at the centerline of the tension member, which was also the through member of the compression-tension pair. The tension member was also crushed by the compression members, creating an oval cross-section with the crack located along the narrow apex of the oval (Photos 2-10 and 2-11).

Similar cracks were seen on the remaining portion of the X braces of the ST 177 B AUX structure as shown in Photo 2-10. A closeup of one of these joints, as shown in Photo 2-11, also reveals a similar bulging on the tension member.

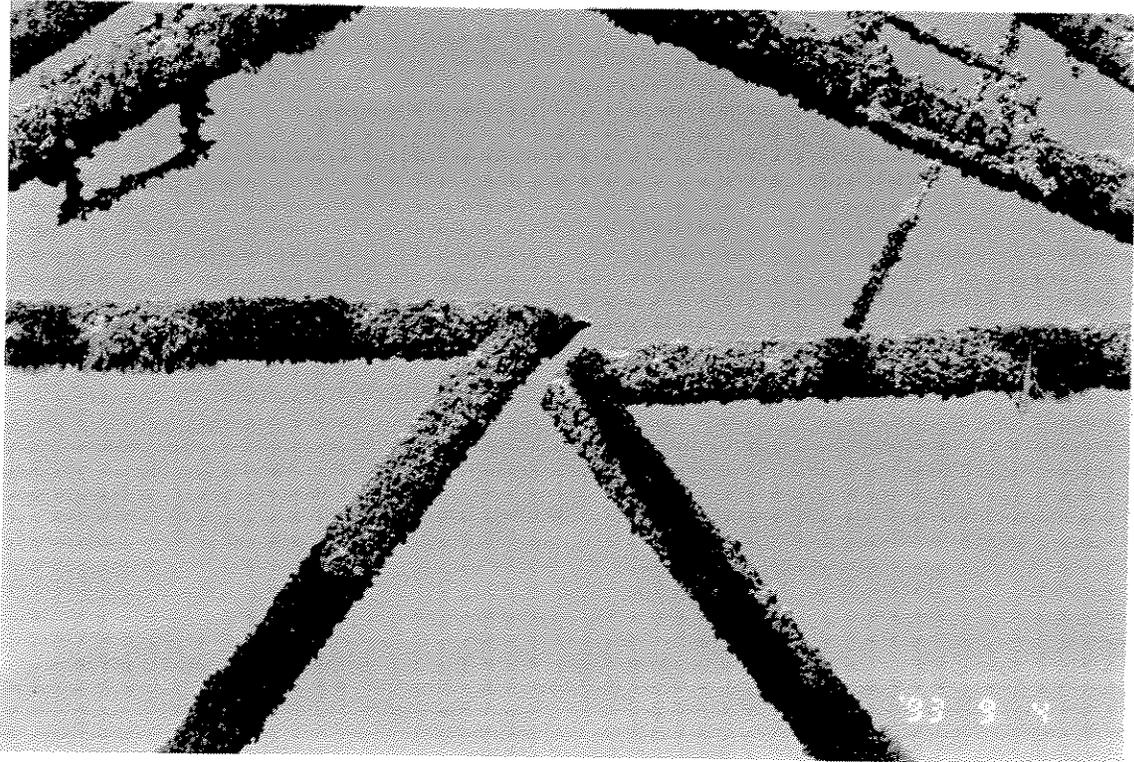
Photo 2-12 K Joint Row A (TN)

All of the K joints on the platform were damaged by complete sever of the chord (Photo 2-12). It appeared that the chord severed due to excessive beam shear. The failure plane was located along a line parallel to the compression member of the K. The failure can be attributed to the chord and K brace members having the same diameter and thickness, with the chord unable to carry the shear load along the approximate 2 inch gap between the two K braces.

K joints were located in the middle two elevations. The uppermost K (closest to the waterline) is located on the lower section of TN (Photo 2-5). A closeup of the K joint on ROW 2 is shown in Photo 2-12. Andrew waves moved basically from right to left in the photo. The failure occurred due to complete shear through the chord. The shear plane is in a plane directly along the bottom of the compression brace. Note that the right hand side of the K brace has dropped downward approximately 1 foot. This is due to the portal action of the legs as discussed in Section 2-6.

The ST 177 B joints were designed with approximately a 2 inch gap between the braces and no joint can. This allows high shear stresses in the chord, which eventually failed. As discussed later, the KT joints (which had no gap due to the presence of the vertical T member) did not exhibit this failure mode.

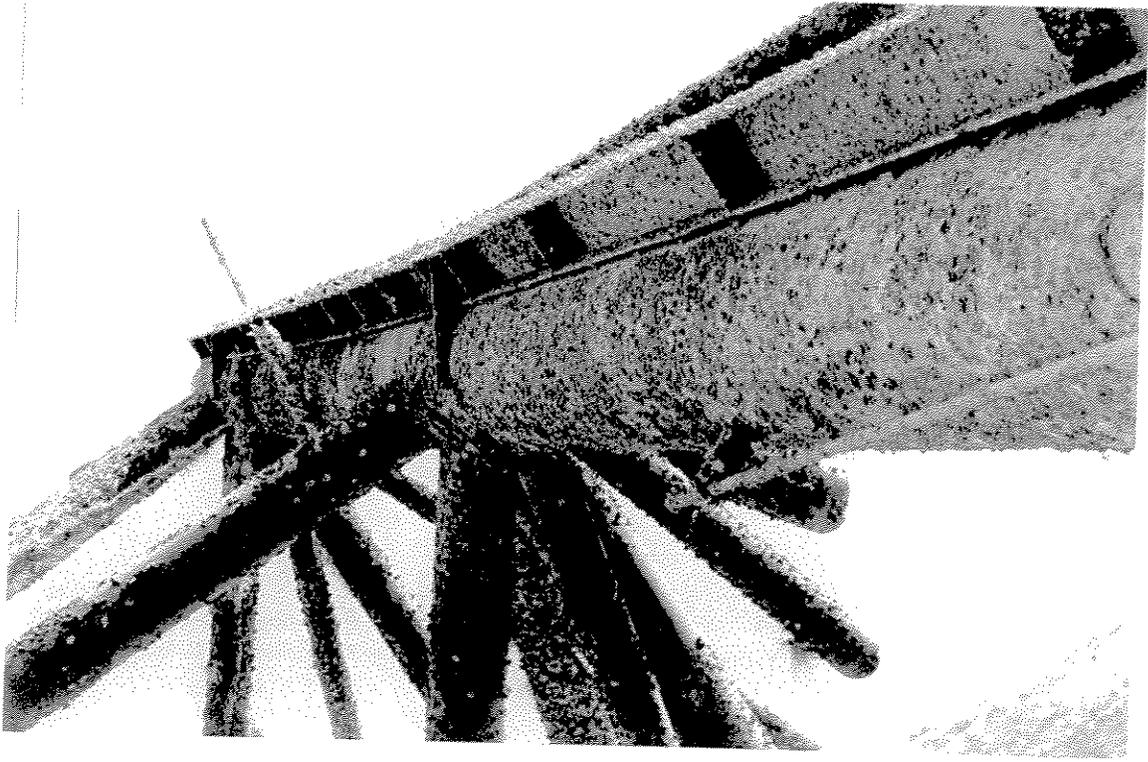
Photo 2-21 View of Leg B1 (BN)

The platform legs in the lower elevations where the K bracing had completely failed had a slight curvature in the direction of the Andrew waves (Photos 2-20 and 2-21). This curvature was possible since the complete loss of the K joints allowed for the formation of large deformations in the legs.

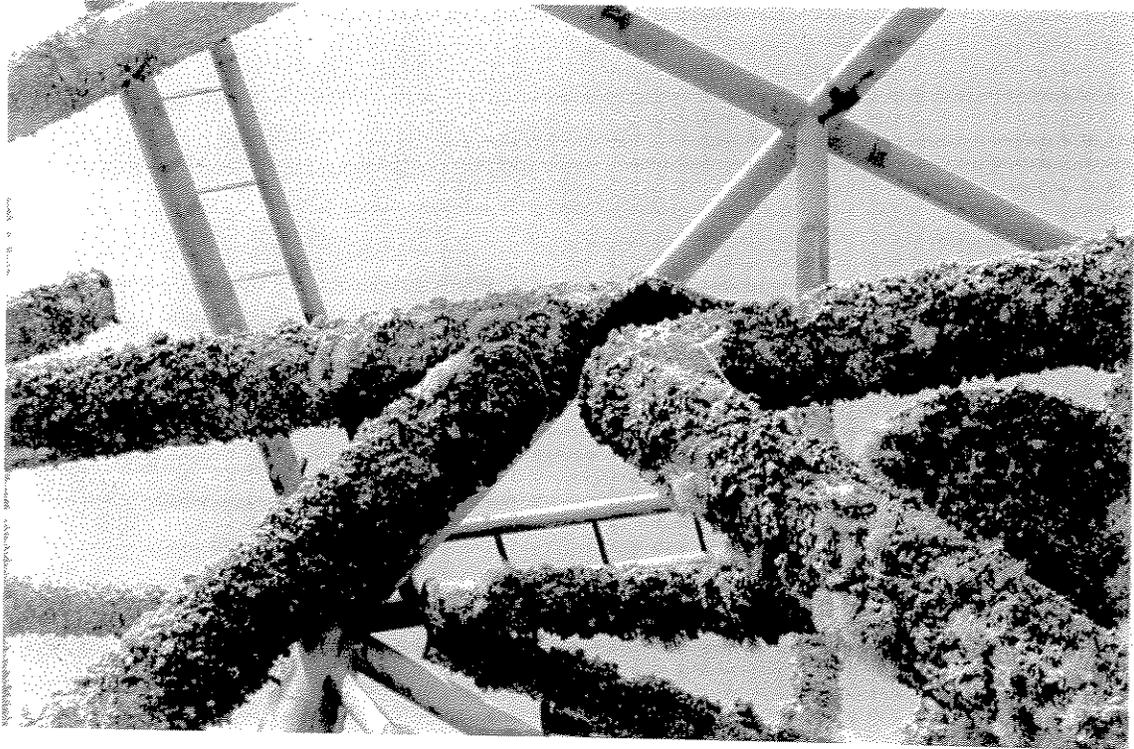
Specimen 1 - TN Row B K Joint (Damaged)

Several intact and damaged joint specimens were cut from the platform and placed in storage in one of Chevron's yards in the New Orleans area. It recommended that these joints be used for further testing of material properties as well as ultimate strength. These joints are unique since they provide the specific type of steel materials and fabrication techniques (rolling, welding, etc.) typical of the 1960's vintage of platforms.

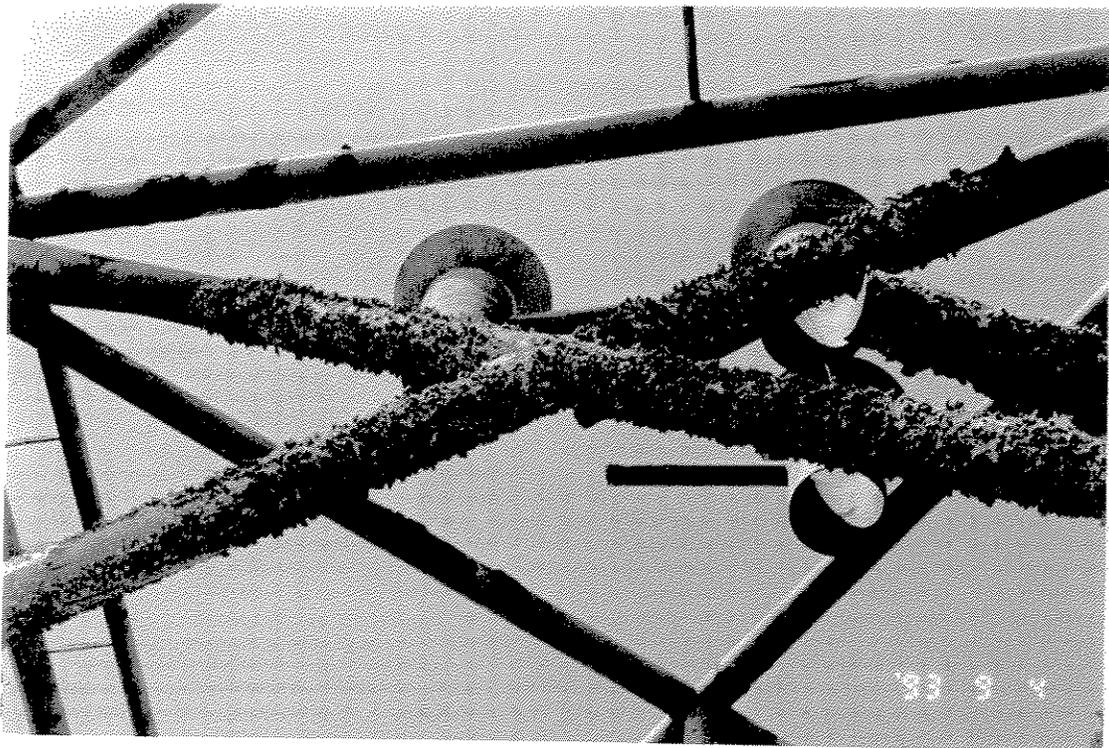
Specimen 2 - TN Row B X Joint (Damaged)

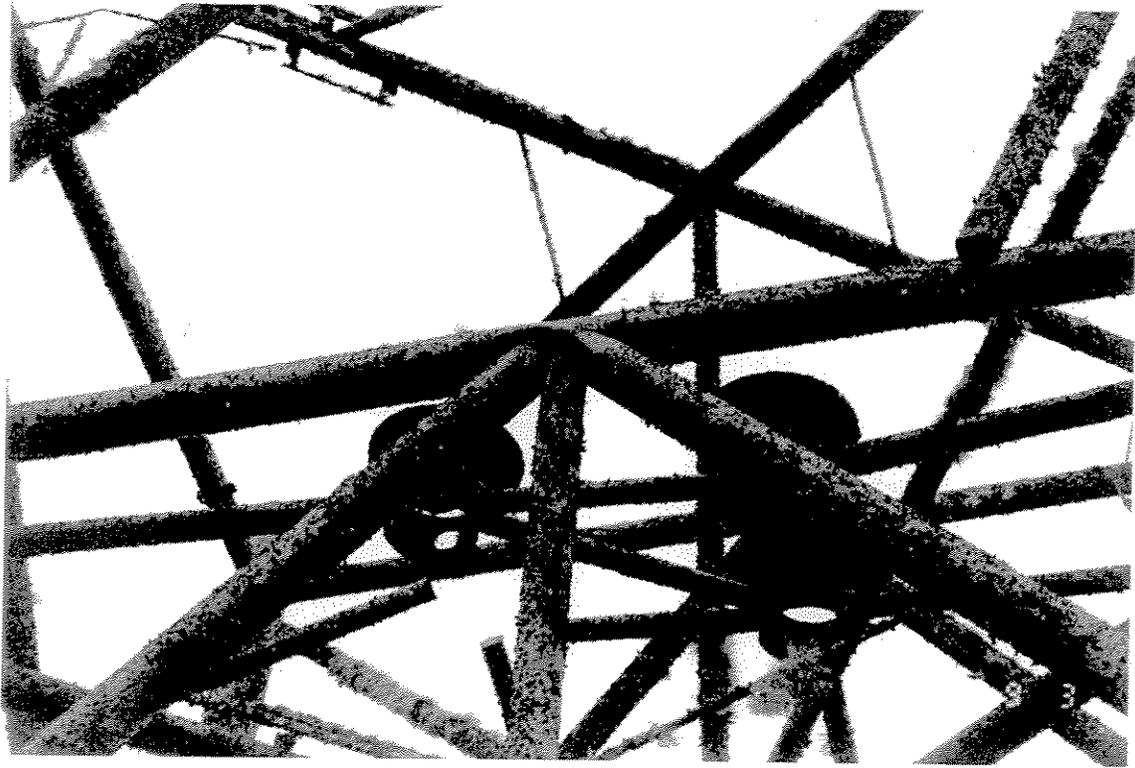
**Specimen 3 - BN Row B KT Joint (Damaged)**

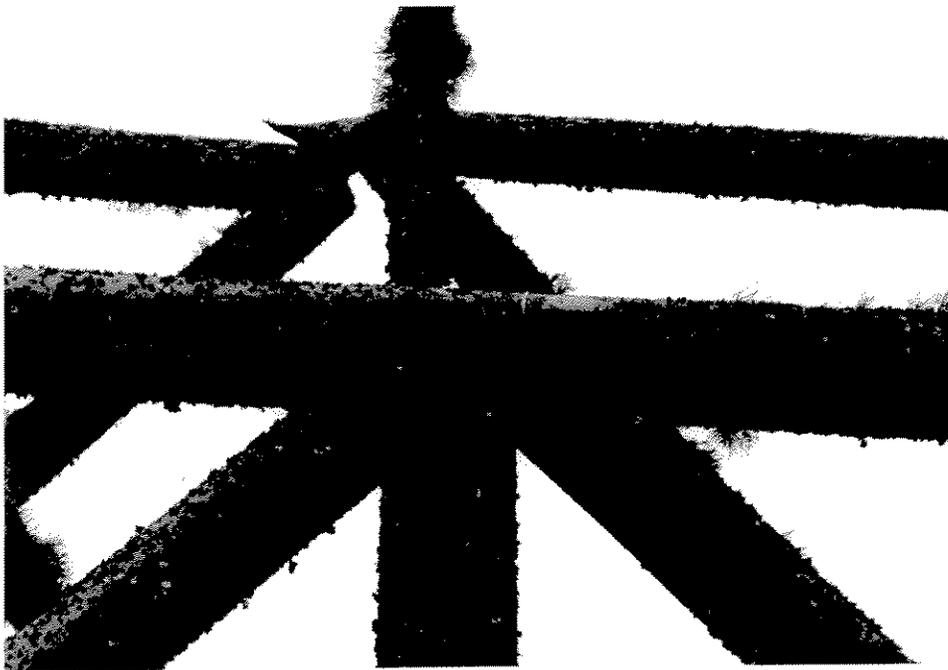
**Specimen 4 - BS Row C KT Joint (Damaged)**
