TECHNICAL REPORT

Report No.: 94-3243	Subject Group: D8, P3
Report title: Factors of Safety for Grouted Connection Phase II the Impact of Cyclic Load on Connections with High H/S Values	
Work carried out by: Monica Skjolde	
Work verified by: for Arne Sele	
Date of last rev.:	Rev.No.:
Number of Pages: 71

FATIGUE TESTING OF GROUTED CONNECTIONS

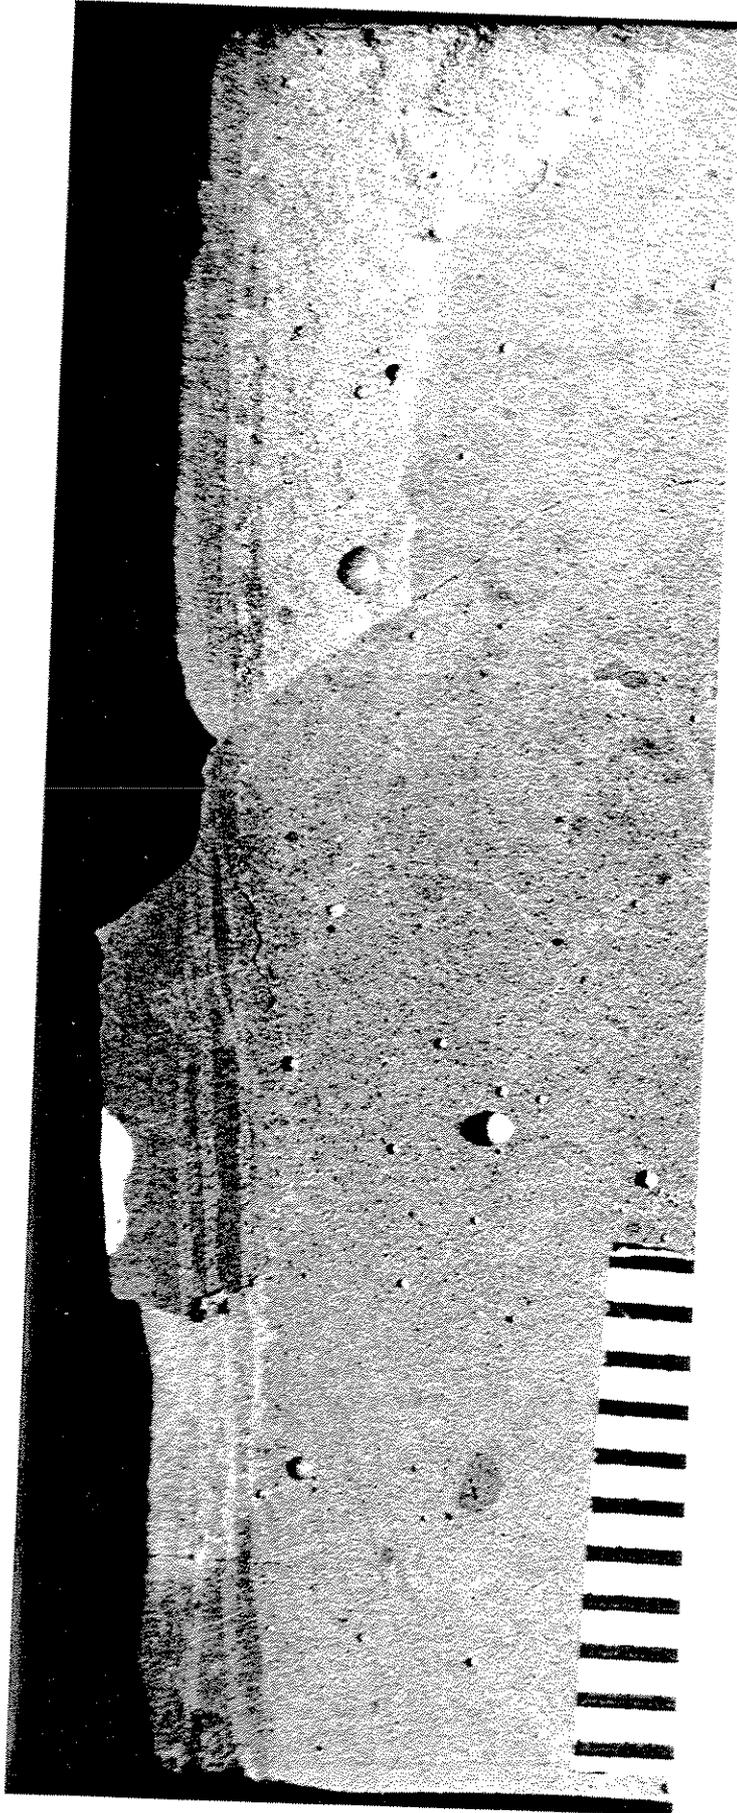
Fig. 5.6.2 The ground specimen with the dark grey layer towards the top of the photo is revealed.
Magnification 6X.

Two samples were prepared for examination. A specimen with a fractured surface and a specimen with a ground surface were subject to examination. Grinding of the specimen revealed a darker grey layer towards the surface of the inner pipe in which the two observed lines were located. Figure 5.6.2 shows the layer and the here denoted base material. The specimens were prepared with a thin gold layer on the surface prior to examination in a scanning electron microscope (SEM). Attached to the microscope is an energy dispersive X-ray spectrometer (EDS) which was applied for microanalysis of the specimens. The system detects elements down to and including fluorine in the periodic system. Consequently oxygen, nitrogen and so on cannot be detected.

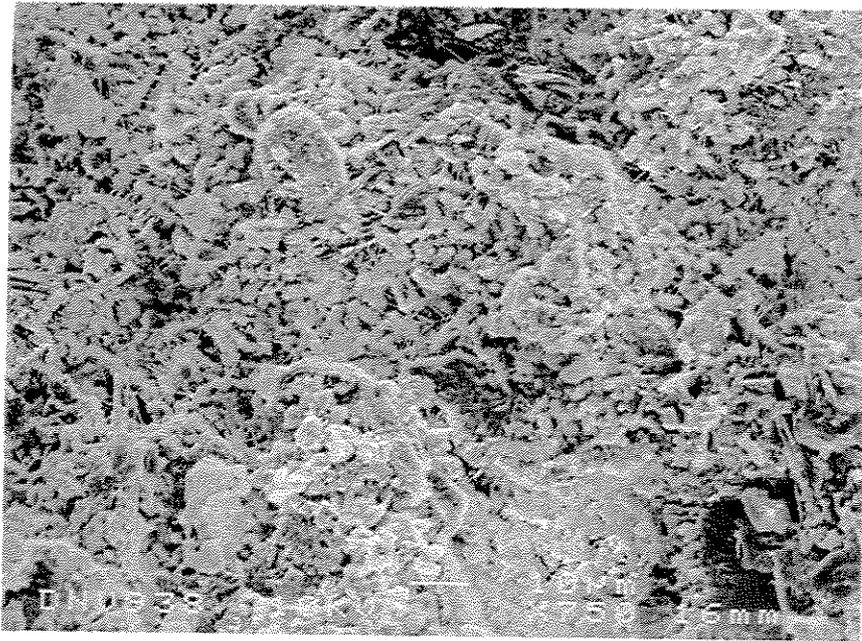
Fig. 5.6.8 The fracture appearance in the "base material". Magnification 750X.

An examination of the fracture appearance carried out both in the lines, in the dark grey surface layer and in the base material, showed some variation in the structure (figure 5.6.7 and 5.6.8).

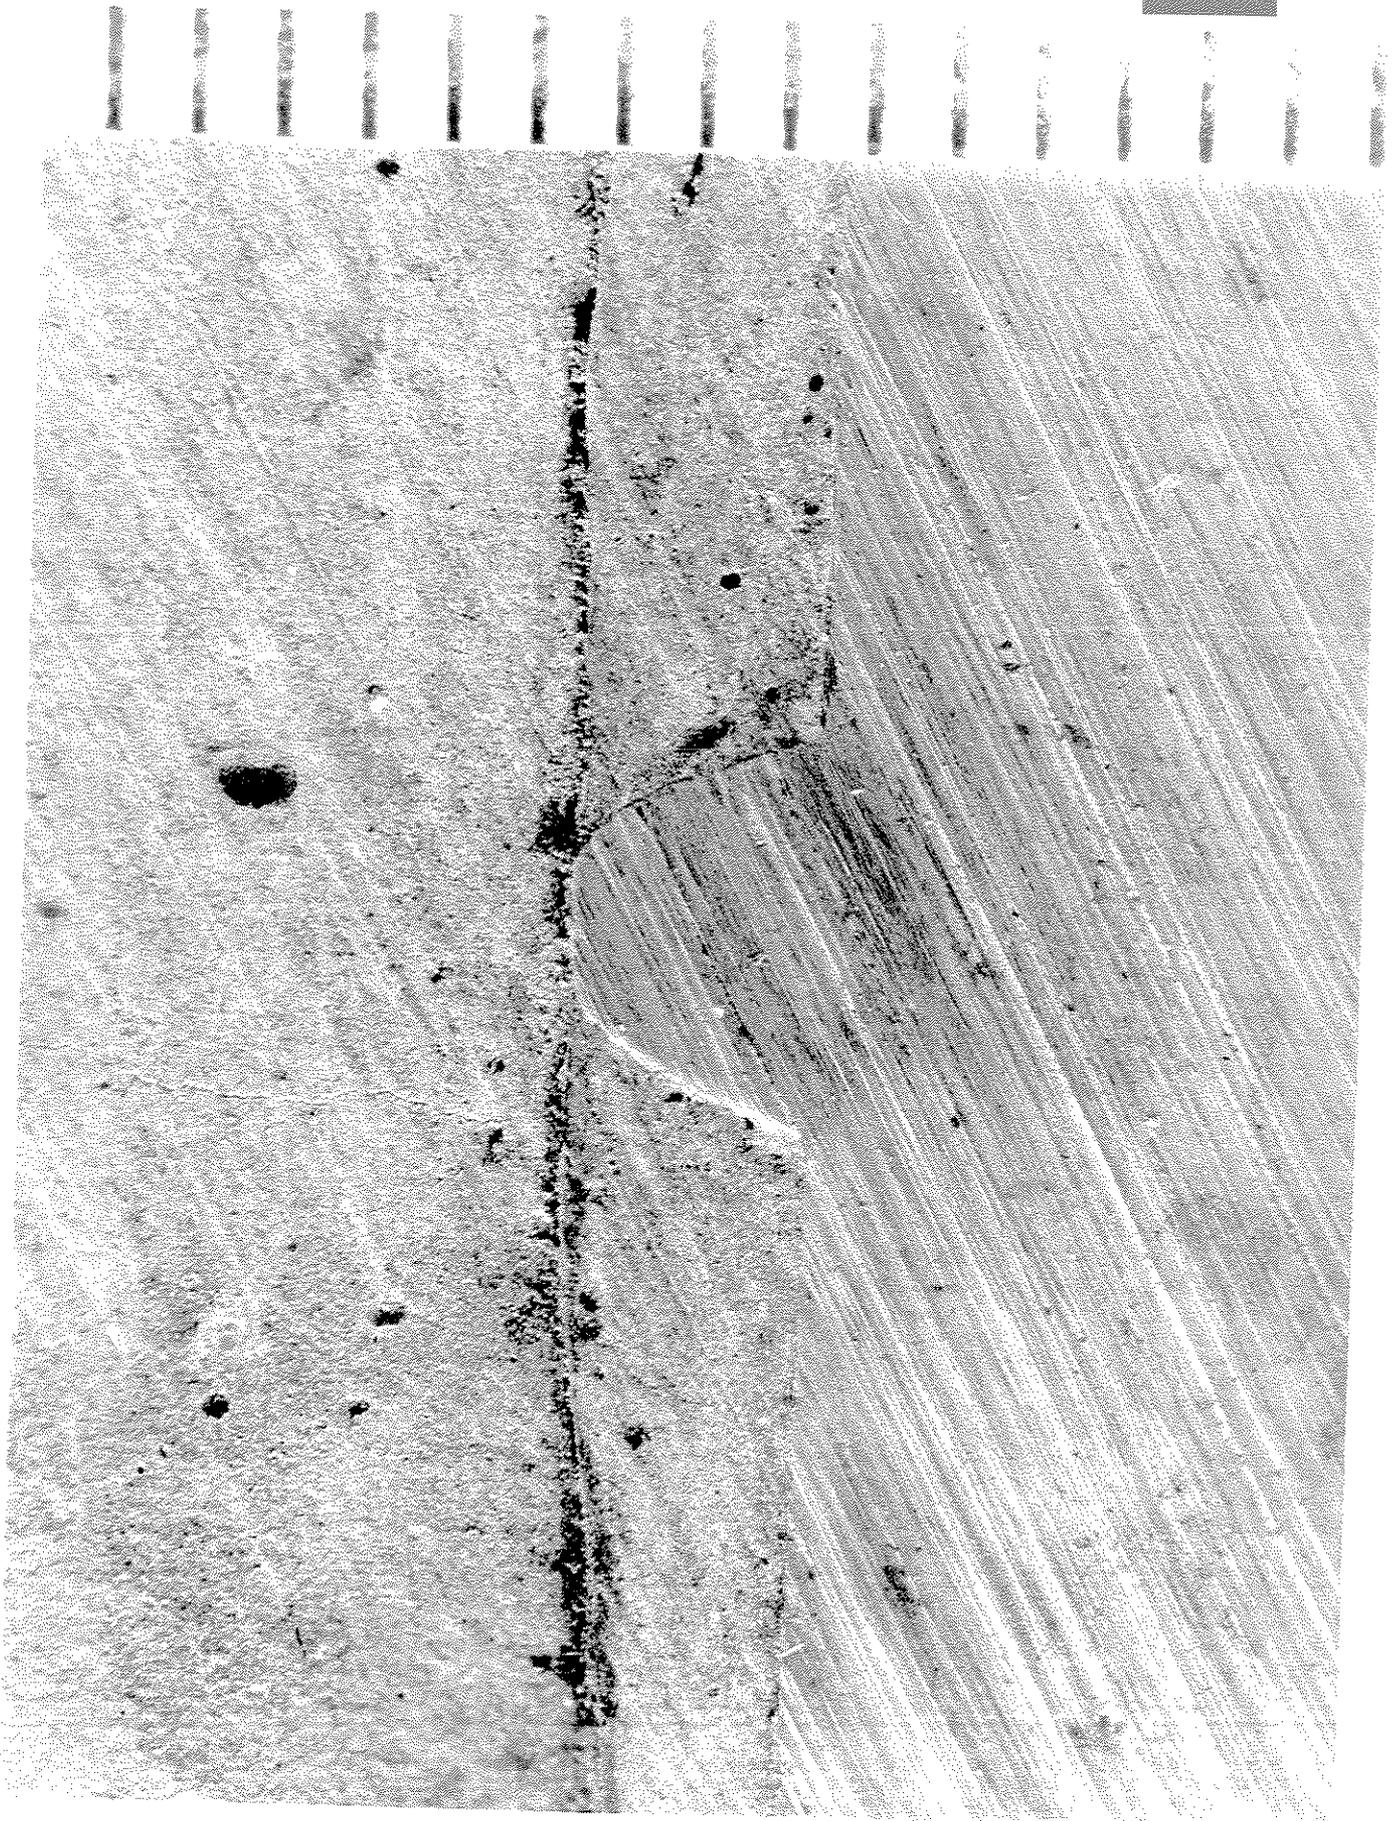
Figure 5.10.3 Local detail of disturbed zone

It was clearly observable that there was a disturbed zone similar to that found in specimen no 6. (Due to a rougher method of sectioning the disturbed zone had cracked) The trajectory of the disturbed zone was observed to differ from that of specimen no 6 in that it between shear keys deflected out to the steel interface. This is shown in Figs. 5.10.1, 5.10.2 and 5.10.3.
