# SINTEF REPORT

**Mechanical Oil Recovery in Ice-Infested Waters (MORICE)**

**Phase 5**

This report describes the work conducted in Phase 5 of the program “Mechanical Oil Recovery in Ice-Infested Waters” (MORICE). The objective of the program is to develop technologies for more effective recovery of oil spills in ice. The specific objectives in Phase 5 were to:

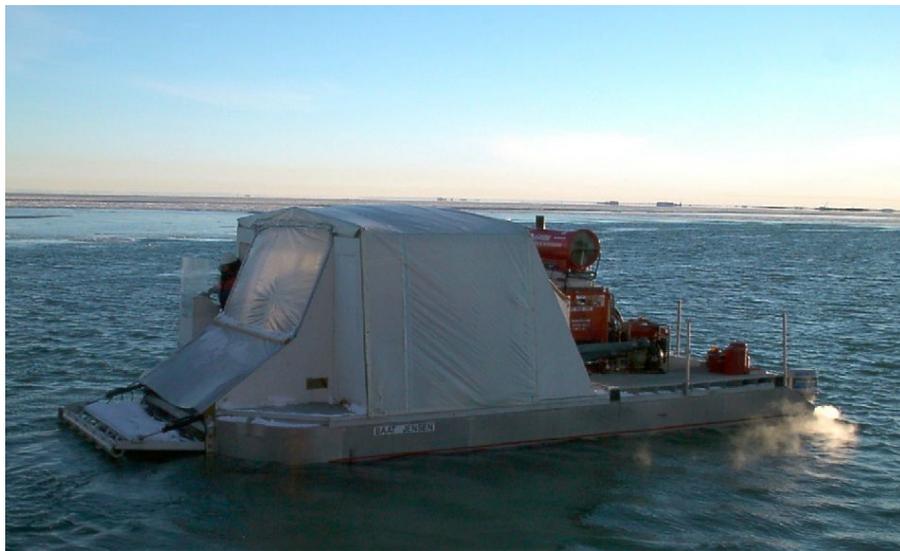
*Figure 3.1 Work platform with modified shape of the superstructure at the bow.*

The work platform is a catamaran with simple aluminum pontoons filled with foam, connected by two main 6" by 6" steel beams, several aluminum deck beams and a superstructure consisting of aluminum channels covered with tarp. This modular design makes it possible to fit the entire platform into a standard 40-foot container for transportation. The length of the vessel without ice feeder is approximately 9 m (30 feet), and the total width between the pontoons is a maximum of 3 m (10 feet). The cross section of each pontoon is rectangular, 110 cm (43 in.) wide and 95 cm (37 in.) deep. Two outboard motors are used to propel the vessel.

With the reduced bow height of the superstructure, the entire bow area with the whole ice feeder could be observed from the driver's position. This makes maneuvering the vessel and operation of the ice feeder and LGB much easier. Still, the driver cannot see the aft deck and the port side of the vessel, but for the rest of the MORICE program this should not be too much of a problem.

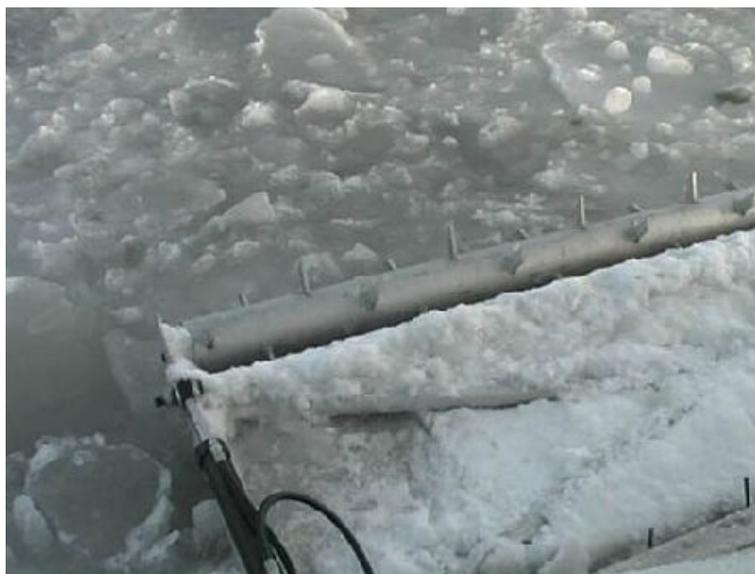
An ice feeder was designed to ensure that the ice and the oil would flow towards the LGB positioned in between the pontoons of the work platform. The feeder is mounted on a frame with its rotational axis approximately 1 m in front of the bow. A hydraulic motor powers it, and the vertical position is adjusted with two hydraulically operated rams, one on each side. Including the tines, the diameter of the ice feeder is approximately 14 inches (35 cm). When rotating, the tines act as claws working from above the ice. Depending on the vertical position of the feeder, the ice can either be pushed gently by the feeder, or be submerged. The rotational speed of the feeder decides the rate at which the ice is processed. It can be reversed if too much ice enters the LGB. The only modification made after the previous phase was that an aluminum plate was fixed to the underside to avoid ice from becoming stuck in the frame supporting the ice feeder (Figure 3.2).

*Figure 3.2 Ice feeder operating in broken ice. Snow covers the frame with the aluminum plate.*

In general, the ice feeder worked as intended, and the structural strength and control of the feeder seem to be appropriate. One new observation regarding the feeder was made: The young and weak ice that was negotiated with the feeder was broken into small pieces, 5 to 12 inches (15-30 cm). With the distance from the feeder to the belt of approximately 6 feet, the ice was not very effectively fed towards the LGB. The remedy may be to add 2 or 3 inches wide flat aluminum (or even plywood) between the spikes on the ice feeder to turn the feeder into a paddle drum, which could push the water in the right direction. The spikes would still have the same effect as before.

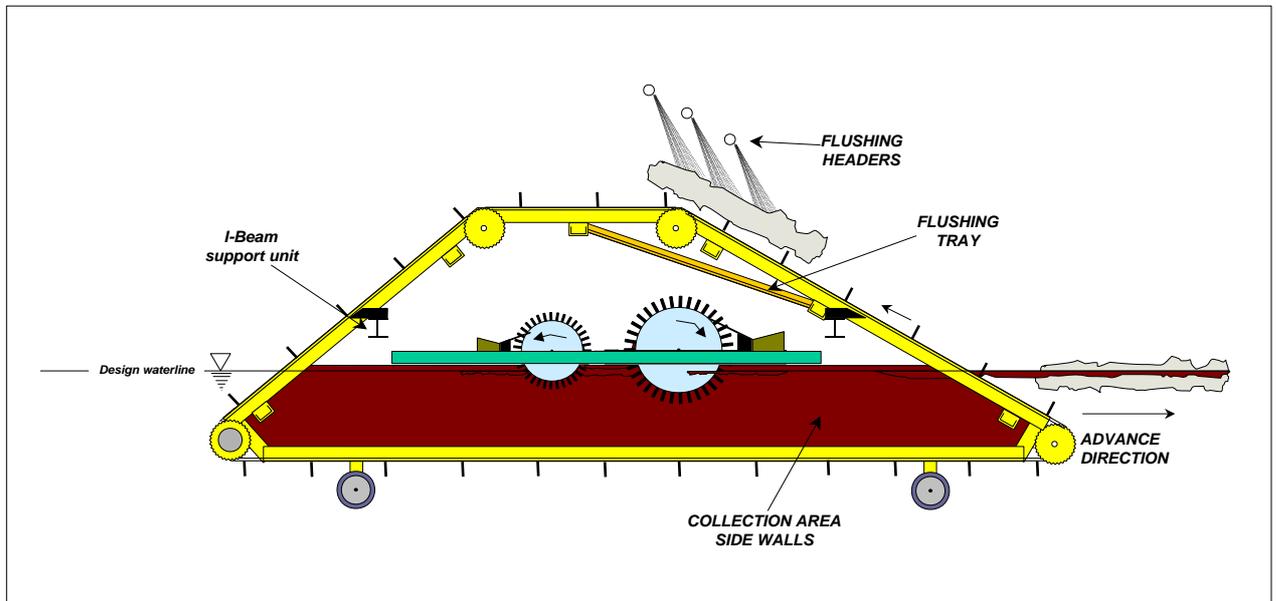
Figure 3.3 Lifting Grated Belt with flushing system and recovery unit.

Figure 3.3 shows a diagram of the Lifting Grated Belt. The unit advances to the right as ice pieces are lifted and deflected over the grated inclined plane by means of the moving rakes. A flushing tray just below the front section of the moving belt prevents the flushing water from interfering with the oil recovery operation below. A trough at the end of this tray is available to guide the flushing product to the front of the recovery area. In this recovery area, an oil recovery unit can then recover oil from a mixture of oil and small ice.

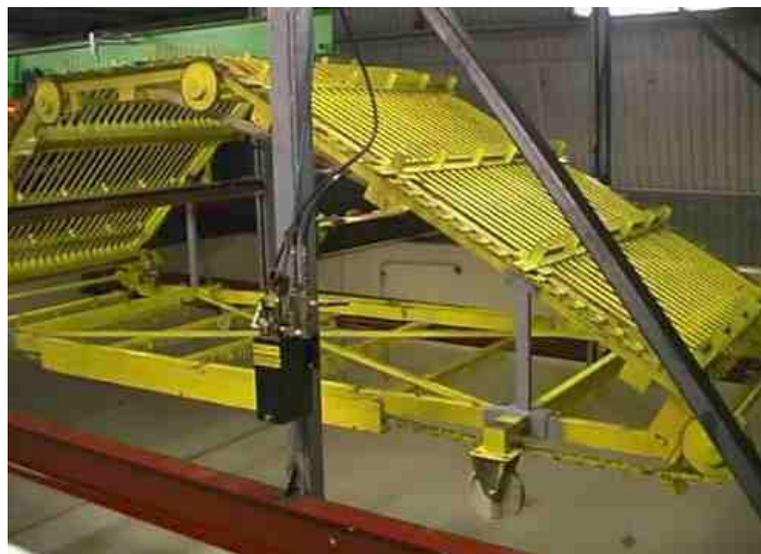
Figure 3.4 Lifting Grated Belt installed in the HSVA tank.

In Figure 3.4, the LGB has just been installed in the HSV A test tank. The unit appears to be a simple, open unit since the side plates had to be removed to get it into the tank. With the LGB lifted to its upper position, the recovery unit should be able to slide sideways into or out of the LGB to facilitate repair and maintenance, as well as installation on board and removal from the work platform. When in the lower, operational position, there is a wide opening between the sides of the LGB and the pontoons of the work platform. A hinged plate at the bow of each pontoon is inserted to guide ice and oil onto the grating. In this way, the swath width of the Lifting Grated Belt is increased from the original 170 cm (67 inches) to 300 cm (118 inches). Sidewalls fastened at the waterline to the frame of the LGB prevent small ice forms and oil from escaping to the sides after having entered through the grating.

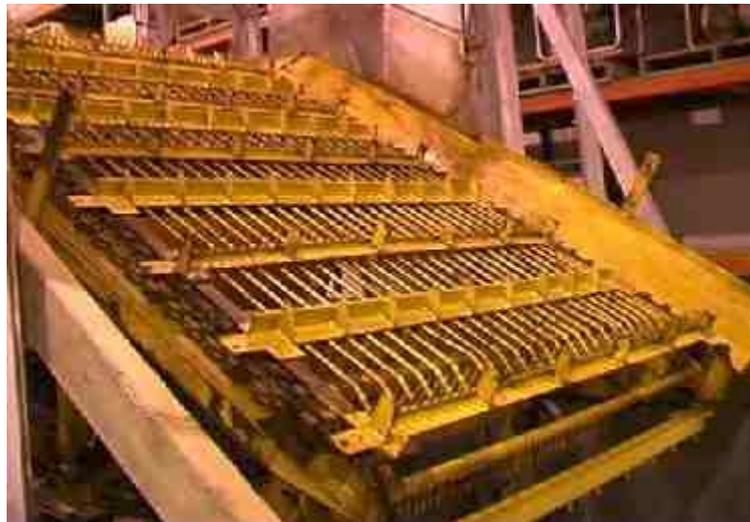
Much stronger rakes were installed prior to the ice testing, comprised of angle iron with teeth. The same number of new rakes were added as the old rakes to double the total number, see Figure 3.5.

*Figure 3.5 Lifting Grated Belt installed on work platform. New rakes have been added in between old ones.*

Larger ice pieces were processed well, especially after installation of the new and stronger rakes that were added in between the old ones. During ice testing in the field, the ice was smaller than experienced before, with more slush and other small ice forms. This was due to the relatively early stage of the freeze-up. These ice conditions presented different problems for the ice processing. One item that had to be attended to was re-tightening the nuts and bolts holding the new rakes in place once they had been operated for a short time and worked loose. Two rakes detached during the ice testing, resulting in the chain also coming off the sprocket. After re-tightening all the new bolts and nuts, the rakes worked without any problems. Further refinements to the LGB to improve the processing of larger ice pieces are not considered to be required at this point.

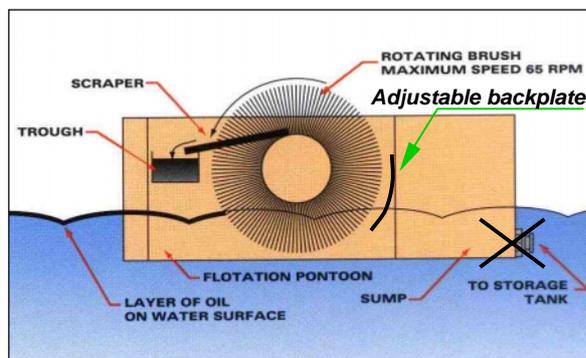
Figure 3.6 The Rotating Brush Skimmer principle (diagram from Aqua-Guard). The skimmer operates towards the left. An adjustable backplate was installed, and the recovered product was pumped directly from the trough.

Aqua-Guard has been making simple, lightweight rotating brush skimmers (Figure 3.6) in different sizes for many years. In their homepage, Aqua-Guard says about their rotating brush skimmers (RBS):

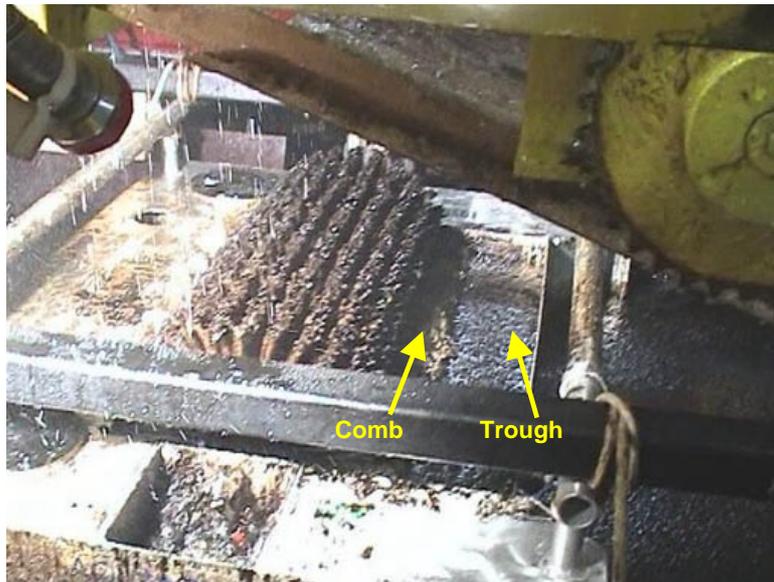
*Figure 3.7 RBS-10 operating in the LGB during oil and ice testing at HSVA.*

The unit was to float in the recovery area inside the LGB. The rotating brush was powered by a hydraulic motor, and an external pump would be used to transfer the recovered product from the trough. The discharge fitting prepared for the trough was not used. Instead, the suction hose from the transfer pump was operated manually to empty the trough when needed. A back plate behind the rotating brushes retains product that would otherwise be lost behind the unit.

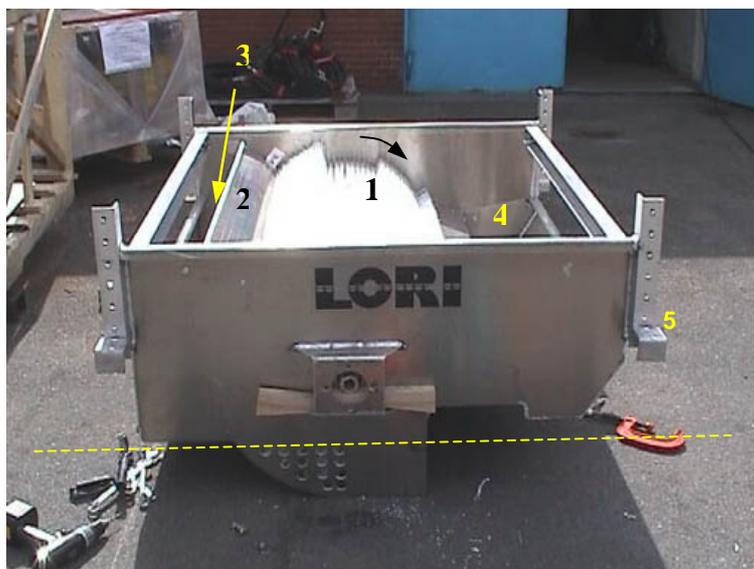
Figure 3.8 LORI Brush Drum before lab testing.

The LORI Brush Drum is seen in Figure 3.8. The brush drum (1) has bristles with varying length and stiffness to scoop the ice, and rotates in the direction of the arrow. The waterline is indicated with a dotted line, the skimmer moving to the right. The rear comb (2) removes ice (and oil) from the bristles, and the product falls into the rear trough (3) behind the comb. A second comb at the front is intended to scrape off more oil into another trough (4) while the rear comb is supposed to scrape off mostly ice. From either trough there is an outlet where flexible hoses connected to a pump transfer recovered product. The whole unit would be installed in the LGB, with the brackets (5) resting on beams connected to the LGB.

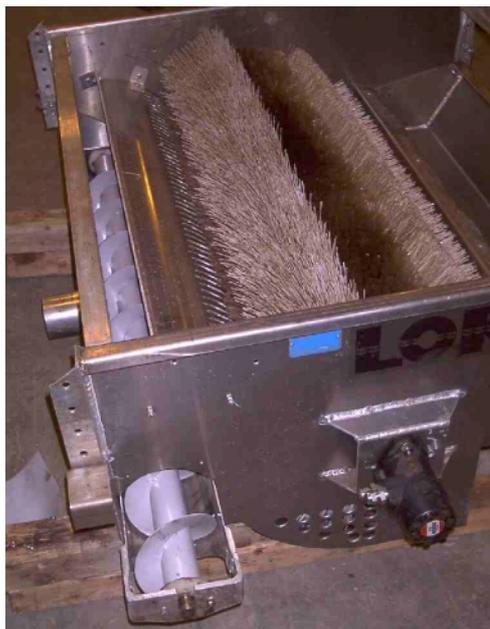
*Figure 3.9 LORI Brush Drum with auger installed.*

After a few tests with the original skimming system submitted to MORICE for these tests, the unit was removed from the LGB and the following modifications made before it was tested again, this time in oil and ice:

After the modifications had been made, three more tests were carried out with the unit, this time with both oil and ice in the test tank. The LORI Brush Drum with horizontal and vertical augers managed both to pick up and move the recovered product under the test conditions, but a lot of oil was lost through openings in the juncture between the two augers. The tighter comb clearly removed a lot more oil compared to the comb originally supplied with the skimmer.

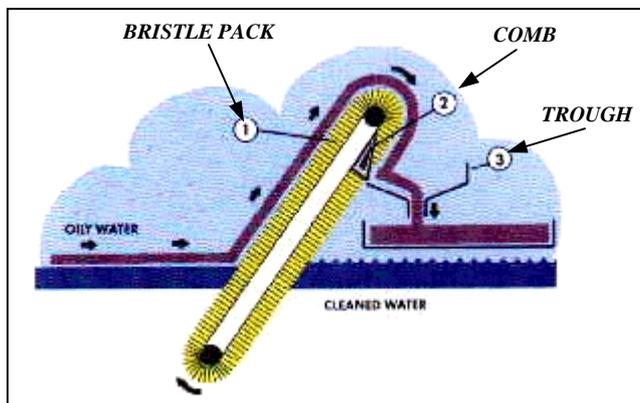
Figure 3.10 LORI Brush Pack principle (from LORI homepage).

LORI prepared a second recovery unit for the lab tests in Hamburg, a Brush Pack unit with reduced overall length. The principle of operation of the Brush Pack is indicated in Figure 3.10 above: One or more inclined chains with bristles lift oil (and debris, e.g., ice) out of the water. The space between the bristles allows most of the water to drip off. Since the action of the bristles creates an outward movement of water, the Brush Pack needs an inward flow of water and oil to work, which normally is easy to obtain by advancing the system through the water. The oil is scraped off by a comb and flows into a trough where it can be transferred to storage by a pump.

To be able to utilize this unit, it was decided to try and operate the Brush Pack so that the entire unit travelled in the reverse direction. In Figure 3.10 this means that the Brush Pack would operate towards the right. In this way, the action of the brushes would draw oil and ice towards the skimmer, pulling both oil and ice down from the surface, the challenge being to avoid oil escaping at the bottom where the bristles change direction. To reduce this problem, a backplate was installed behind the brushes where oil would otherwise escape.

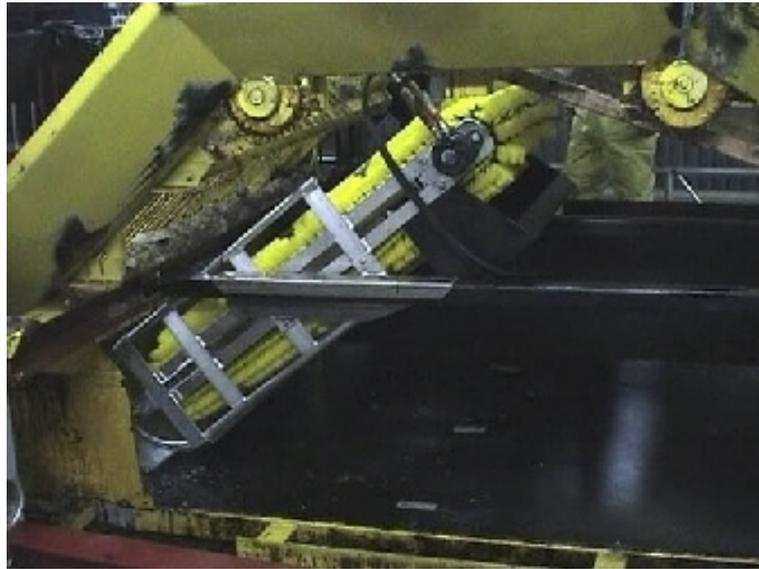
In Figure 3.11, the Brush Pack has been installed backwards in the Lifting Grated Belt, close to the rear, descending side of the LGB. The trough had a hose fitting in the bottom where the suction hose from a lobe pump was attached.

*Figure 3.11 LORI Brush Pack installed backwards in LGB, Hamburg. Operational direction is to the right.*

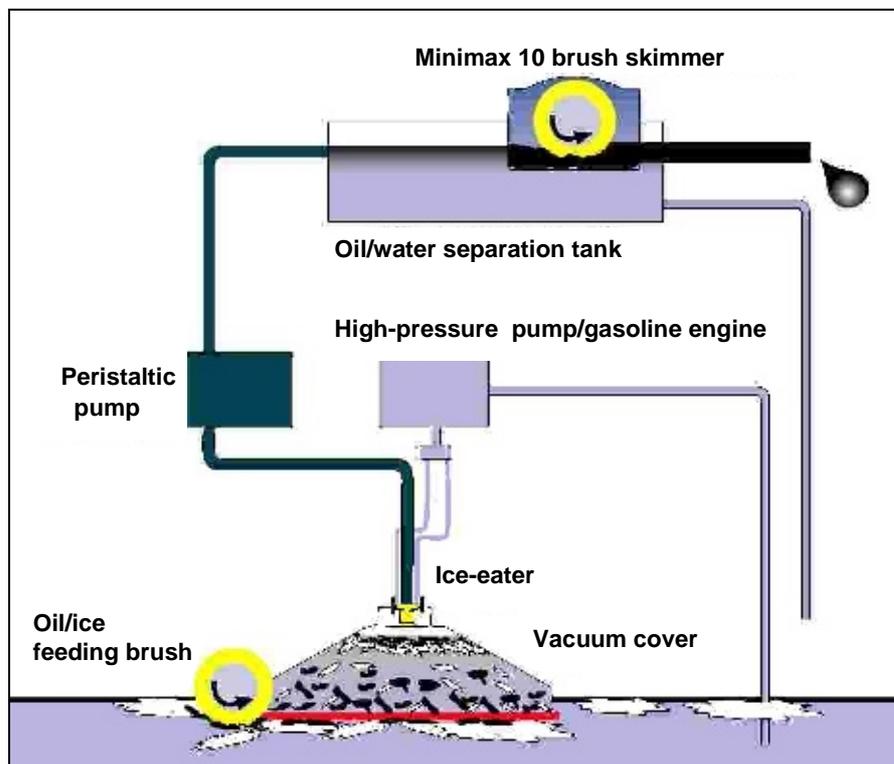
Figure 3.12 Schematic diagram of the Lamor unit.

As mentioned earlier, the LAMOR unit was not used in the HSVA lab tests, but the unit qualified for the ice testing through a demonstration. A schematic diagram of the LAMOR recovery unit is shown in Figure 3.12. The concept works as follows:

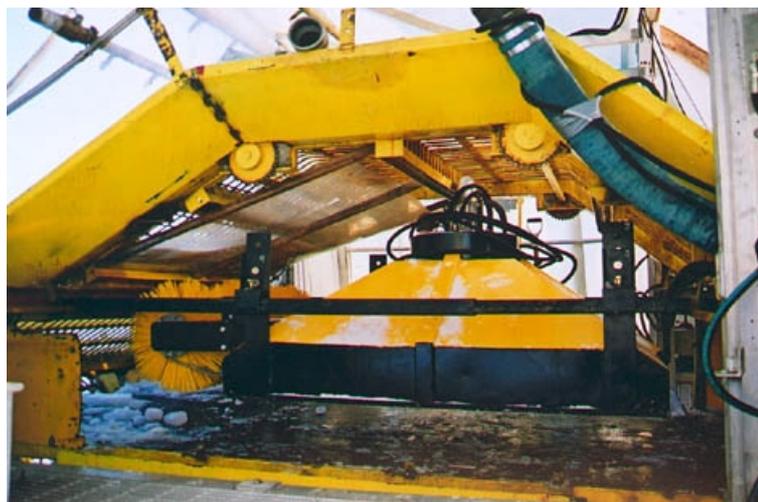
The LAMOR unit was relatively easy to fit inside the LGB, see Figure 3.13. The unit was assembled after arriving in Prudhoe Bay, and after dry runs at the ACS base it was used for the open water testing together with the work platform and LGB.

*Figure 3.13 LAMOR recovery unit installed in the Lifting Grated Belt, Prudhoe Bay.*

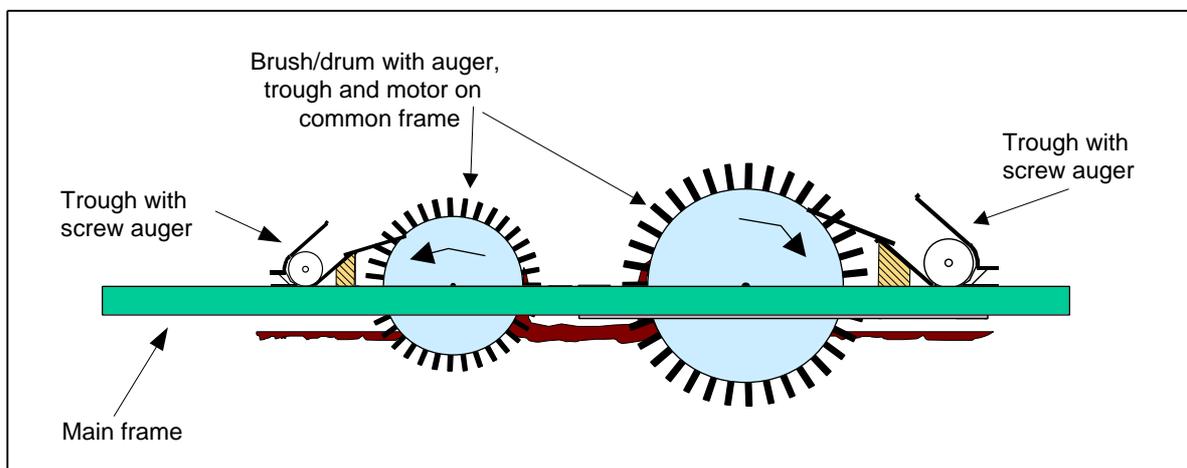
Figure 3.14 The Brush Drums with one large and one small drum.

A conceptual diagram of the recovery unit is seen in Figure 3.14. In Figure 3.15 the unit has been installed in the LGB for the lab testing at HSVA. It has a larger drum in the front with a smaller drum placed just behind it. The diameters of the two drums are approximately 45 cm (18 inches), and 32 cm (13 inches), respectively. Hydraulic motors individually power the drums. Each of the drums has its own scraper and trough to collect recovered product. A screw auger in the trough, powered with a hydraulic motor, conveys the product towards the middle of the trough where a hose for the transfer pump is connected.

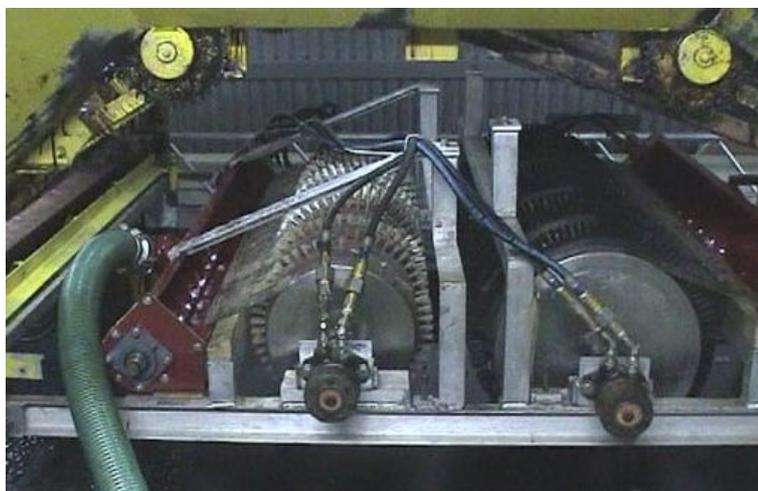
*Figure 3.15 MORICE Brush Drum installed in the LGB for lab testing in oil and ice.*

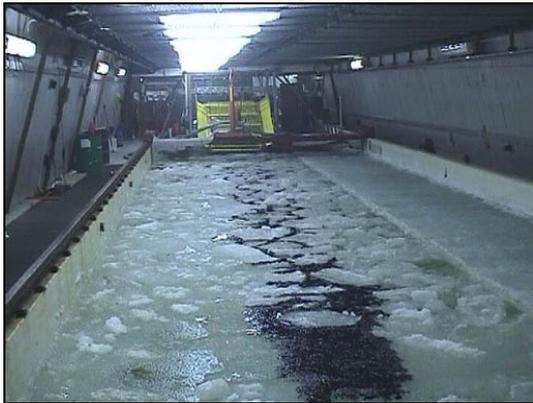
Ice conditions in the HSVA test tank immediately after the first oil has been deployed. We see a lot of small/slush ice. About 2 m of fast ice is left on the righthand side of the tank.

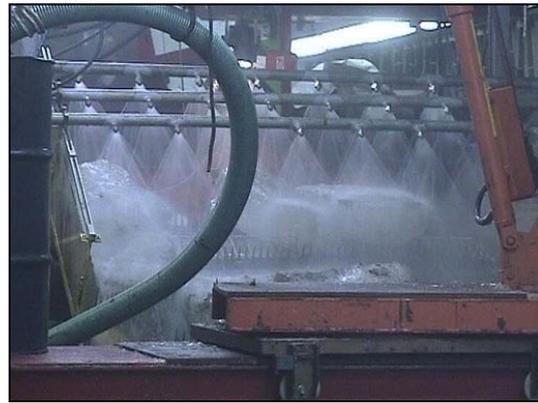
Flushing oil off ice. The spray from adjacent nozzles are overlapping, and nozzles in different spraybars are staggered.

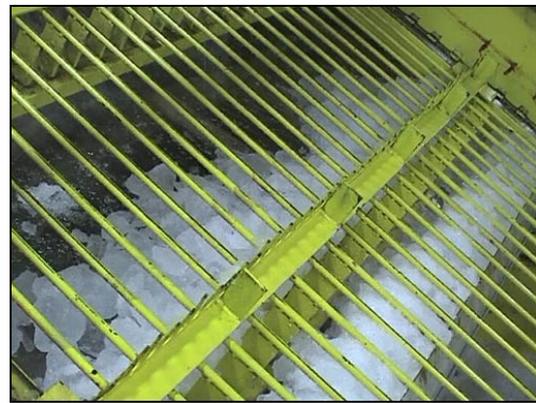
Small ice jammed on flushing tray, before modification. Once some ice is jammed, there is a quick build-up of ice on the flushing tray.

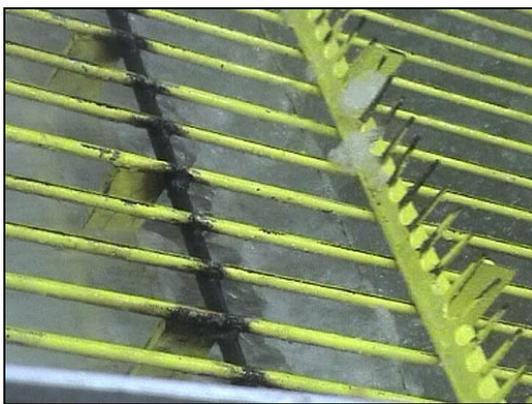
After modification. Two of every three pieces of flat iron supporting the grating bars have been removed. To support the bars, a thicker cross bar (black) has been welded to the grating.

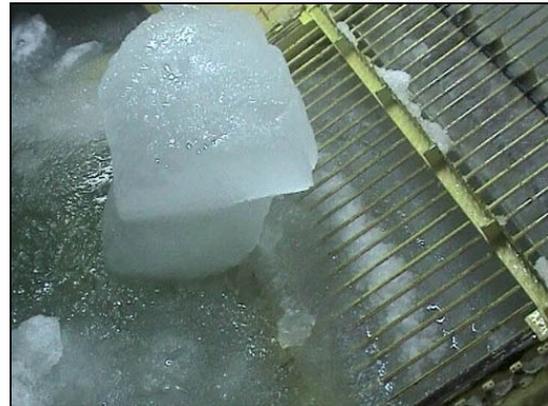
Recovery unit (Aquaguard RBS-10) not able to process the ice fast enough, resulting in small ice building up inside the grating of the Lifting Grated Belt.

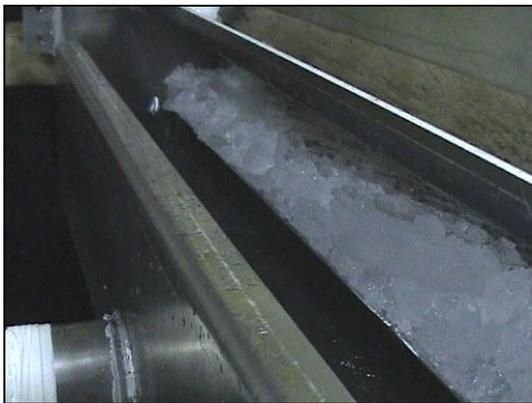
LORI brush unit, rear trough full of fairly dry ice that is not moving towards the outlet, very hard to transfer with a pump.

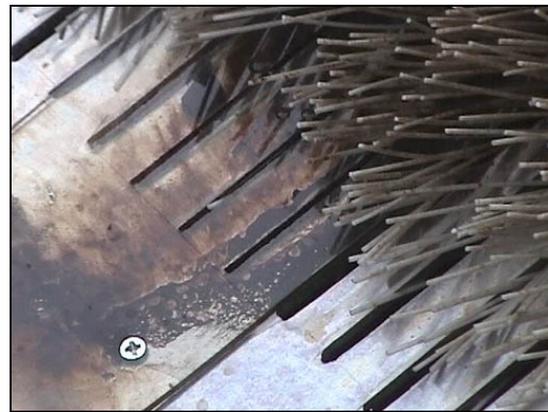
LORI brush unit. The front comb/scrapper has very wide openings. A small lexan (transparent) section of more narrow comb was installed to see the difference.

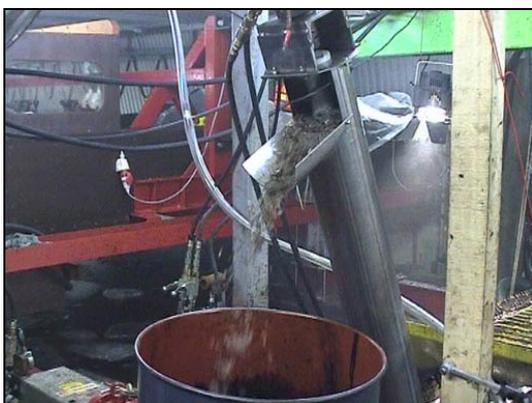
LORI brush unit after installing augers for transfer of recovered product from the rear trough. We see oil and ice being transferred to the open top container.

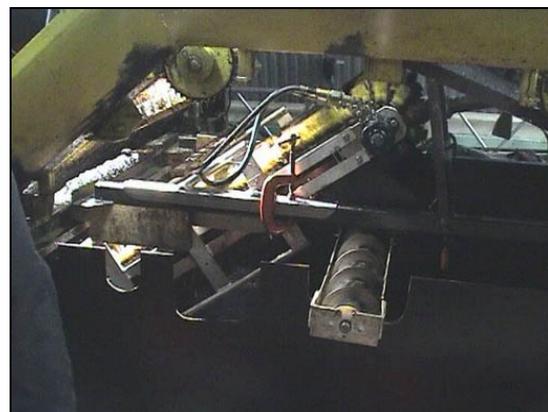
LORI brush pack unit installed after modification with a horizontal screw auger.

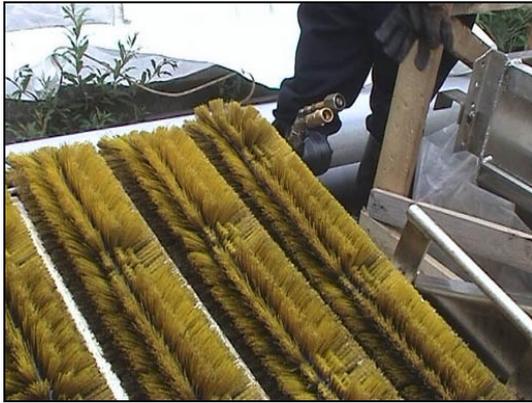
LORI brush pack after operation in ice and oil, sections of bristles have been cut away to give room for ice pieces.

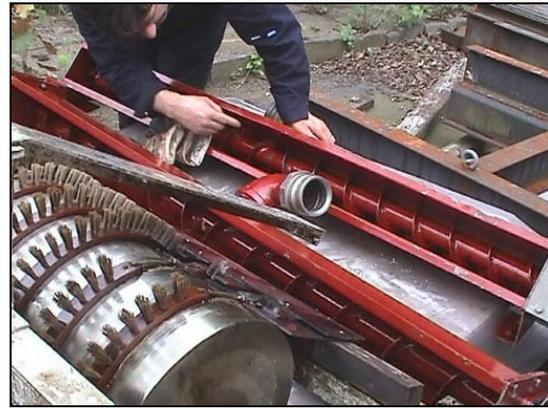
Brush Drum and troughs with screw augers. Note that the two augers operate in different directions when moving product to the outlet at the middle of the troughs.

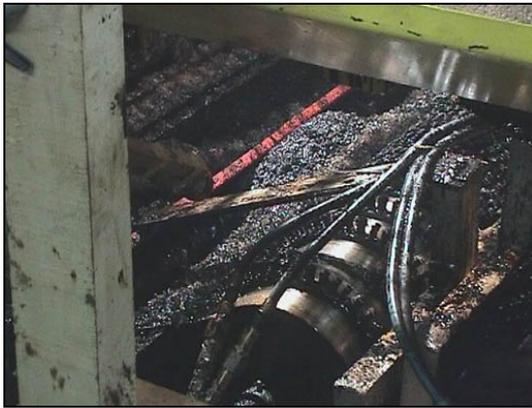
Brush Drum operating in oil and ice. The screw auger is piling up recovered ice and oil at the middle of the trough (the conveyor pump is not running).

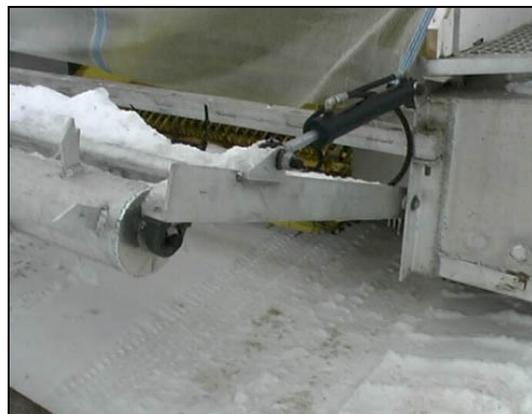
Ice feeder with hydraulic ram to adjust height.

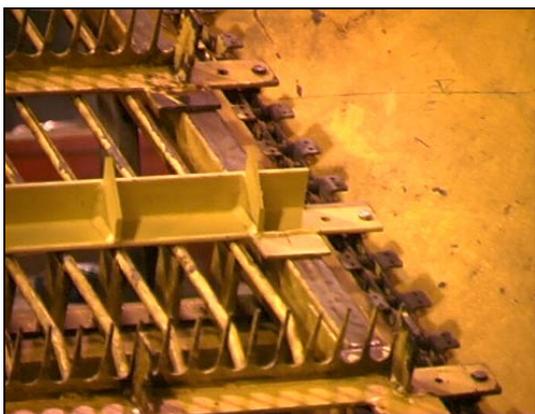
Close-up of new rakes in between old ones.

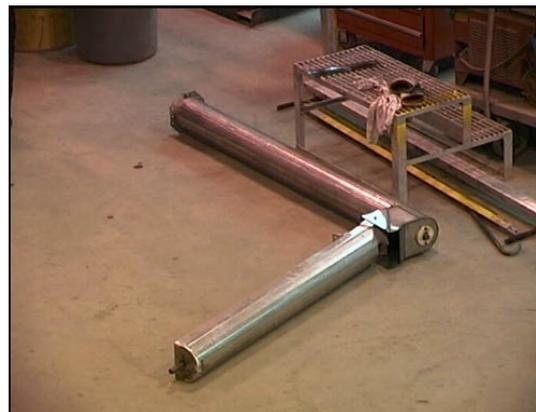
LORI recovery unit, horizontal and vertical screw augers connected prior to installation.

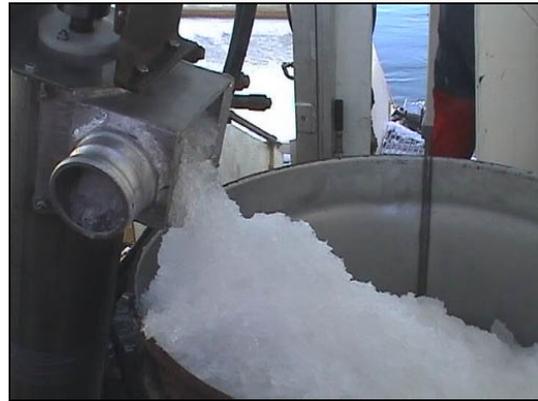
LORI recovery unit, the recovered product is falling from the entrance of the vertical screw auger into the open top container.

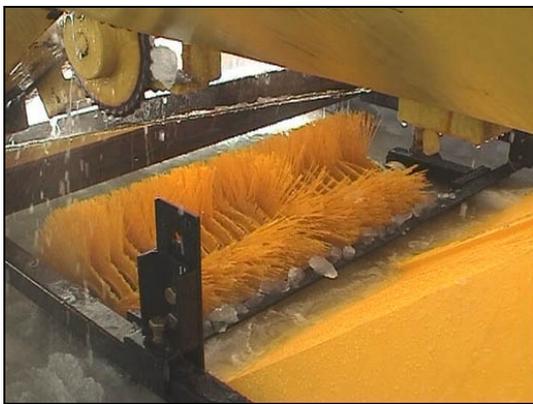
LAMOR unit operating inside Lifting Grated Belt. The cylindrical brush moves ice and oil into the "bell". Some bristles have been removed to improve ice processing.

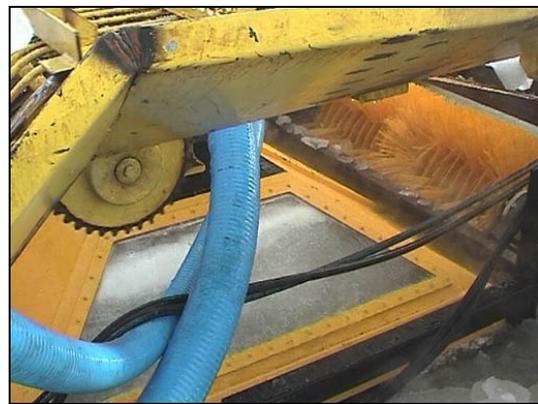
LAMOR unit operating inside Lifting Grated Belt. This "bell" has a window on one side to observe the level inside.

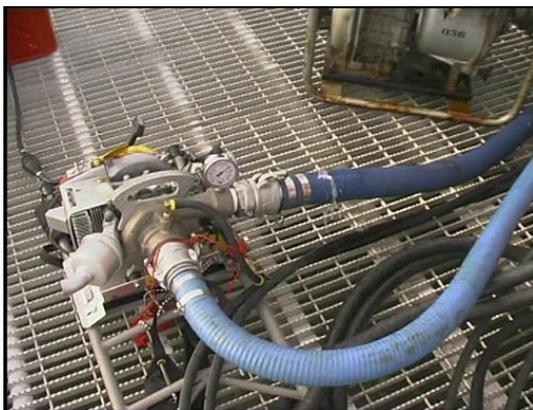
LAMOR unit, water pump for the ice crusher.

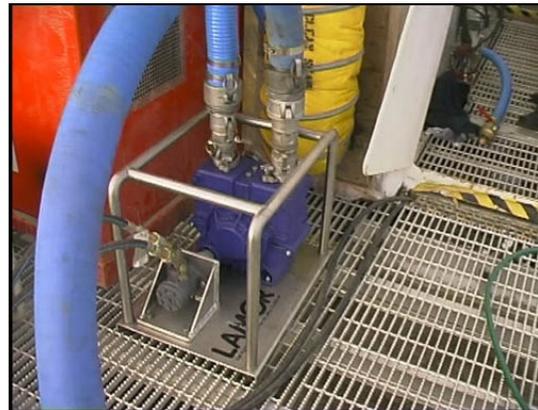
LAMOR unit, peristaltic pump for recovered product.
