Damage Tolerance of Synthetic-Fiber Mooring Rope: Small-Scale Experiments and Analytical Evaluation of Damaged Subropes and Elements

**Final Project Report
Prepared for
Minerals Management Service**

**1435-01-99-CA-31003
Task Order 18034
MMS Project Number 472**

September 2002

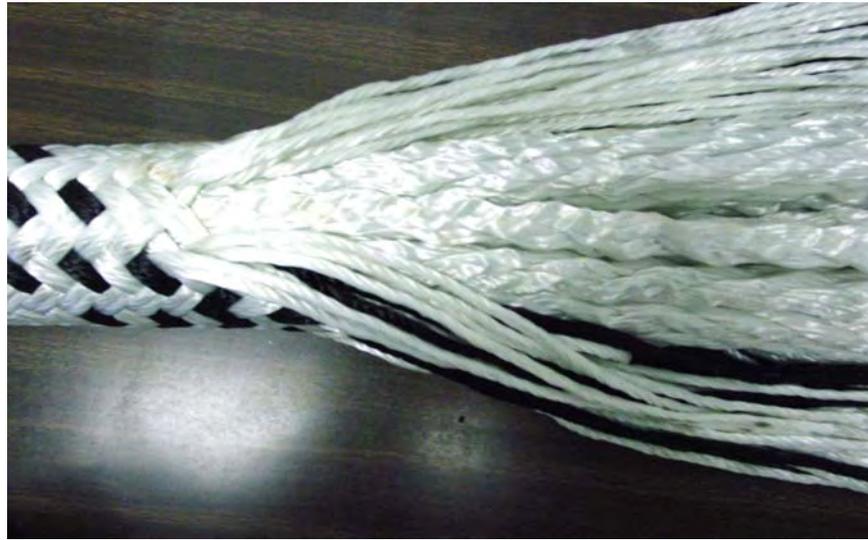
Figure 1 Mooring rope #1.

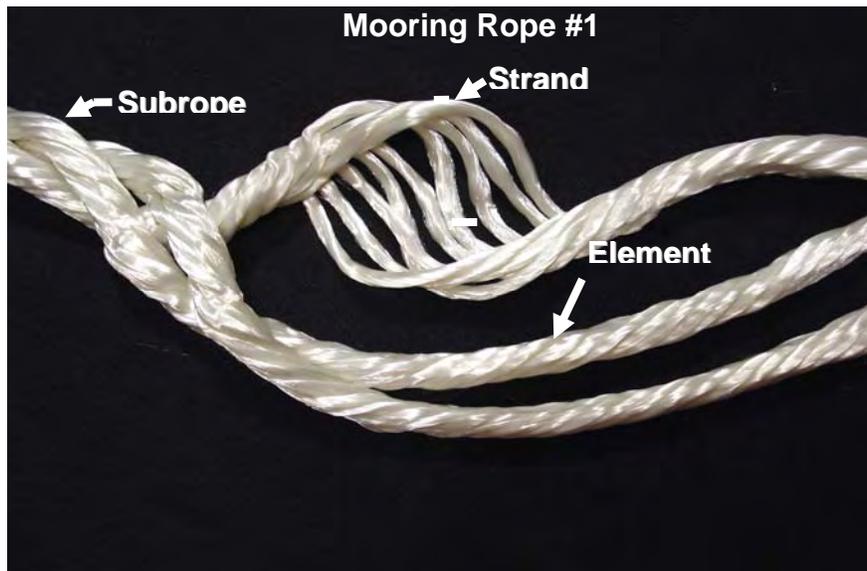
Figure 2 Definitions of strand, element and subrope (Mooring rope #1).

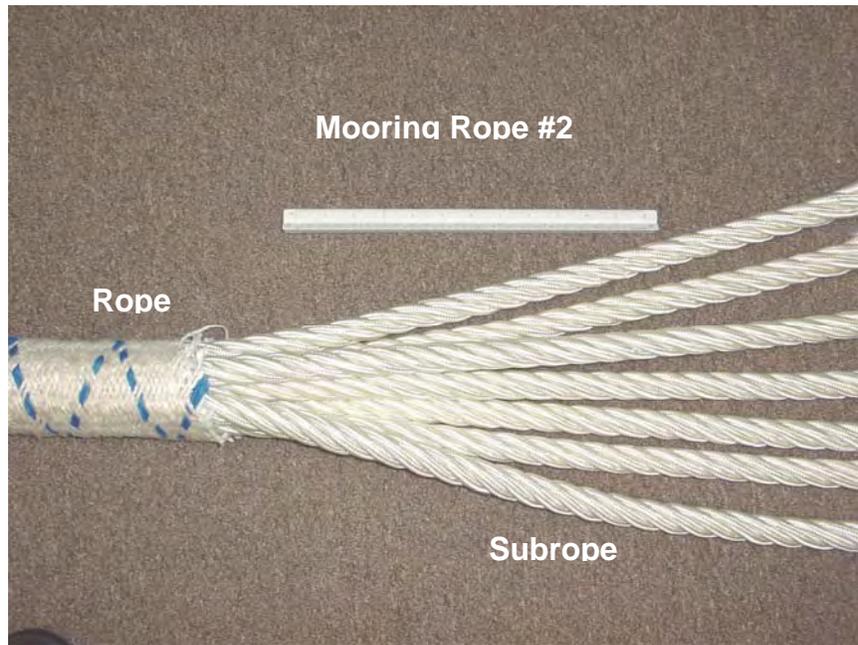
Figure 3 Mooring rope #2 construction.

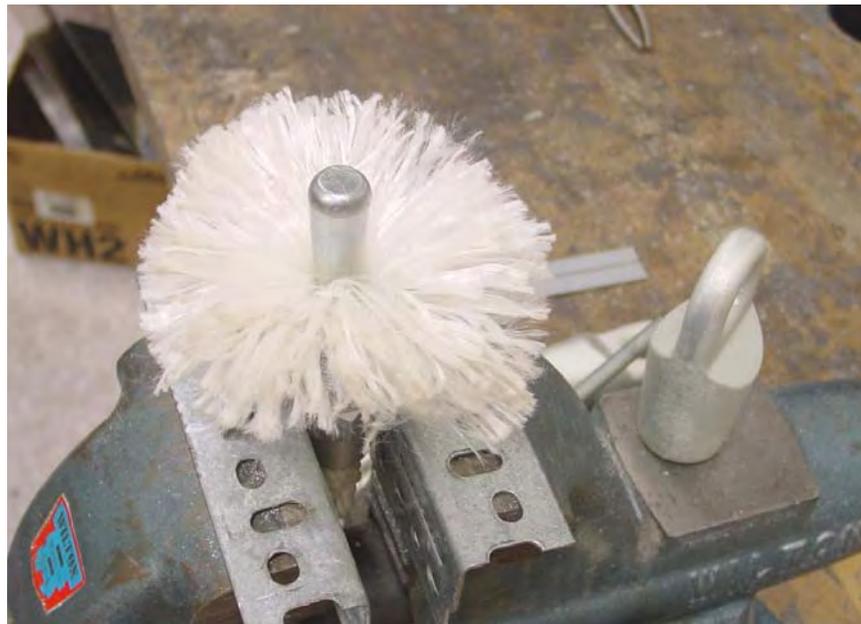
Figure 4 Spike and cone termination.

Rope element test specimens (for both Mooring Rope #1 & #2) were prepared, using a commercially available aluminum cone-and-spike (or barrel-and-spike) type termination, as illustrated in Fig. 4. The element and subrope specimens (of Mooring Rope #1) had a nominal length of 24 inches between end terminations. Preliminary tests indicated a premature failure due to abrasion of the fibers with the aluminum cone and steel spike in the contact area within the grips. This was resolved by inserting a thin piece of paper or tape between the fiber and metal parts. Data recorded included axial loads and strains and, in a limited number of tests, the change of specimen diameter during loading. Rotation of the termination at the end of each test specimen was also measured during the experiment.

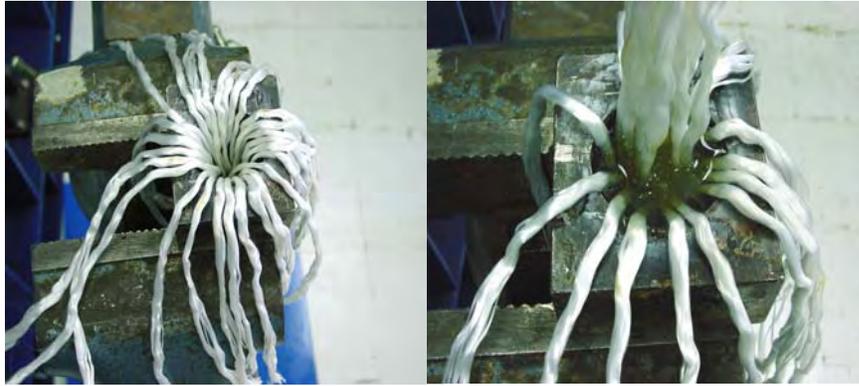
(a) Fiber strands in the cone. (b) Epoxy potting.

Figure 5 Potting subrope test specimen (Mooring rope #1).

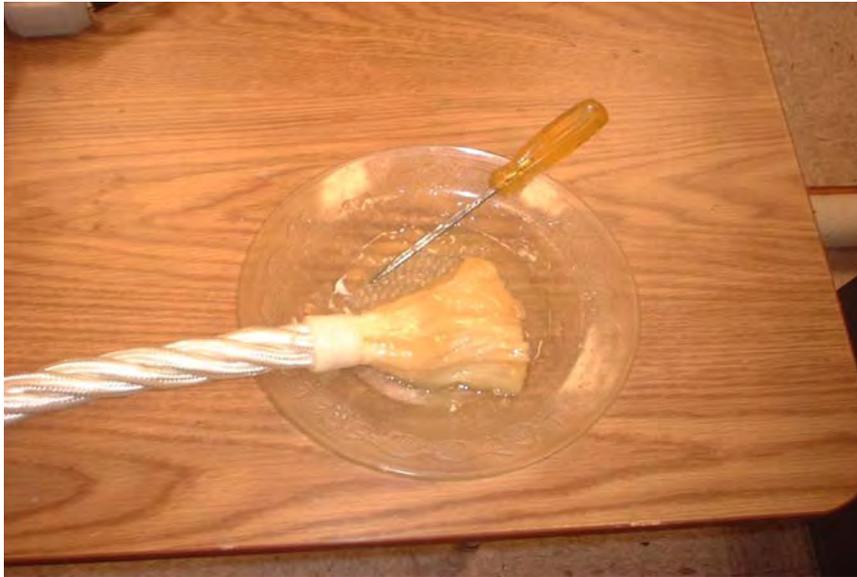
Figure 6 Rope with braided jacket removed (Mooring rope #2).

- (1) Removal of braided jackets of individual elements and washing out the abrasion-resistant coating on fibers with fresh water (Fig.6).
- (2) After drying fibers, presoaking all fibers by stirring the fibers with a hand tool (Fig. 7).
- (3) Applying heat to improve resin bonding (by wrapping a heating tape on the socket surface) (Fig. 8).

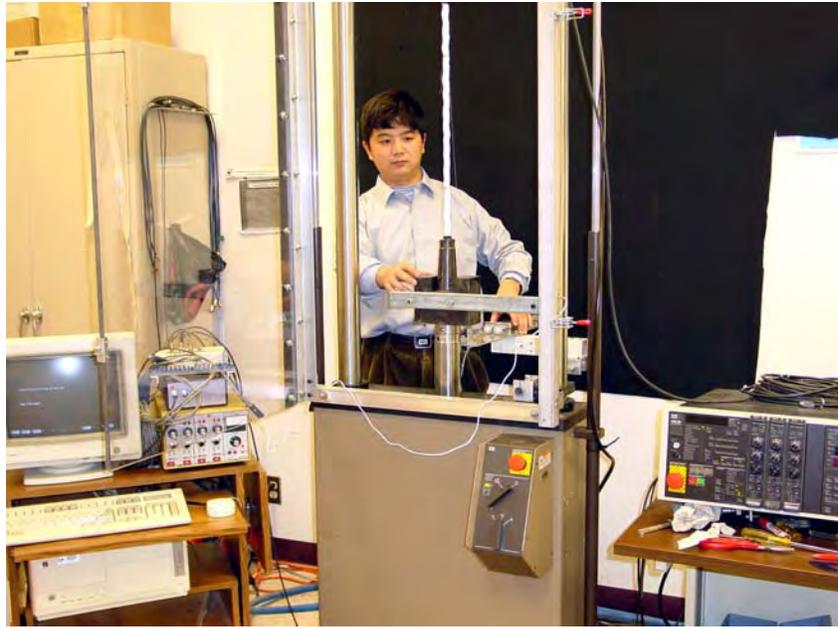
Figure 9 Experimental facilities and setup for subrope test (Mooring Rope #1).

The data collected in a subrope test included the load-cell response, axial strain, and the change in specimen diameter during loading. Strains were measured with two LVDT's connected to the test specimen by a (polyester) sewing thread secured to the rope using a rubber band. Small pulleys were used to allow the LVDT's to be mounted remote from the rope. This arrangement gave the test specimen a gage length up to 24 inches that would result in high accuracy. Most rope element tests were conducted on specimens with a gage length containing three periods of twist. For the tests involving damaged (cut) strands, the string for both LVDT's was secured to the uncut strands or elements. Torque generated during the test was measured, using a load cell mounted on a lever arm attached to a conical metal fixture at one end and restrained by a test machine column on the other. The test system setup for Mooring Rope #1 is shown in Fig. 9.

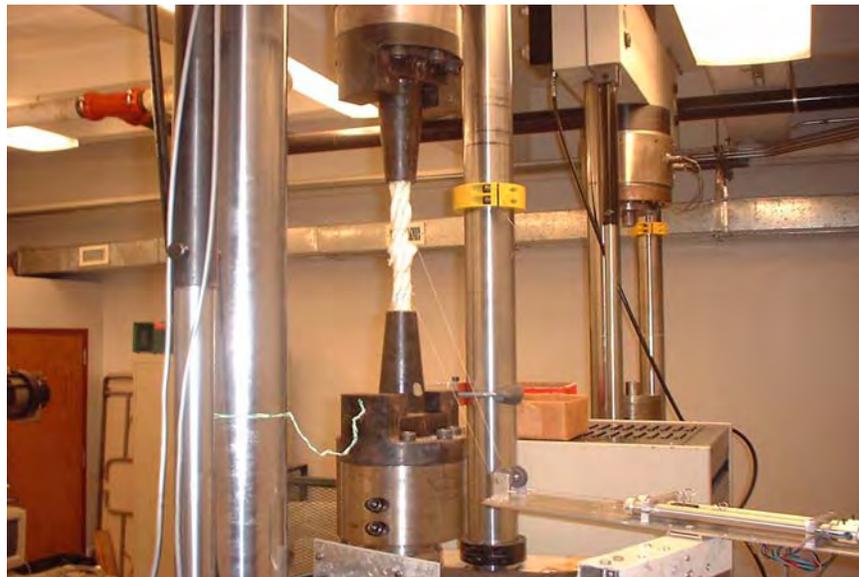
Figure 10 – Subrope test with end termination fixed in test machine (Mooring rope #2).

The expected higher ultimate failure load of Mooring Rope #2 required the use of a larger capacity test machine as shown in Fig. 10. A built-in load cell automatically recorded the torque generated during the test. The stroke length of the larger test machine limited the maximum subrope test specimen to a gage length of two periods of the twist.

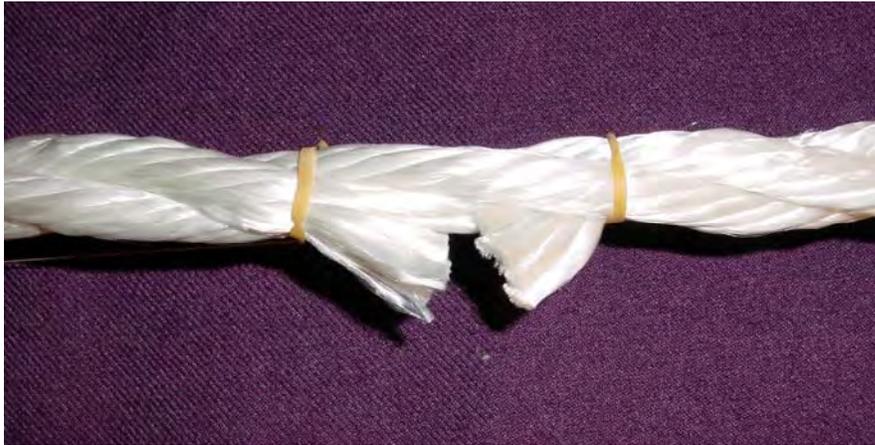
Figure 11 A subrope with damage (cut) (Mooring rope #1).

The damage introduced into both element and subrope specimens was made by cutting a predetermined amount of yarns or strands with scissors or a sharp razor blade. The procedure for preparing a damaged specimen from Mooring Rope #1 involved cutting strands in selected elements after the specimen was mounted in the test machine as illustrated in Fig. 11. The procedure for preparing damaged test specimens from Mooring Rope #2 was to place a shrinking tube around the selected element and cut carefully through the tube and the

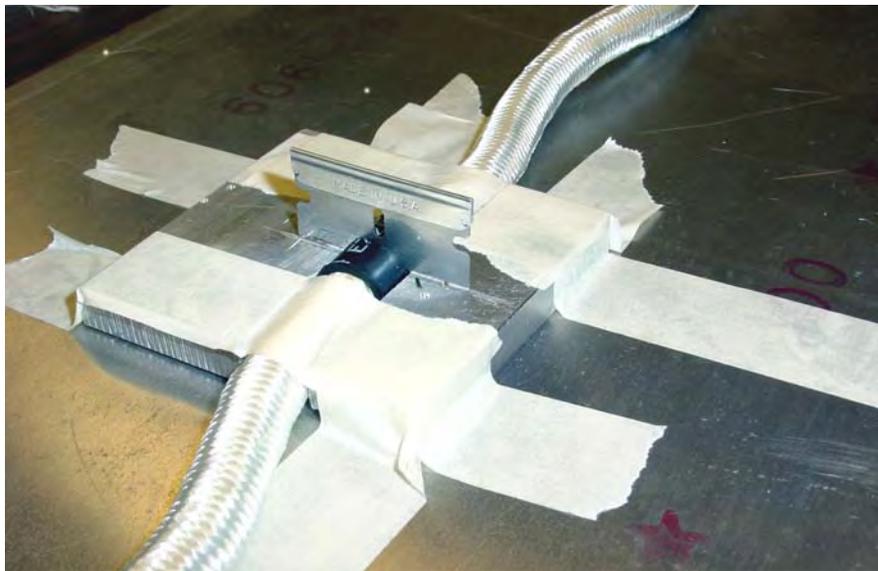
Figure 12 A rope element with damage (cut) (Mooring rope #2).

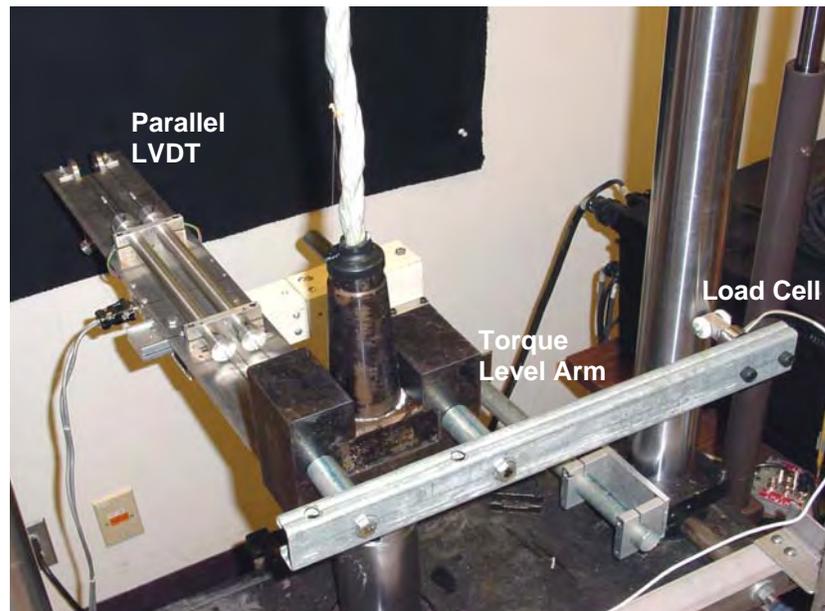
Figure 14 Torque and LVDT measurement devices.

The lower piston of the servo-hydraulic test machine had almost negligible resistance to torque. Since the rope elements and subropes were not torque-balanced, specimen rotations occurred during loading and their final rotation angles were recorded. A few subrope tests were also conducted without the torque restraint. However, the rotations were found to be very significant as to interfere with the aforementioned strain measurements. A torque restraint which was incorporated with a load cell was then installed, thus allowing to measure the torque generated during the test (see Fig. 14).

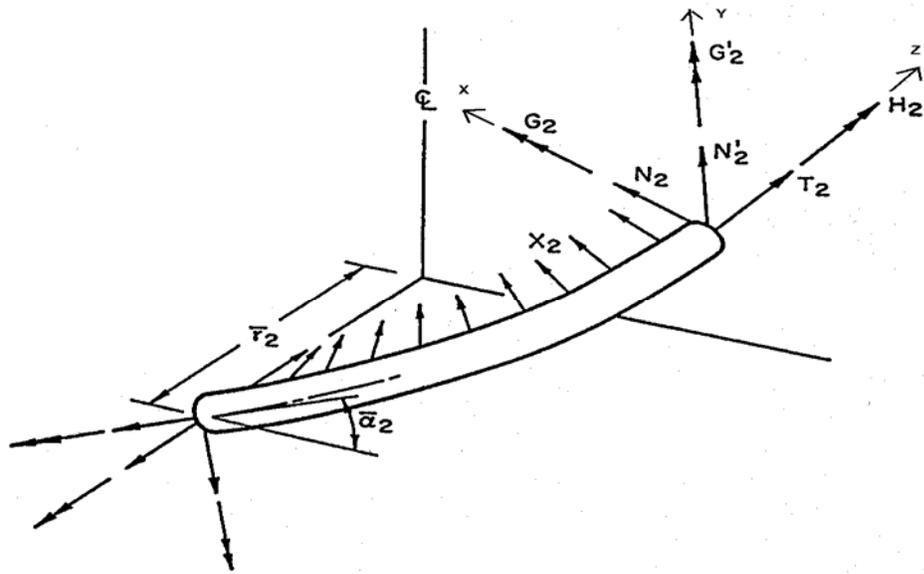
Figure 15 Load, geometry and coordinate system of a fiber strand.

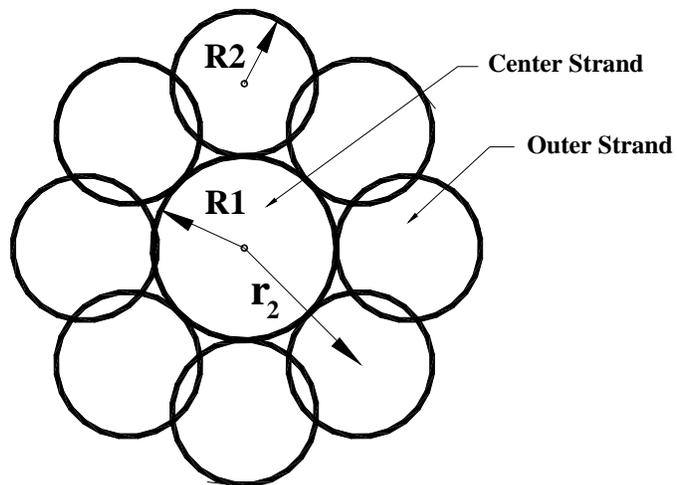
Figure 16 Sectional geometry of a rope element (Mooring rope #1).

The architecture of the rope element (in Mooring Rope #1) was that one strand was centrally located and surrounded by eight other strands. The test data included several kinds of damage (cutting), both symmetric and asymmetric. An appreciable difference is observed between the results of symmetric and asymmetric damage of the same number of strands, as indicated in Tables 3 and 4. Failure loads of the rope elements with asymmetric cuts were lower than those with symmetric cuts (with same degree of damage). Eccentric deformations caused by an asymmetric cut obviously made load transfer and distribution difficult and nonuniform in the spike and cone termination, resulting in premature failure. Other microstructural factors such as differences in twist of strands, misalignment and slippage of fibers within the termination would all affect the $\sigma_n - \bar{\epsilon}$ response. (Considering the number of the complicated factors involved, the current scatter in the $\sigma_n - \bar{\epsilon}$ behavior appeared to be reasonably bounded.) The strand cut in the center of a rope element allowed other strands to deform freely along the axial (longitudinal) direction as the specimen was loaded (as shown in the two photographs of Fig. 40 taken before and during loading). The cut strands were also relatively slack at the entry into the terminations and thus did not result in sufficient lateral traction to cause load-sharing and transfer. Therefore, the influence of strand damage in this case could be related to a net-area effect in the rope element. Even though some variations have been found in the $\sigma_n - \bar{\epsilon}$ response from test to test, basic characteristics of the $\sigma_n - \bar{\epsilon}$ relationships with and without the strand damage seemed to validate this hypothesis.

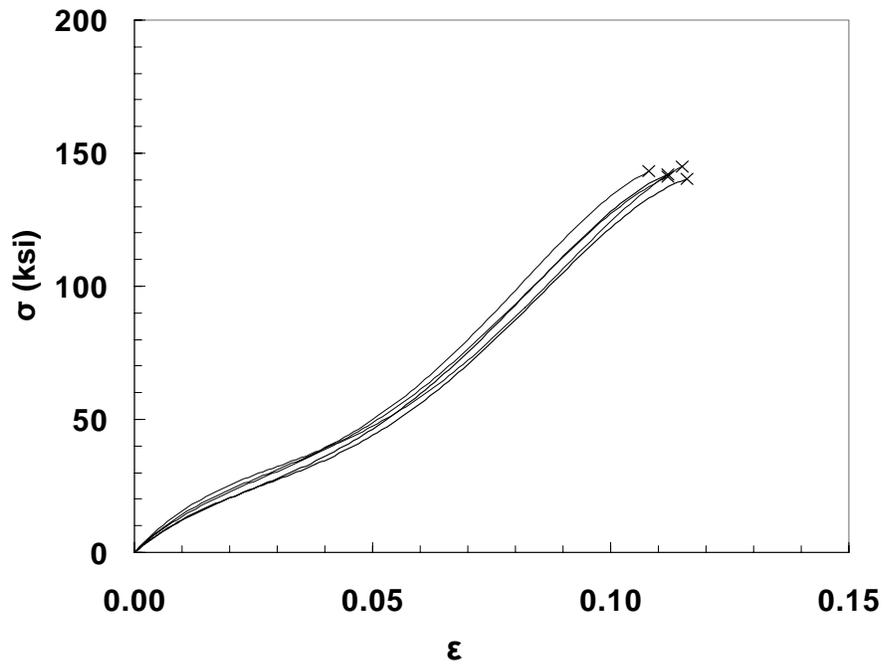
Figure 21 $\sigma - \epsilon$ behavior of polyester yarns (Mooring rope #1).

The stress-strain relationship of 2000-denier yarns of Mooring Rope #1 has been determined and shown in Fig. 21. The initial slope of the σ - ϵ curve decreased slightly with increasing strain and then increased gradually prior to its final failure. The stress-strain behavior of the yarns taken from different strands shows similar characteristics in deformation and failure strength (Fig. 21). Progressive failure of individual fibers within the yarns was observed during the load increase.

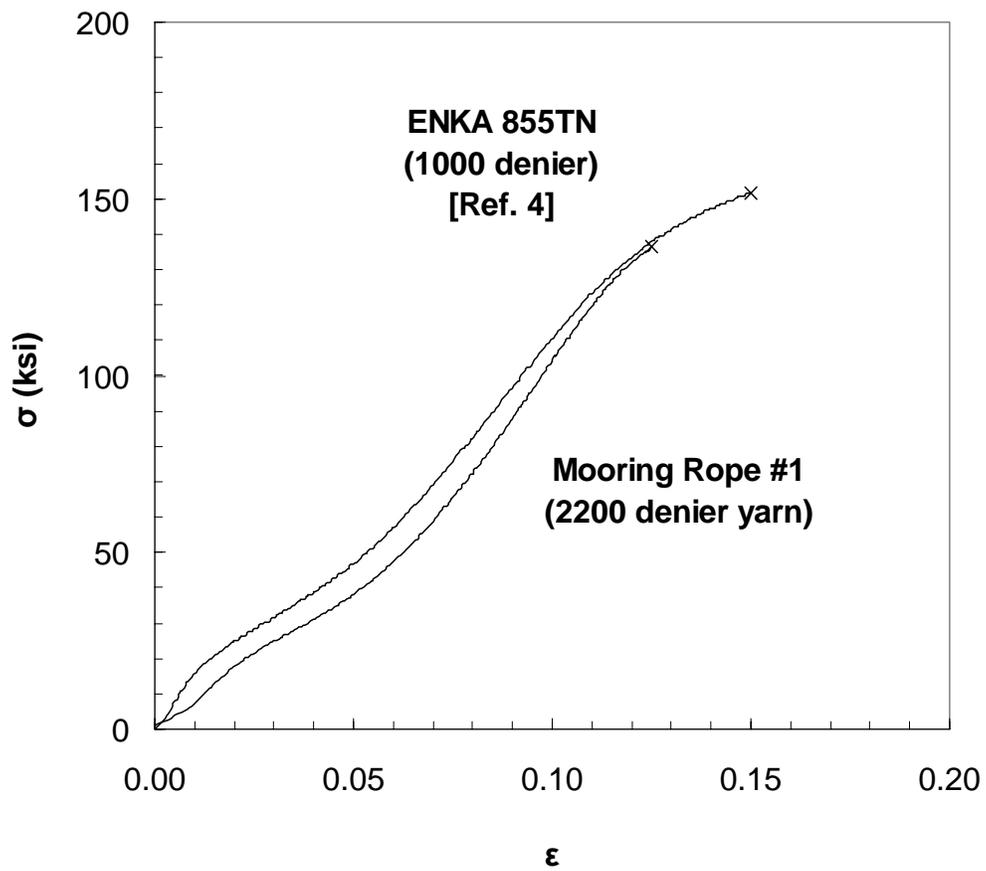
Figure 22 Comparison of test results with published data [4] (polyester yarns).

The stress-strain curve of the Mooring Rope #1 yarn is compared (Fig. 22) with that of a 1000-denier ENKA 855TN yarn reported in Ref. [4]. Although the overall deformation behavior of the Mooring Rope #1 yarn is similar to that of the ENKA 855TN yarn, noticeable differences in failure strain and strength can be observed.

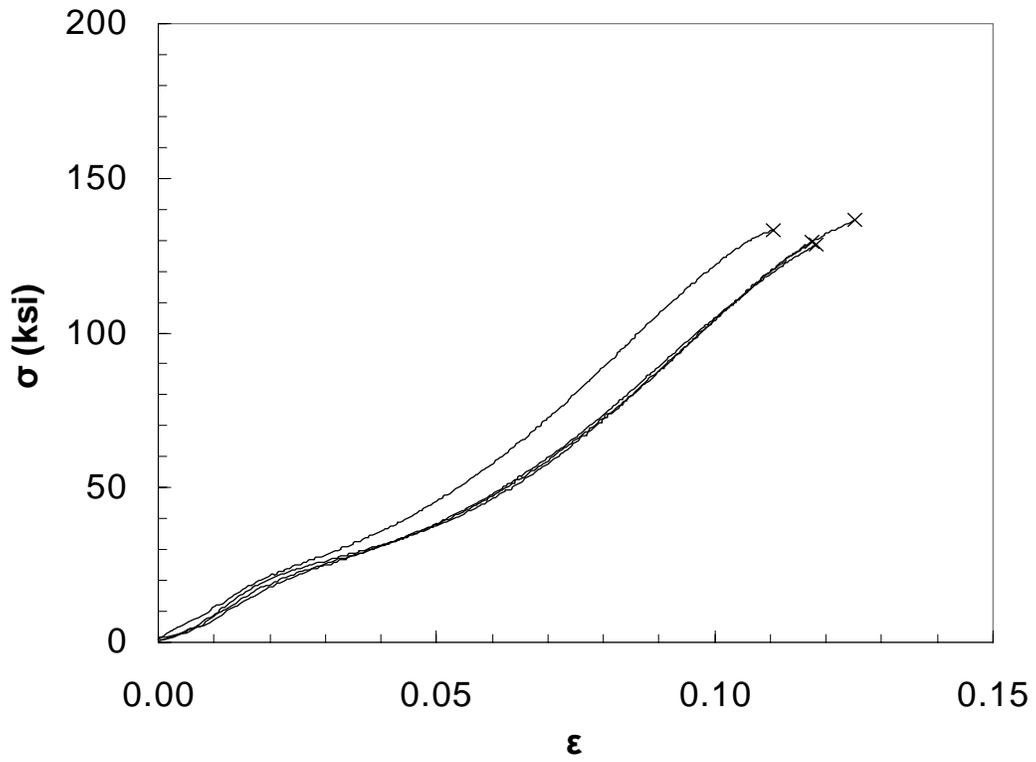
Figure 23 $\sigma - \varepsilon$ behavior of polyester-rope strands (Mooring rope #1).

The stress-strain behavior of polyester rope strands (Mooring Rope #1) has also been determined and shown in Fig. 23. The initial sigmoidal part may be attributed to kinematic deformation of twist of the strand specimen, and its σ - ϵ relationship follows a similar behavior as that of a yarn. Variations in the stress-strain curves of the strands were more appreciable than those of the yarns because of the strand twist kinematics and other initial geometrically induced initial strains. Progressive failure in the polyester strands during testing was also observed in the gage section as shown in Fig. 24.

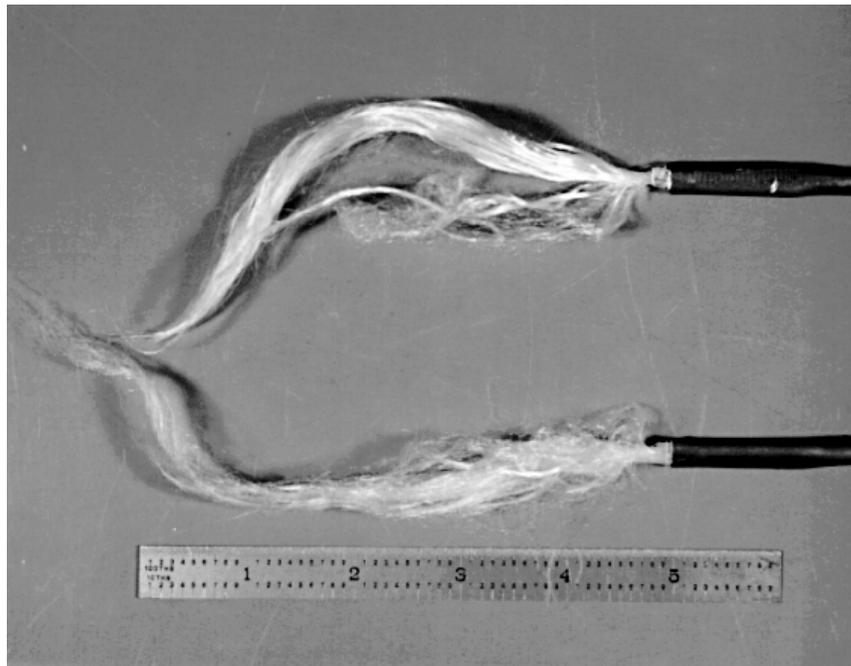
Figure 24 Failure mode of polyester-rope strands (Mooring rope #1).

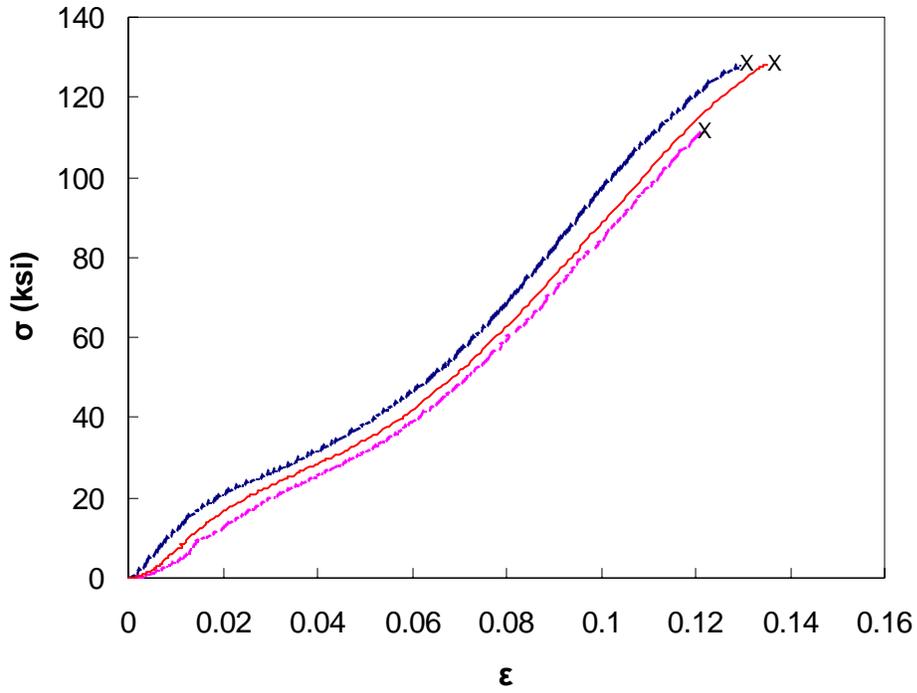
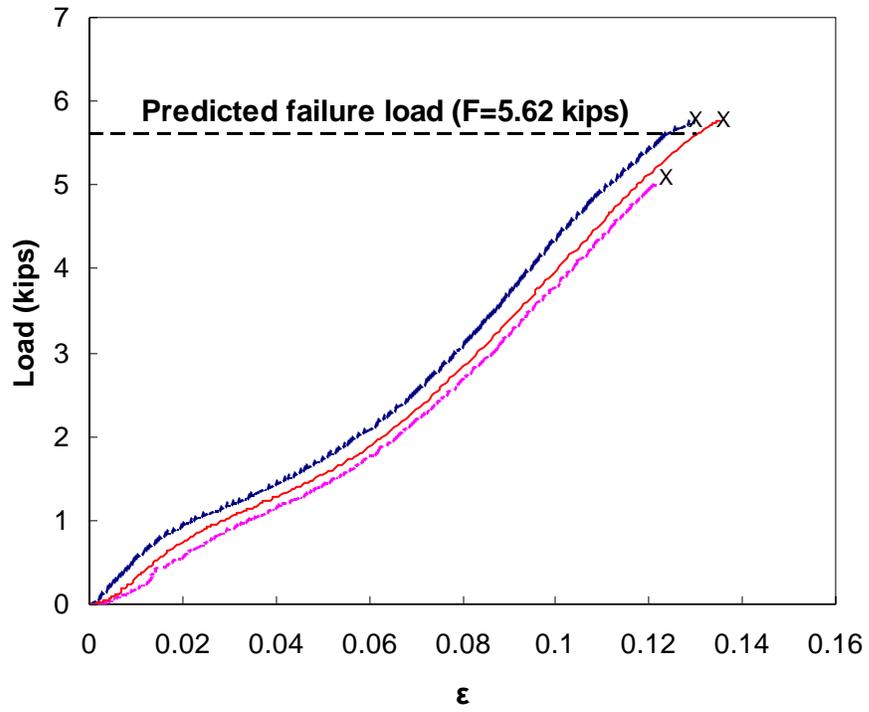
Figure 26 $\sigma - \epsilon$ behavior of undamaged rope elements (Mooring rope #1).

Figure 27 $P - \epsilon$ response of undamaged rope elements (Mooring rope #1).

Tensile test results obtained from undamaged polyester rope elements (Mooring Rope #1) are shown in Figs. 26 and 27. The ultimate strength of the rope element has been determined and given in Tables 3 and 4. General characteristics of the element load-strain behavior were found to be similar to those of the strands. The initial sigmoid and subsequent deformations in the σ - ϵ curve of the rope element were more pronounced due to the kinematics of twist within an element than those in a strand. Significant variations in the element test data were attributed to the difference in the initial amount of twist and to a lesser degree, uneven loading on the strands due to unequal length of the strands unintentionally introduced during specimen preparation. A small

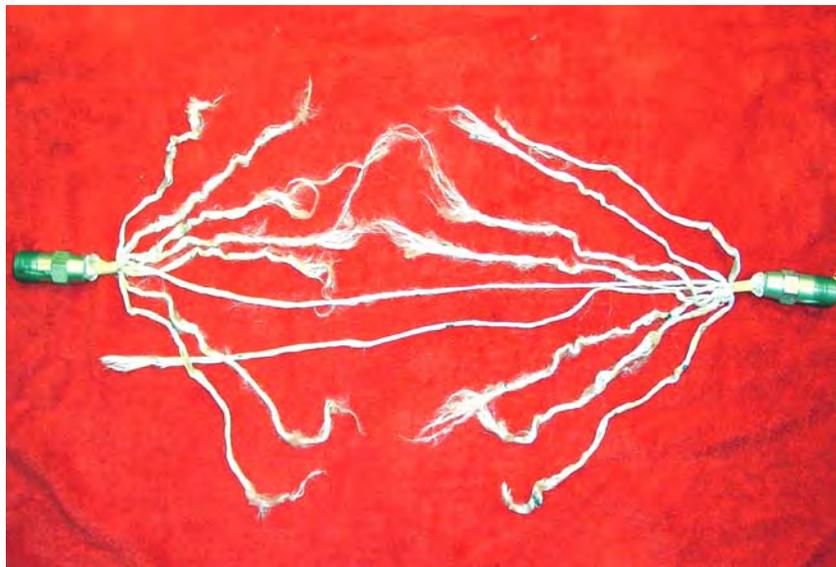
Figure 28 Rope element failure mode (Mooring rope #1).

variation in the rope element failure strength was found in the cases which had the failure occurring in the gage region. The characteristic failure mode observed in the undamaged Mooring Rope #1 elements is shown in Fig. 28. Progressive strand failure was found within both the rope element specimen and its terminations.

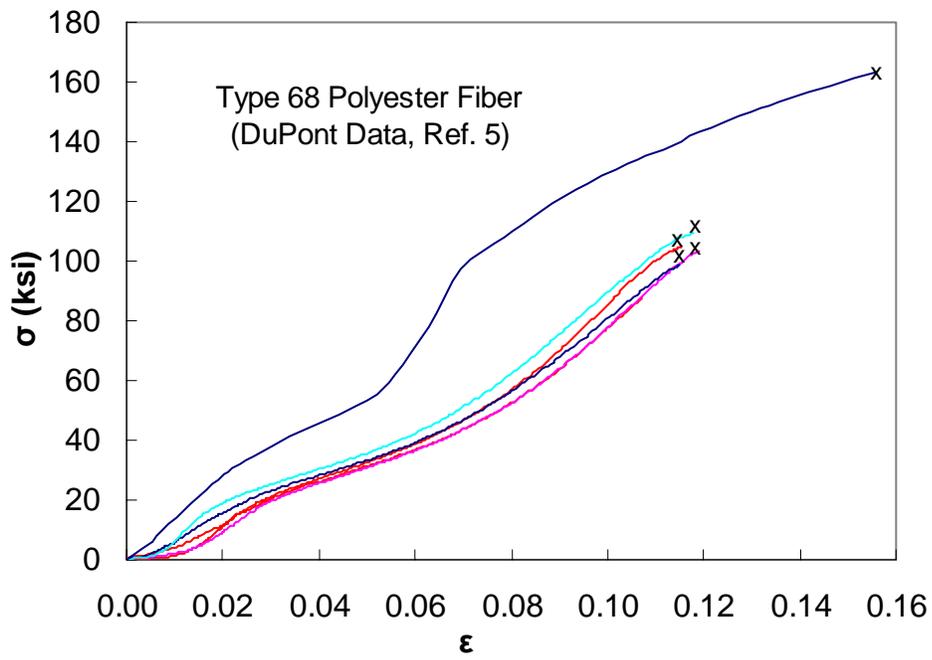
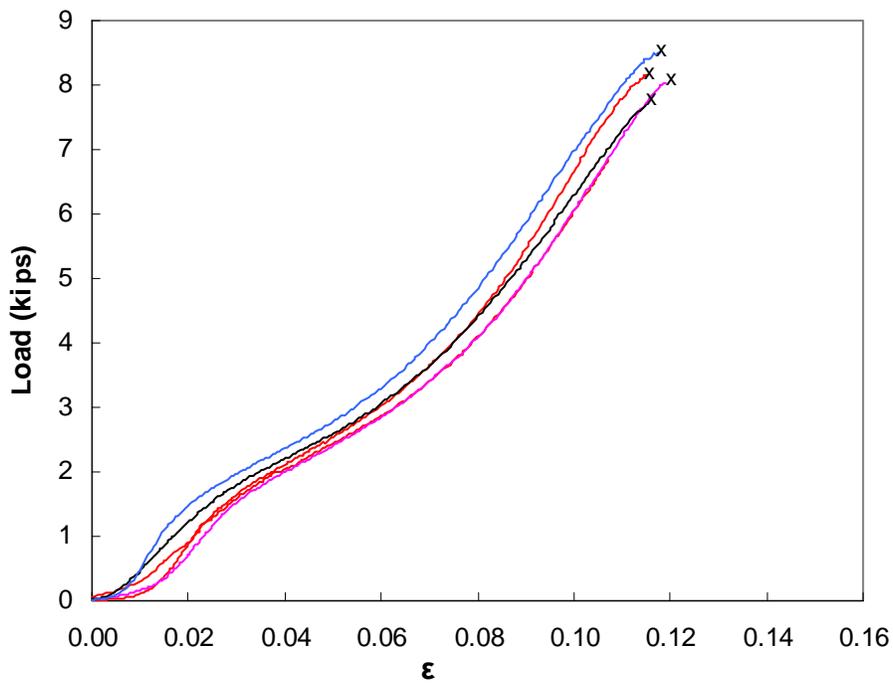
Figure 29 $\sigma - \varepsilon$ behavior of undamaged rope elements (Mooring rope #2).

Figure 30 $P - \varepsilon$ response of undamaged rope elements (Mooring rope #2).

The tensile stress-strain and load-deformation behavior of undamaged polyester rope elements (Mooring Rope #2) are shown in Figs. 29, 30. Also shown in Fig. 29 are the yarn data provided by the manufacturer. The difference in stiffness was caused by kinematic deformations due to initial element in twist and perhaps some other misalignments. The responses for all, but two, specimens fell in a fairly narrow range. The ultimate strength of the Mooring Rope #2 element measured in the tests is presented in Table 6. Measurements of lateral contraction in an undamaged rope element test as a function of the applied axial strain were made and shown in Fig. 31. A clip-on diametric extensometer was attached on the rope element during the test. Due to Poisson's effect, the cross section of the element specimen contracted under an applied tensile load. The rope element cross-sectional geometry changed axisymmetrically with an increasing axial load. (A discontinuity in the diametric change shown in the figure might be caused by relative movements at the contact point between the specimen and the extensometer contact arm, due to a rotation of the specimen.)

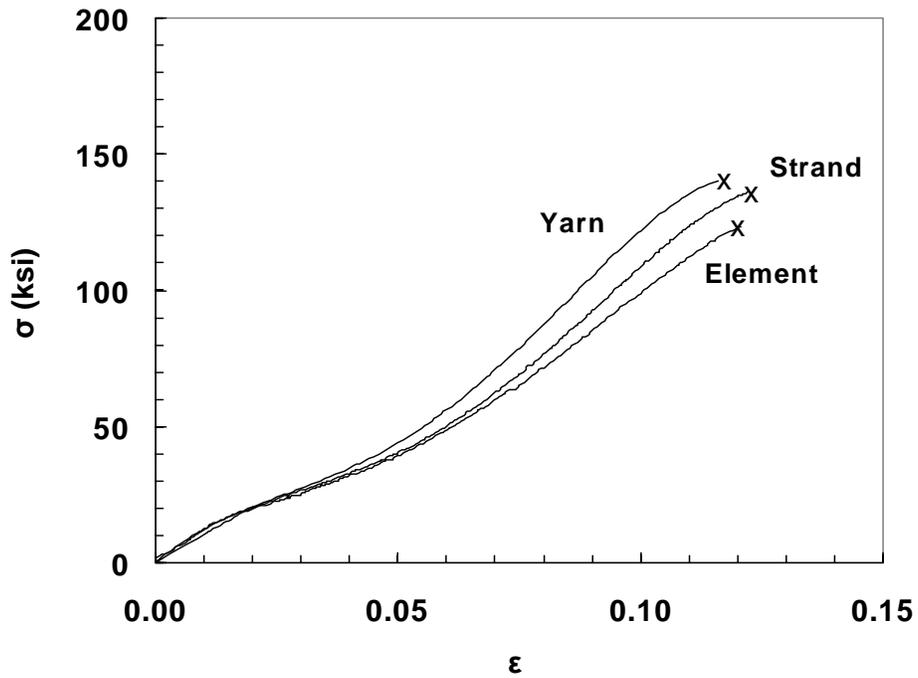
Figure 32 Comparison of stress-strain relationships among yarn, strand, and element (Mooring rope #1).

Comparisons among typical stress-strain curves of undamaged polyester yarns, strands and elements are given in Fig. 32. While initial deformation characteristics were similar at the three levels of the rope scale, appreciable differences in strain-hardening at a higher stress could be seen. Their failure strengths are found to be also dependent on the specimen size. The yarns had the highest failure strength and the strand strength was lower than that of the yarns. The rope element strength was lower than both the yarn and the strand strength. With an increasing specimen size, it became difficult to load all fibers uniformly. Therefore, it is possible that fiber-stress variations in a rope element could be largest and the progressive fiber breakage commenced at a lower applied load. The rope element also experienced a high degree of geometrically nonlinear deformation due to twisting kinematics in rope elements, leading to low strain hardening and strength.

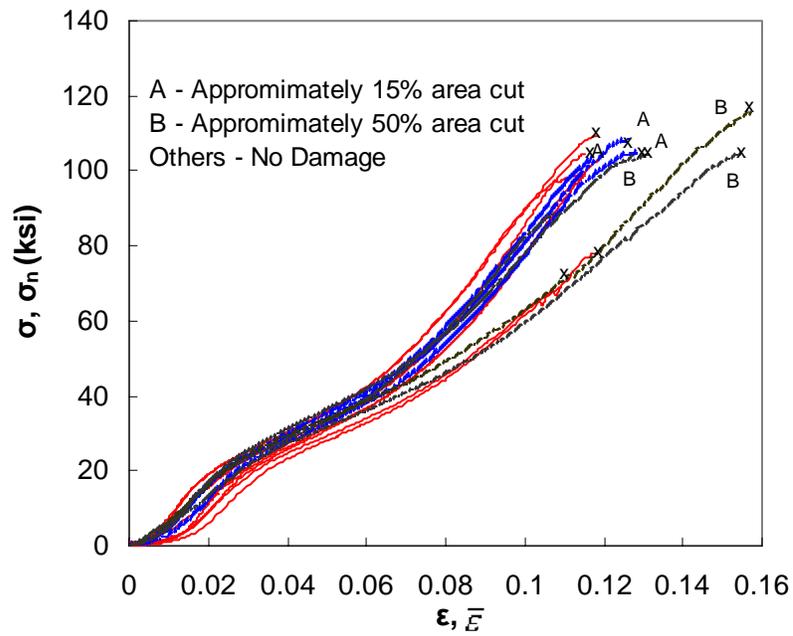
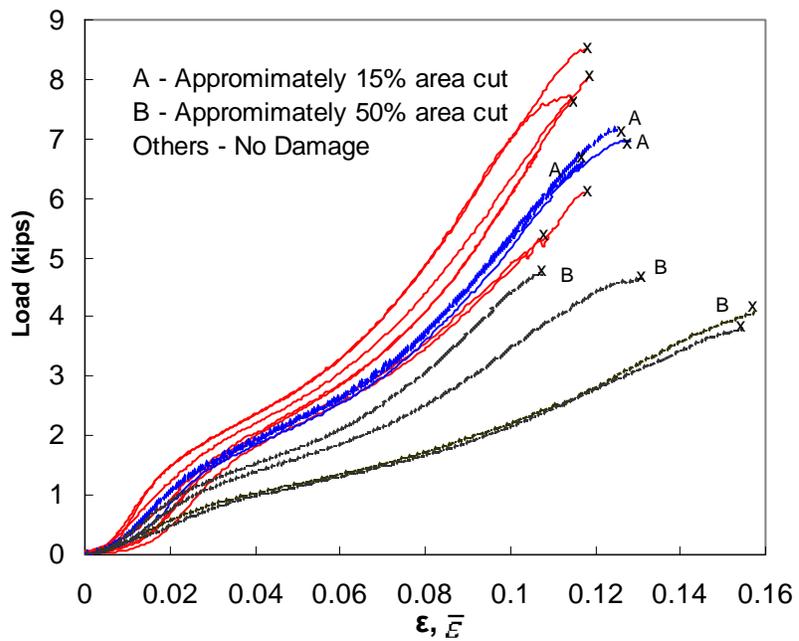
Figure 41 $\sigma_n - \bar{\varepsilon}$ and $\sigma - \varepsilon$ behavior of Mooring rope #2 elements (undamaged and damaged).

Figure 42 $P - \bar{\varepsilon}$ responses of Mooring rope #2 elements (undamaged and damaged).

Test data of damaged rope elements (Mooring Rope #2) with approximately 15 and 50 percent reduction of cross-sectional area are presented in Figs. 41 and 42. Detailed examinations of the test specimens following their failure, such as the one shown in Fig. 43, enabled to affirm accurately the amount of cross-sectional area loss. Most of the $\sigma_n - \bar{\epsilon}$ results fell within the upper undamaged band; however, the responses of four specimens (i.e., 2 undamaged and 2 damaged) were in the lower band. Discussions with the rope manufacturer revealed no apparent reasons for the two distinct responses of the elements from Mooring Rope #2, as all rope elements used in the study were made in a single run to make subropes.

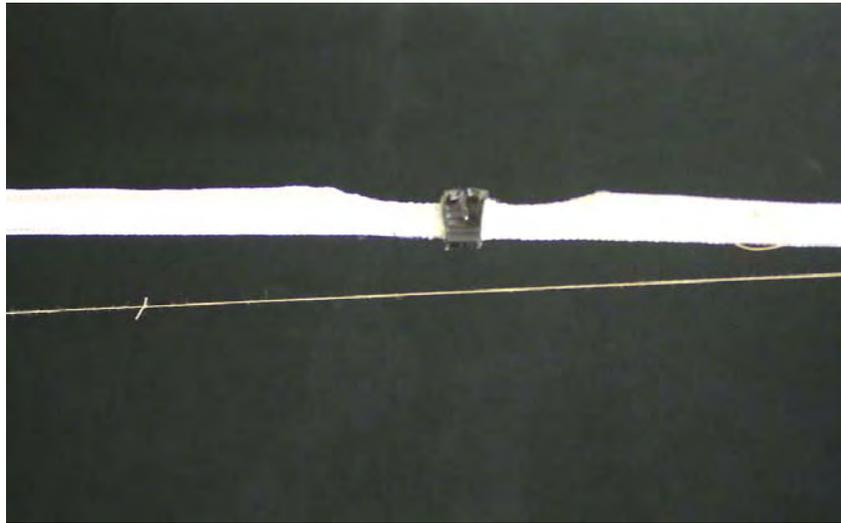
Figure 45 Neck-down of cut fiber-strand migration during rope element test (Mooring rope #2).

Relatively high failure strengths of the damaged rope elements were obtained in these tests; however, the element failure almost always involved some influence of the termination. Although some yarns failed within the test section as the load approached its failure strength, other yarns would begin to fail progressively in the termination. During the test, cut ends were often observed to translate as a unit within the braided jacket as indicated by necking down in an element cross-section (Fig. 45). The loose condition of cut ligaments at the

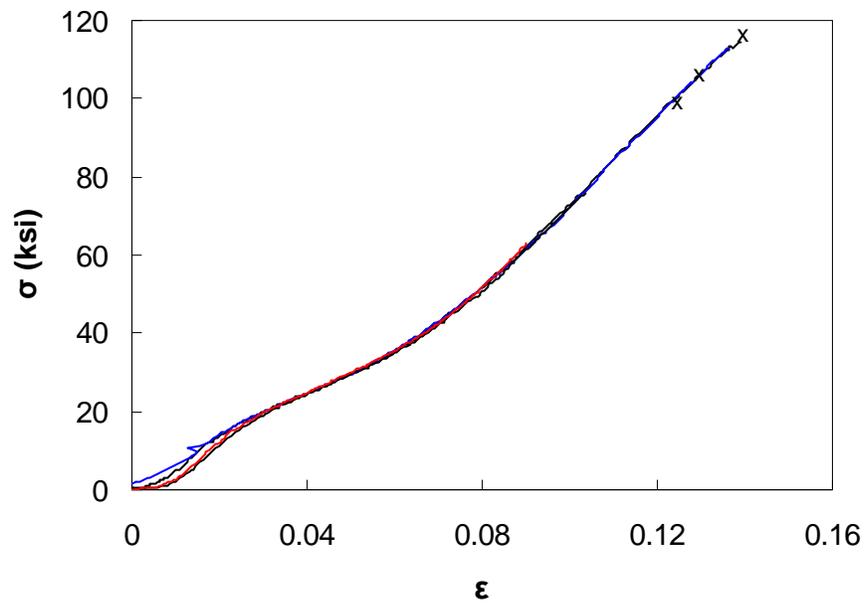
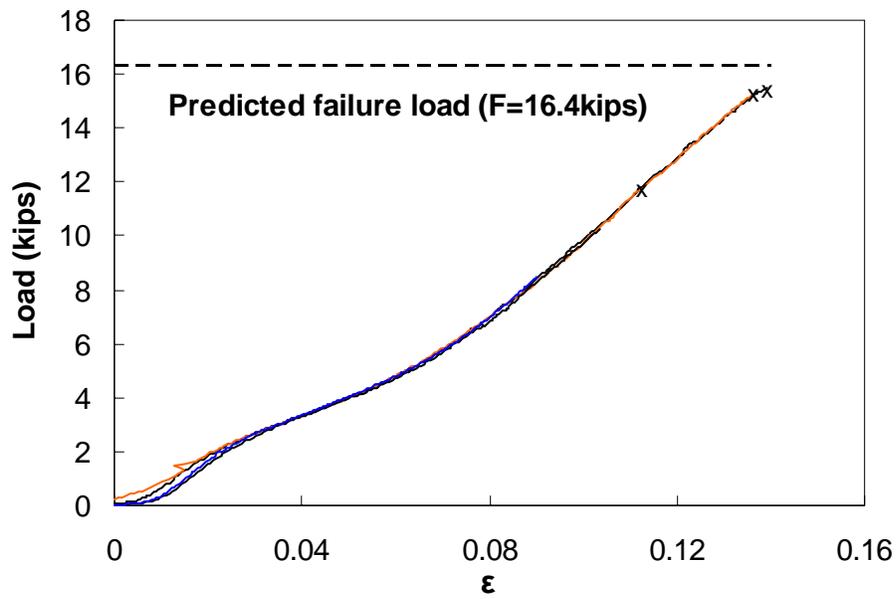
Figure 46 $\sigma - \epsilon$ behavior of undamaged subropes (Mooring rope #1).

Figure 47 $P - \epsilon$ response of undamaged subropes (Mooring rope #1).

The load-deformation response of an undamaged subrope (Mooring Rope #1) is presented in Figs. 46 and 47 with its ultimate failure strength given in Table 5. Four different specimens in the tests exhibited almost identical responses.

A comparison between the predicted subrope failure strength and the subrope test data is given in Fig. 47 and in Table 5. The failure strength and the torque generated in a subrope without damage (Mooring Rope #1) are predictable, based on the current rope mechanics analysis. It can be seen that the predicted subrope failure strength is quite close to the test data; however, the maximum torque calculated is larger than that obtained in the tests. One may expect some discrepancies between the test data and the subrope predictions, for the section shape of the subrope under loading would no longer keep its circular geometry as originally assumed in the analysis. The pitch radius of the helical subrope will be reduced more significantly than the deformation assumption made in the rope mechanics formulation. Viscoelastic relaxation is not considered in the present polyester subrope failure analysis.

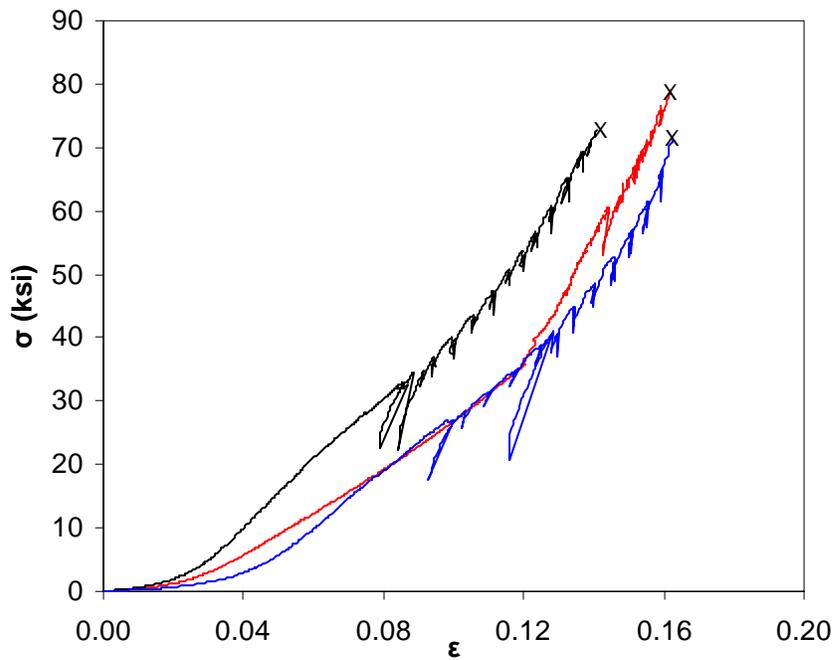
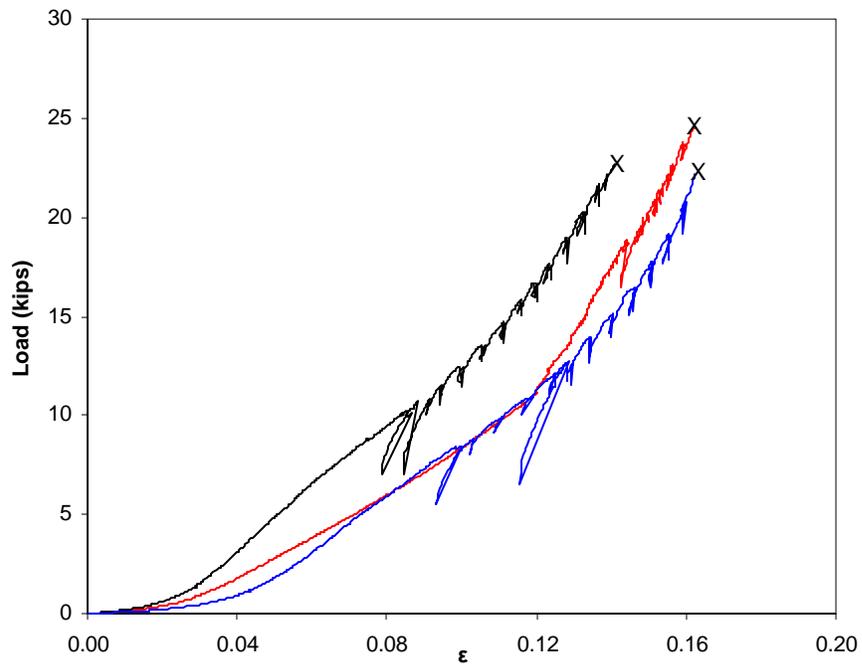
Figure 48 $\sigma - \epsilon$ behavior of undamaged subropes (Mooring rope #2).

Figure 49 $P - \varepsilon$ response of undamaged subropes (Mooring rope #2).

The load-deformation response of undamaged subropes (Mooring Rope #2) is presented in Figs. 48 and 49, and their ultimate strengths are given in Table 7. All the three test specimens exhibited premature failure near their terminations. The results also show that the present socket termination was not 100-percent efficient. The failure strength of the subrope obtained here about is 64% of the reported ultimate break load of the subrope, which is close to the value expected by a state-of-the-art approach (Page 17 in [6]) (The strength of socket termination can be as low as 70% of that with a spliced termination.)
