Damage Tolerance of Synthetic-Fiber Mooring Rope: Small-Scale Experiments and Analytical Evaluation of Damaged Subropes and Elements

**Final Project Report
Prepared for
Minerals Management Service**

**1435-01-99-CA-31003
Task Order 18034
MMS Project Number 472**

September 2002

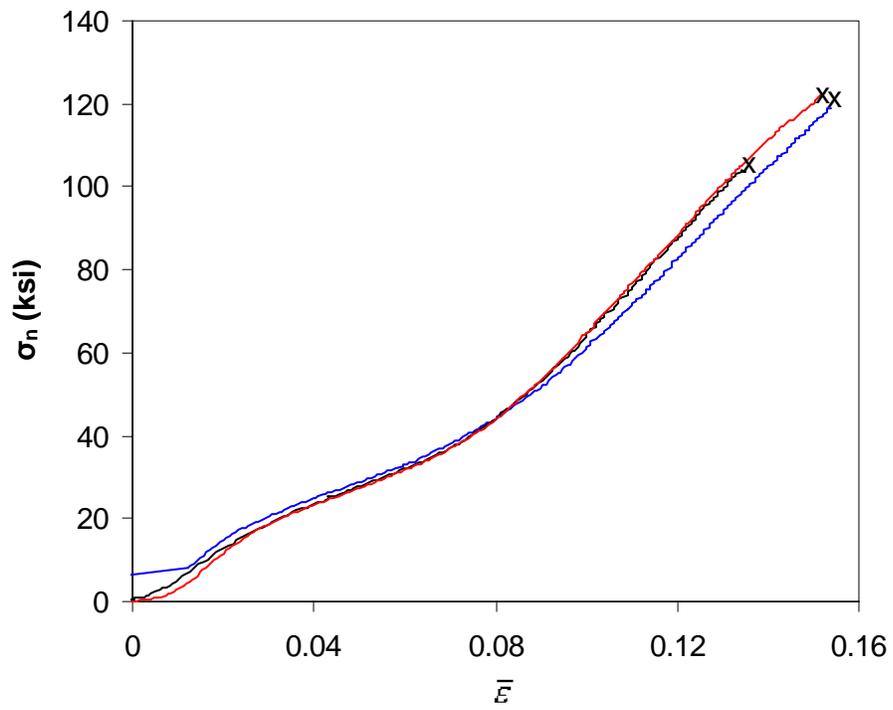
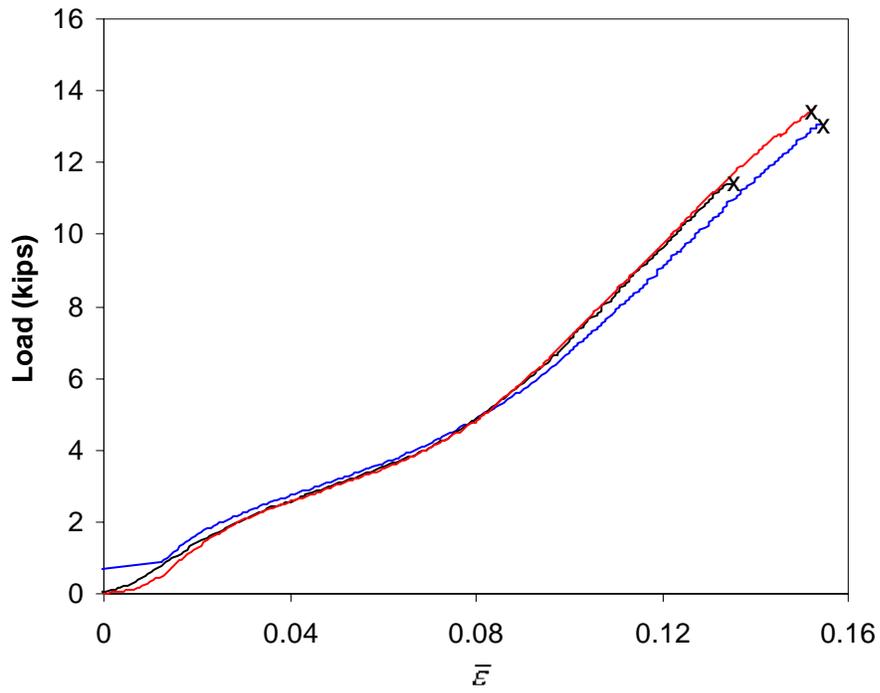
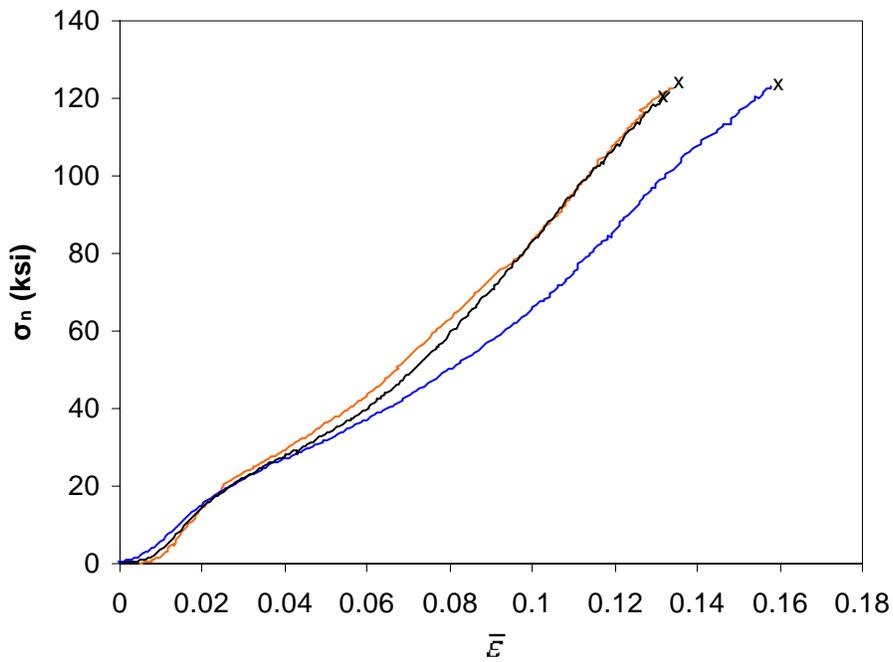
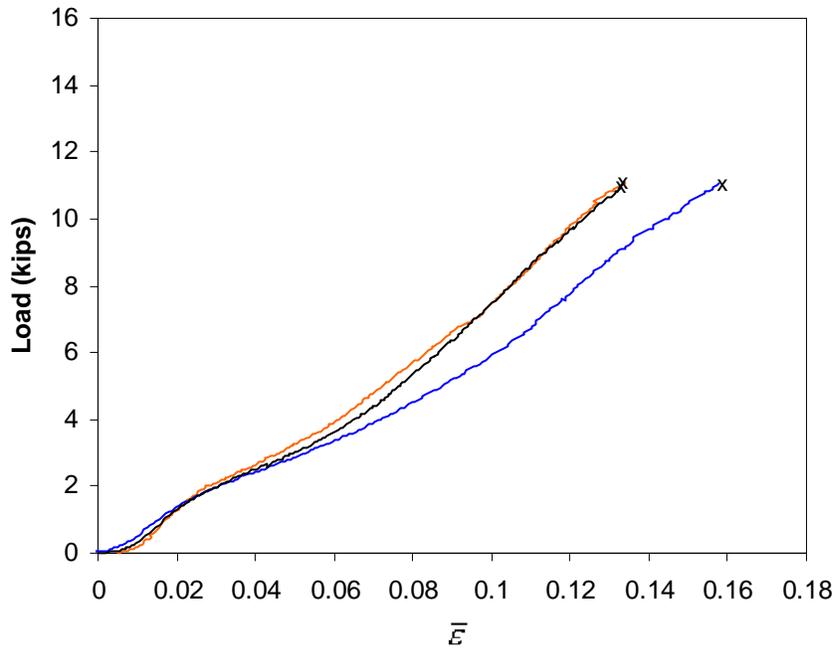
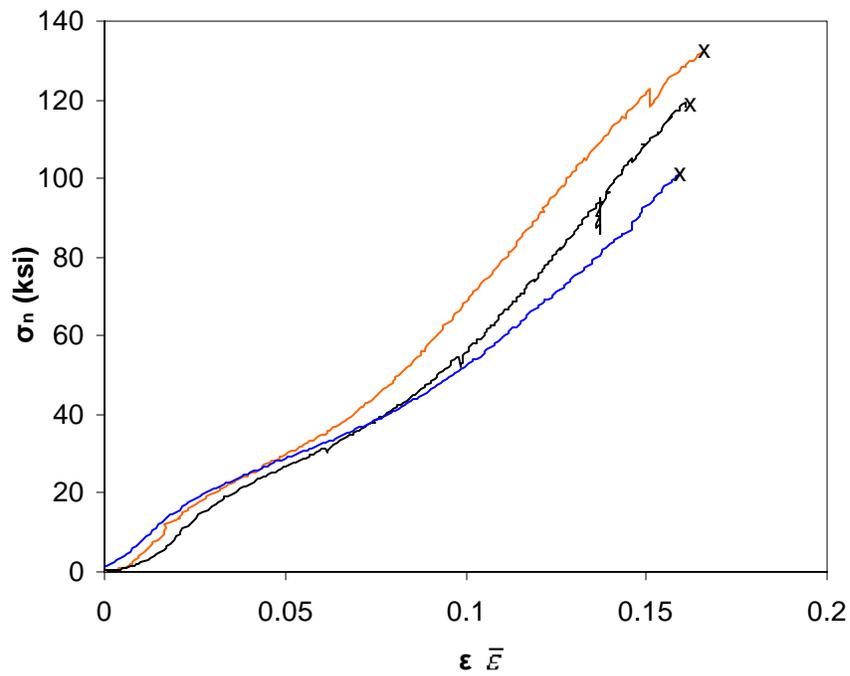
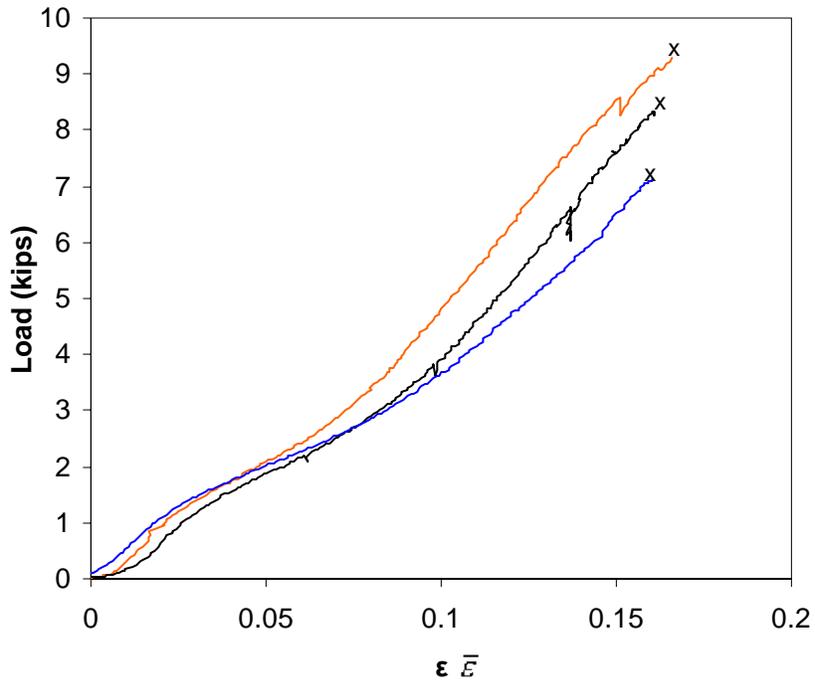
Figure 50 $\sigma_n - \bar{\varepsilon}$ behavior of subropes with 5 strands cut (Mooring rope #1).

Figure 51 $P - \bar{\epsilon}$ response of subropes with 5 strands cut (Mooring rope #1).

Figure 52 $\sigma_n - \bar{\epsilon}$ behavior of subropes with 9 strands cut (Mooring rope #1).
(5 strands cut in one element, and 4 strands in second element)

Figure 53 $P - \bar{\epsilon}$ response of subropes with 9 strands cut (Mooring rope #1).
(5 strands cut in one element, and 4 strands in second element)

Figure 54 $\sigma_n - \bar{\epsilon}$ behavior of subropes with 13 strands cut (Mooring rope #1).
(9 strands cut in one element, and 2 strands in each of other two elements)

Figure 55 $P - \bar{\epsilon}$ response of subropes with 13 strands cut (Mooring rope #1).
 (9 strands cut in one element, and 2 strands in each of other two elements)

Following the same approach in describing the responses of damaged rope elements (Sec. 7.4), the behavior of subrope specimens (Mooring Rope #1) with 5, 9, and 13 strands cut is shown in Figs. 50-55. The measured failure strengths of the damaged subropes are given in Table 5. With the data obtained, it appears that the trend of damaged rope response was similar to that without damage. Considering all the microstructural and geometric variables that may affect the subrope response, the data seem to suggest the damaged subrope failure (Mooring Rope #1) was governed by a net-area response.

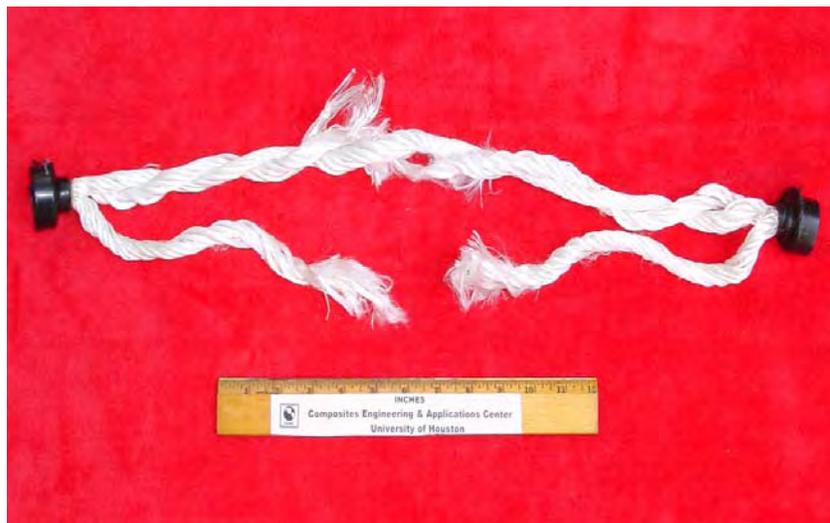
Figure 56 Damaged subrope failure mode (Mooring rope #1).
 (5 strands cut in one element, and 4 in another element)

While the subrope test to some extent was influenced by the efficiency of the termination, it did, in many cases, also contain material failure in the gage section. A photograph of a damaged subrope failure with 9 strands cut (5 in one element and 4 in the others) is shown in Fig. 56. The failure involved separation of the remaining 4 strands in the element with 5 cut strands and additional damage in the other elements. An interesting phenomenon observed in many tests was local melting of polyester fibers in the vicinity of the breaks and even bonding to adjacent strands away from the break, as shown in Fig. 57. Apparently, the friction generated at failure when fibers sliding relative to one another and the strain energy released were sufficient to melt the fibers.

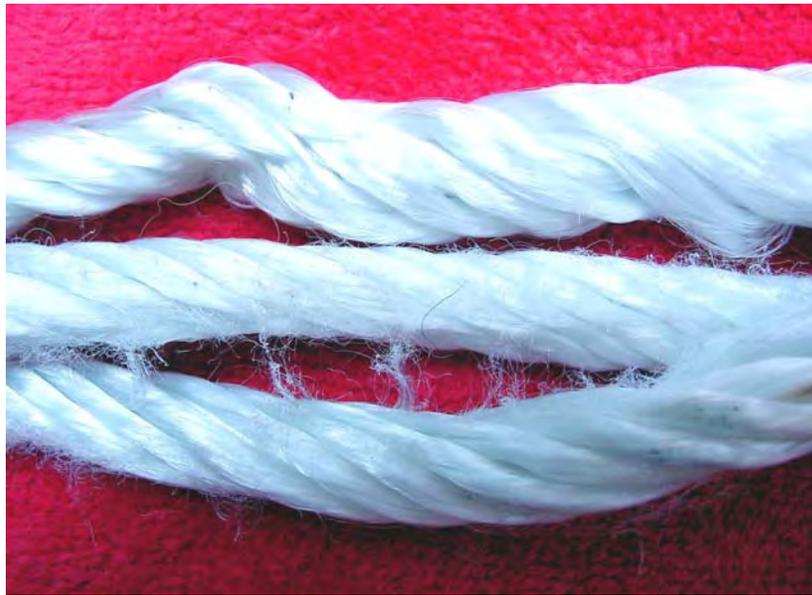
Figure 57 Local melting of polyester fibers during break of damaged subrope (Mooring subrope #1).

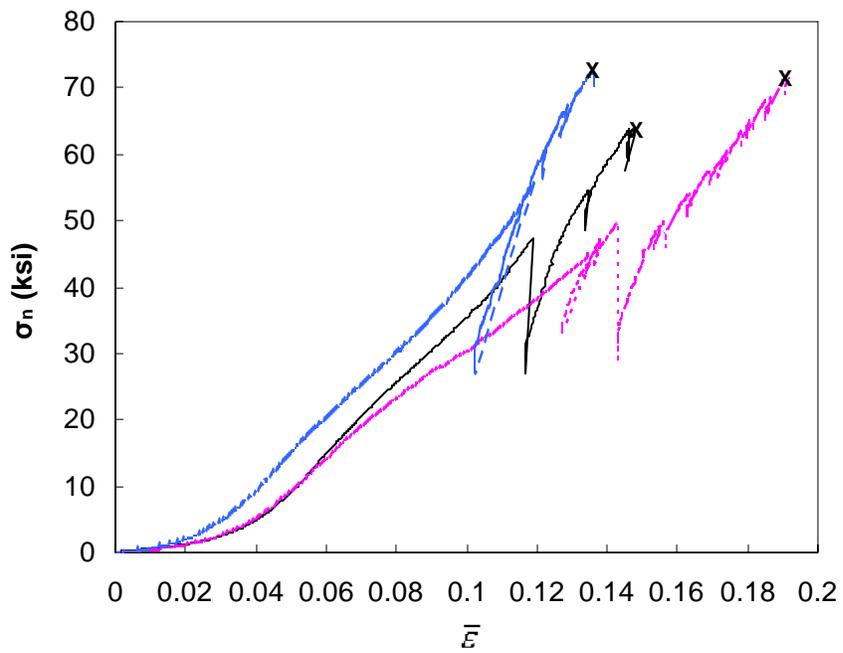
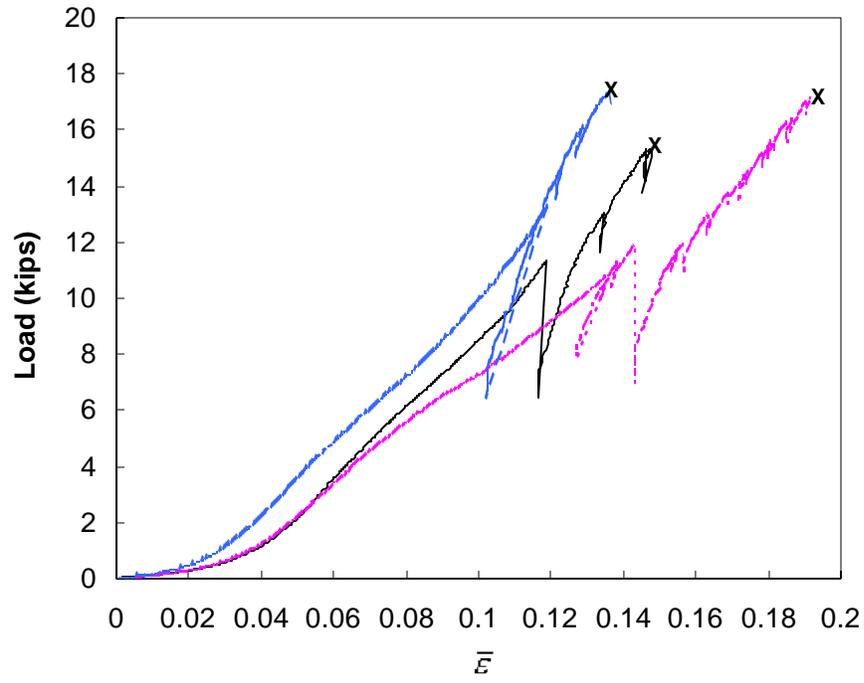
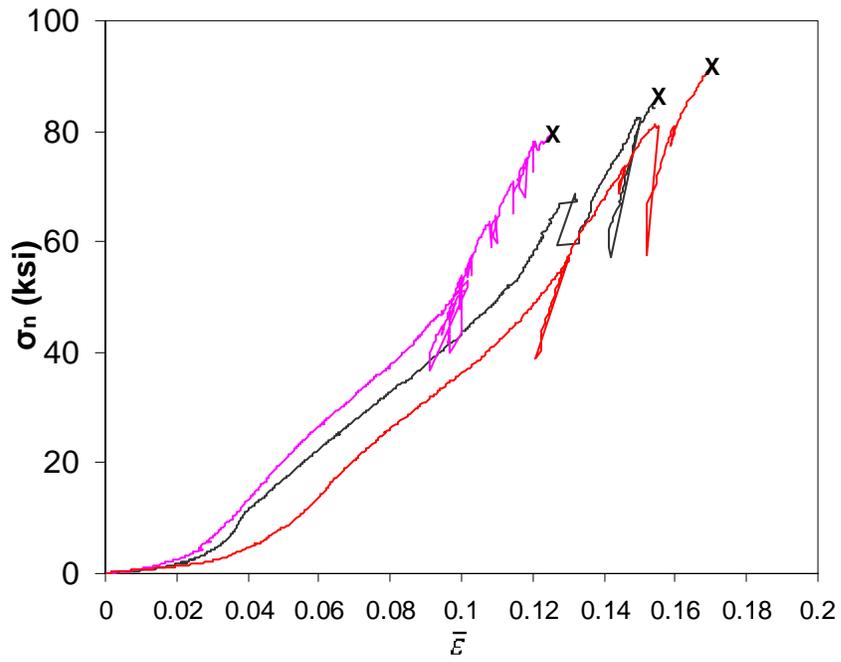
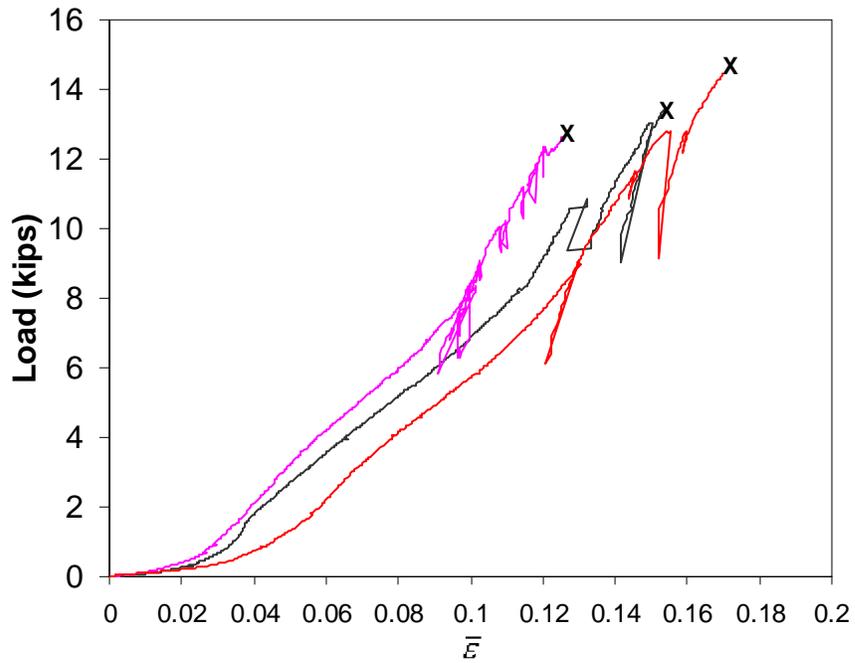
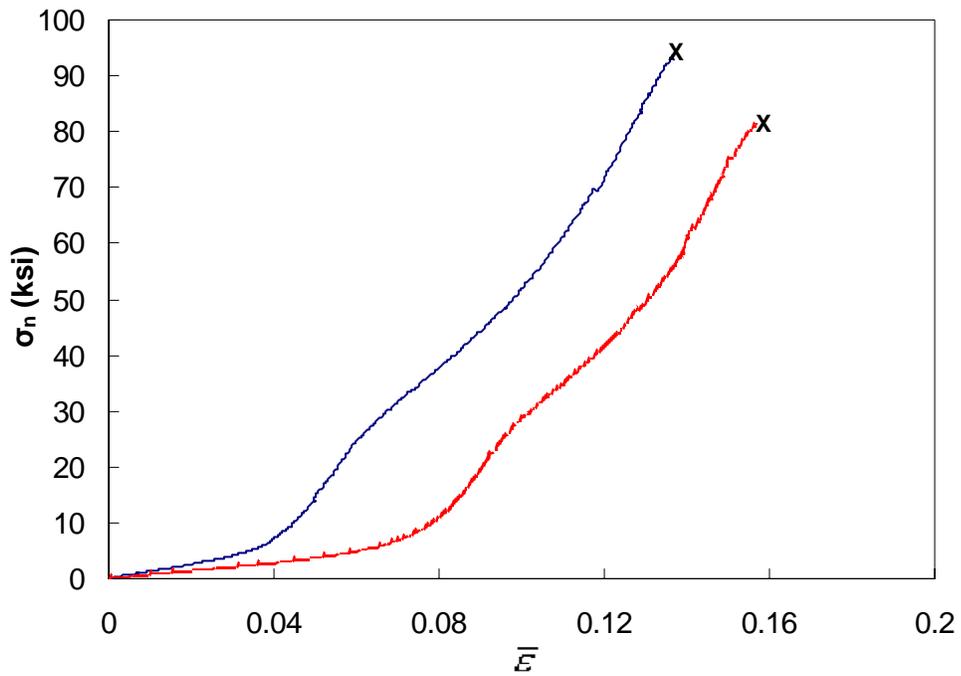
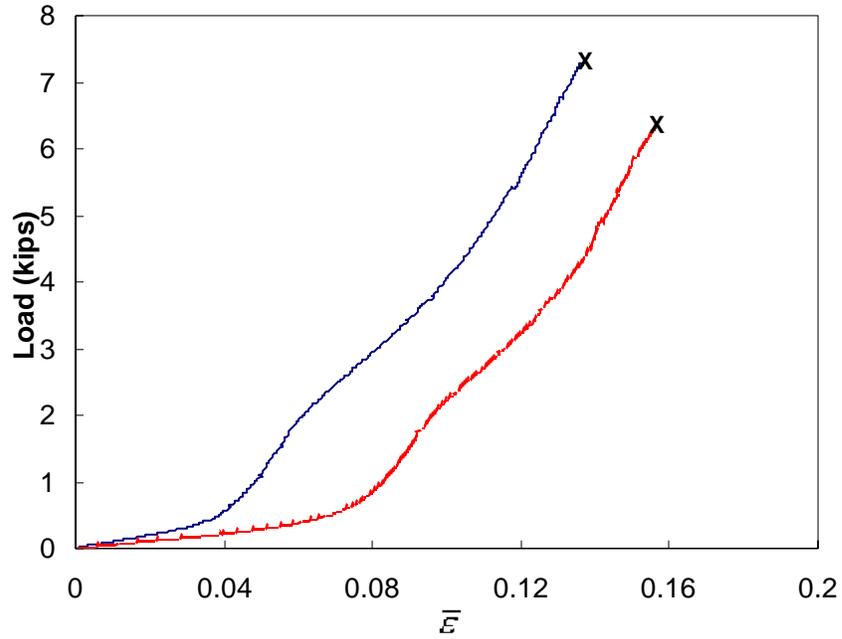
Figure 58 $\sigma_n - \bar{\epsilon}$ behavior of subropes with 1 element cut (Mooring rope #2).

Figure 59 $P - \bar{\epsilon}$ response of subropes with 1 element cut (Mooring rope #2).

Figure 60 $\sigma_n - \bar{\epsilon}$ behavior of subropes with 2 elements cut (Mooring rope #2).

Figure 61 $P - \bar{\epsilon}$ response of subropes with 2 elements cut (Mooring rope #2).

Figure 62 $\sigma_n - \bar{\epsilon}$ behavior of subropes with 3 elements cut (Mooring rope #2).

Figure 63 $P - \bar{\epsilon}$ response of subropes with 3 elements cut (Mooring rope #2).

The results of subrope test specimens (Mooring Rope #2) with 1, 2, and 3 elements cut have been determined and shown in Figs. 58-63. The failure strengths of damaged and undamaged subropes are reported in Table 7. Premature failures were observed in all tests. Load dropping appeared in the experiments due to cone bedding and sliding in the socket except the case of one-element cut. Damage tolerance responses of the

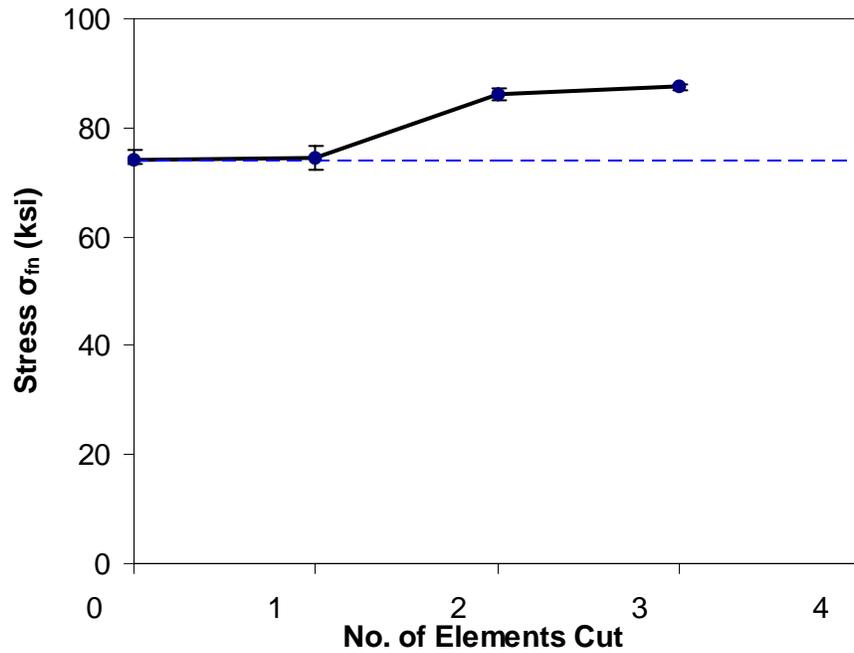
Figure 64 Subrope failure stress (Mooring rope #2) with different rope elements cut.

subropes are given in Fig. 64. Failure strength degradation in the damaged subrope tests is shown in Fig. 65. The failure stress is noted to be about the same when a small amount of damage was present and increases when a large amount of damage was introduced in the subrope.

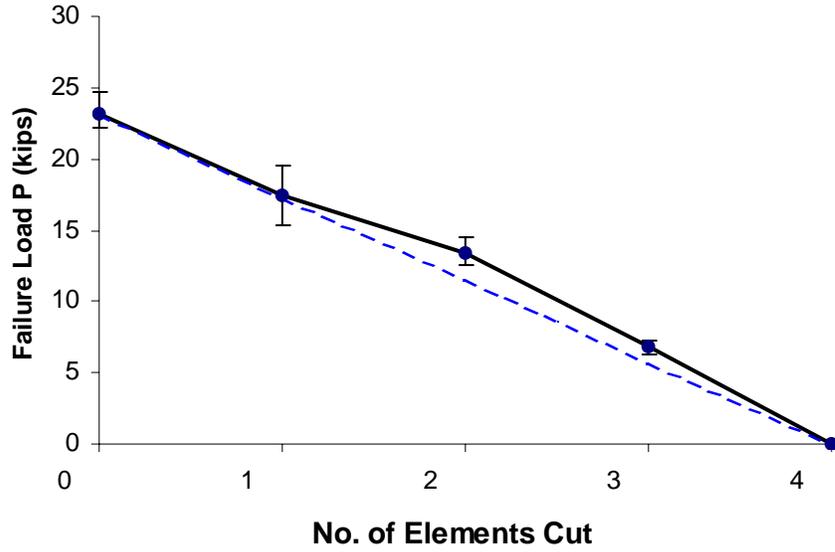
Figure 65 Failure strength of subropes with different elements cut (Mooring rope #2).

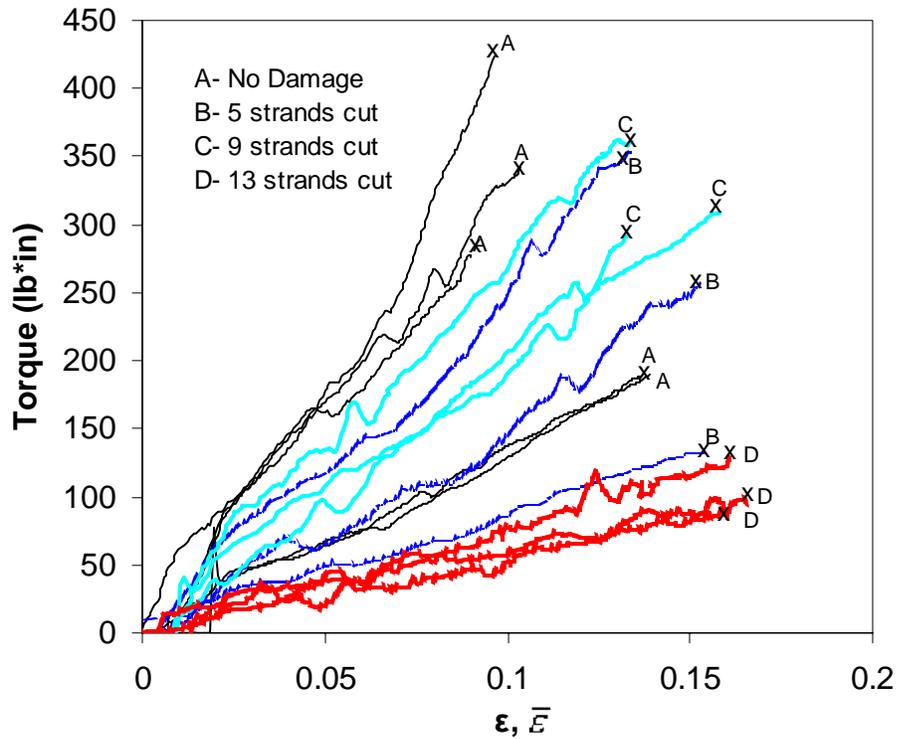
Figure 66 Torque measurements in subrope tests with and without damage (Mooring rope #1).

Several experiments on the subropes of Mooring Rope #1 were conducted first without a torque restraint. A torque measurement device was then installed to provide accurate torque measurements in the tests on both undamaged and damaged subrope specimens. The results are given in Fig. 66. The torque generated was found to be approximately linear with the applied load (or strain). The maximum torque measured was approximately 350 in-lbs. Specimens with 9 or 13 cut strands have fairly consistent responses in the tests while more variations were seen in the undamaged subrope and the damaged specimens with 5 strands cut. The torques measured from both undamaged and damaged subrope (of Mooring Rope #2) tests are also given (Fig. 67). A correlation between the maximum torque generated and the failure load was not found in the study.

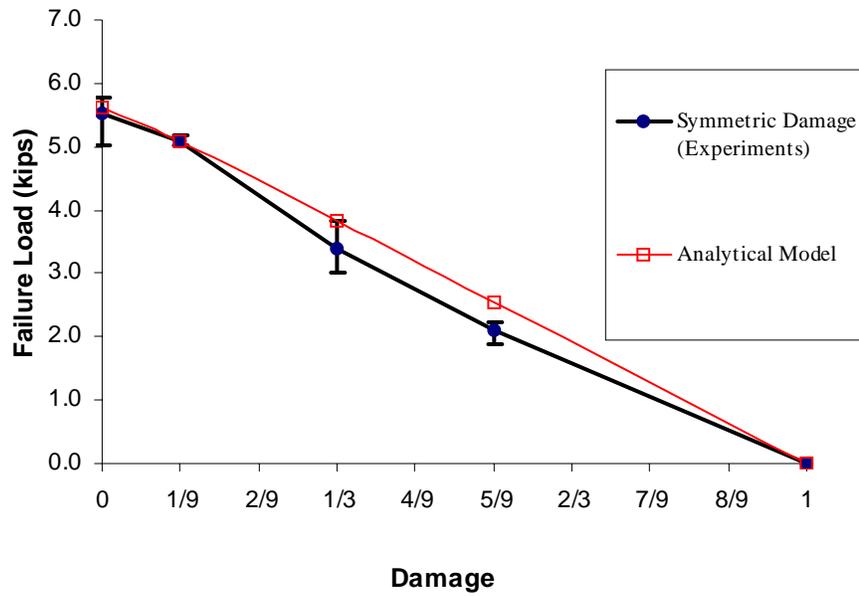
Figure 69 Damaged rope-element failure strength predicted from analytical model and compared with experiment data (Mooring rope #1).

The residual failure strength determined by the aftermentional rope mechanics analysis and the tests results obtained from the rope element experiments (for Mooring Rope #1) are given Fig. 69. It can be seen that the results agreed well for both the undamage case and the cases with small damage. For example, only a 0.12% difference exists in case of a rope element with one strand cut. For the elements with small damage, a small difference between predicted and test failure strength is observed. In the case with 5 strands cut, the prediction has a 16% difference from the test results. From the comparison, one can see a noticeable difference when the element rope had a large induced damage.
