4. PERFORMING ORGANIZATION REPORT NUMBER(S) NRL Memorandum Report 5472	5. MONITORING ORGANIZATION REPORT NUMBER(S)
6a. NAME OF PERFORMING ORGANIZATION Naval Research Laboratory 6b. OFFICE SYMBOL (*If applicable*)	7a. NAME OF MONITORING ORGANIZATION
6c. ADDRESS (*City, State, and ZIP Code*) Washington, DC 20375-5000	7b. ADDRESS (*City, State, and ZIP Code*)
8a. NAME OF FUNDING / SPONSORING ORGANIZATION Department of Interior 8b. OFFICE SYMBOL (*If applicable*)	9. PROCUREMENT INSTRUMENT IDENTIFICATION NUMBER
8c. ADDRESS (*City, State, and ZIP Code*) Mineral Management Service Reston, VA 22091	10. SOURCE OF FUNDING NUMBERS PROGRAM ELEMENT NO.: DOI PROJECT NO.: TASK NO.: 328 WORK UNIT ACCESSION NO.: DN380-566

11. TITLE (*Include Security Classification*)
Offshore Oil Platform Underwater Inspection: A Study and Evaluation of a Scanning Beam Sonar

13a. TYPE OF REPORT	13b. TIME COVERED	14. DATE OF REPORT (*Year, Month, Day*)	15. PAGE COUNT
Final	FROM 8/83 TO 9/84	1984 November 9	26

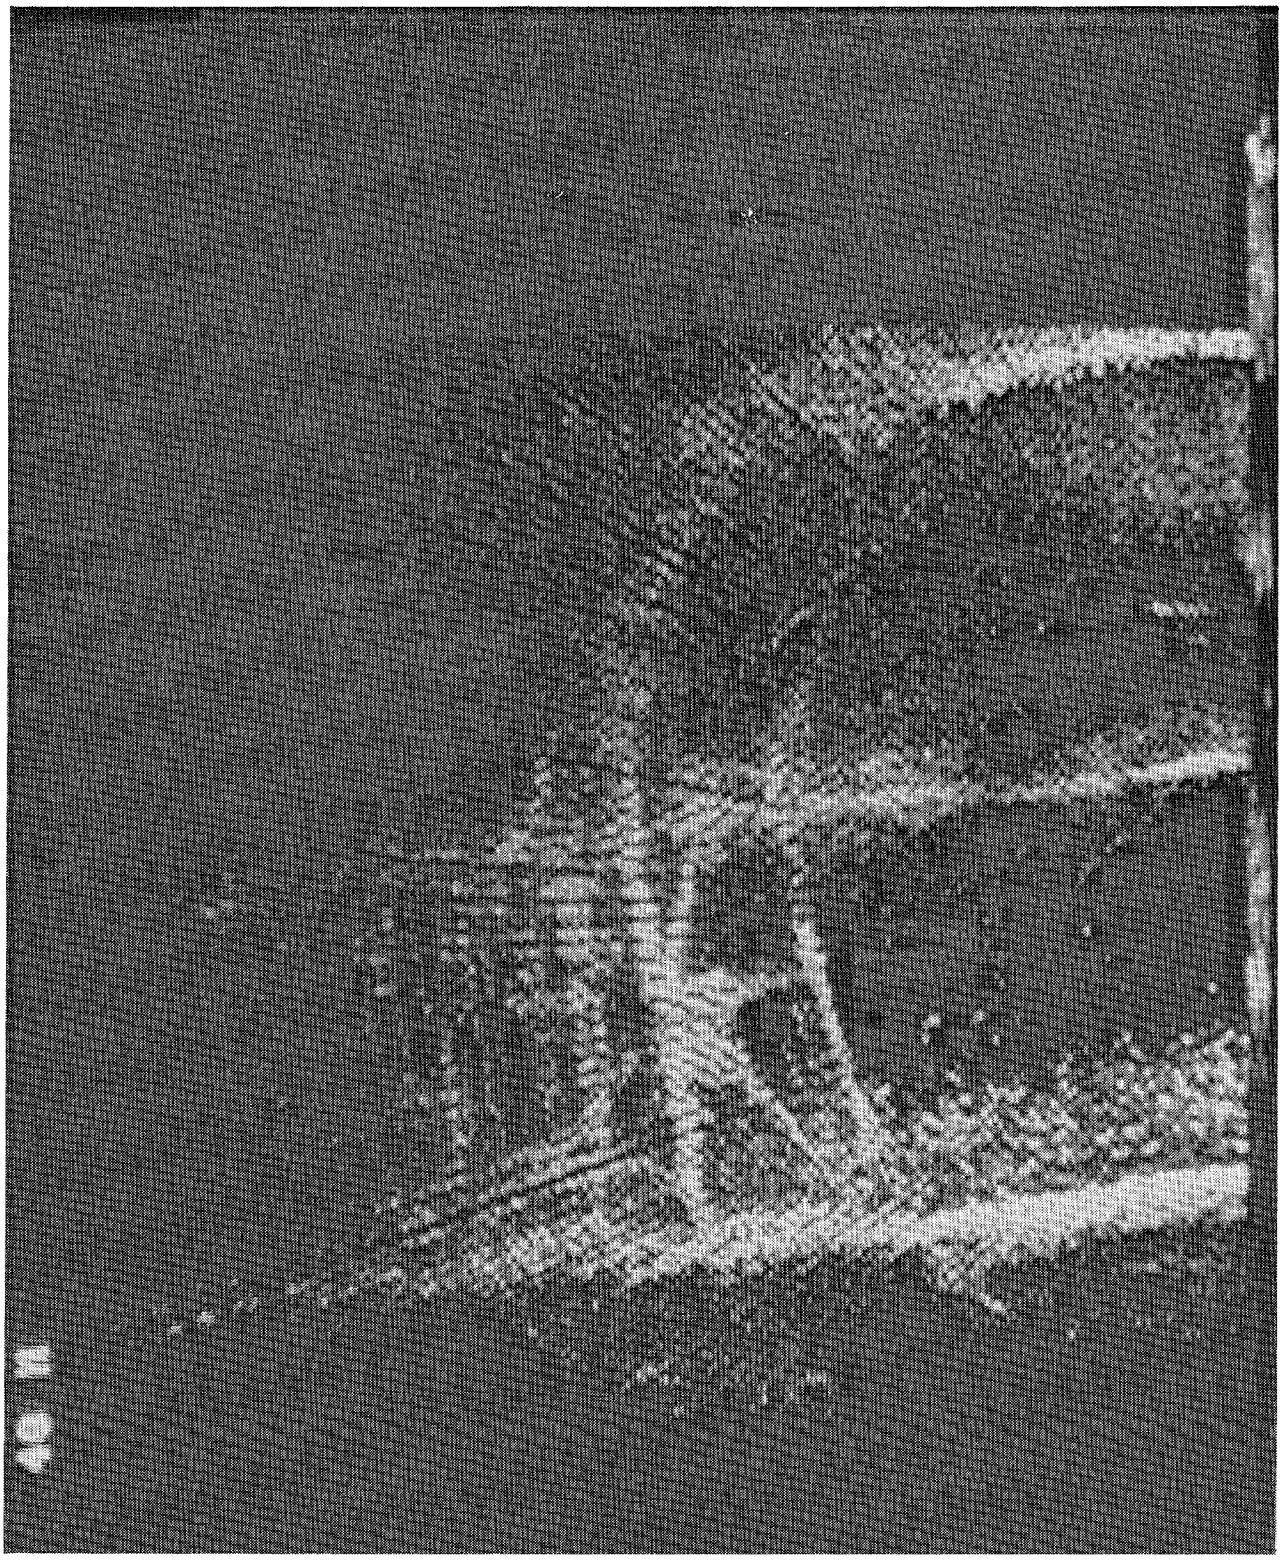
Fig. 5 — Profile view of production platform

In Fig. 5 a sonar image profile view of the production platform is shown. The sonar head is deployed on the outside corner of the platform, as illustrated in Fig. 4(a), position 1. The approximate distance of the sonar head from the platform is 10 m. The scan angle is 180 deg, and the range is set at 40 m. Note that the origin of the scan line (sonar head) is located in the center of the far right hand edge of Fig. 5, and the distance from the right to left edges is 20 m.

The white horizontal lines in the center and bottom of Fig. 5 are surface and bottom returns. The corner leg of the platform is shown in the lower center of the image.

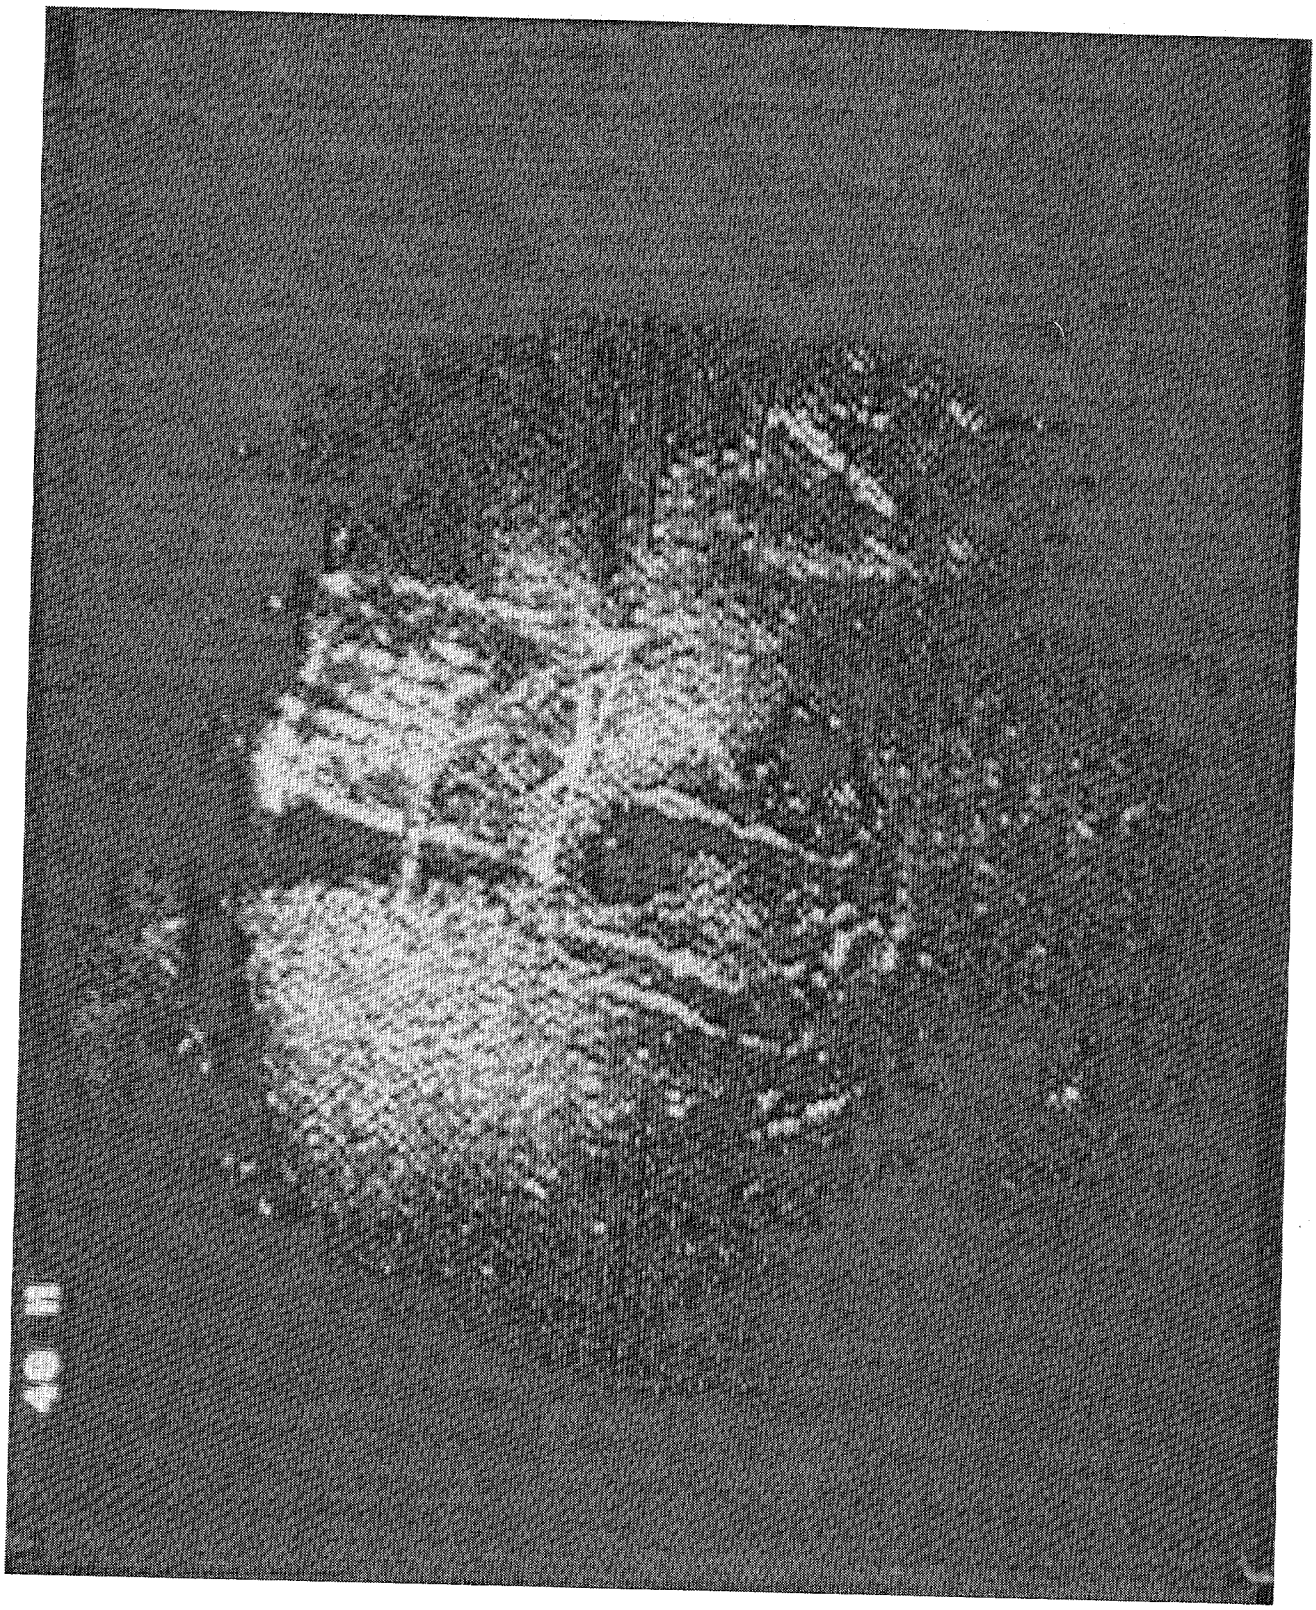
Fig. 6 — Plan view of production platform

Figures 6 and 7 shows a plan view of the platform, with the AS 360 range setting at 40 and 20 m, respectively. The sonar head is located as shown in Fig. 4(a), position 2 and is scanning continuously. The approximate distance of the sonar head from the platform is 5 m. Two platform corners, connected by cross structure, are visible in the upper right quarters of both Fig. 6 and Fig. 7. The block of white circles inside the structure, which are visible in Fig. 6 and Fig. 7 are vertical pipes (risers). These risers are about 30 and 60 cm in diameter. The three straight lines in the center of the scan are legs of the jack-up barge.

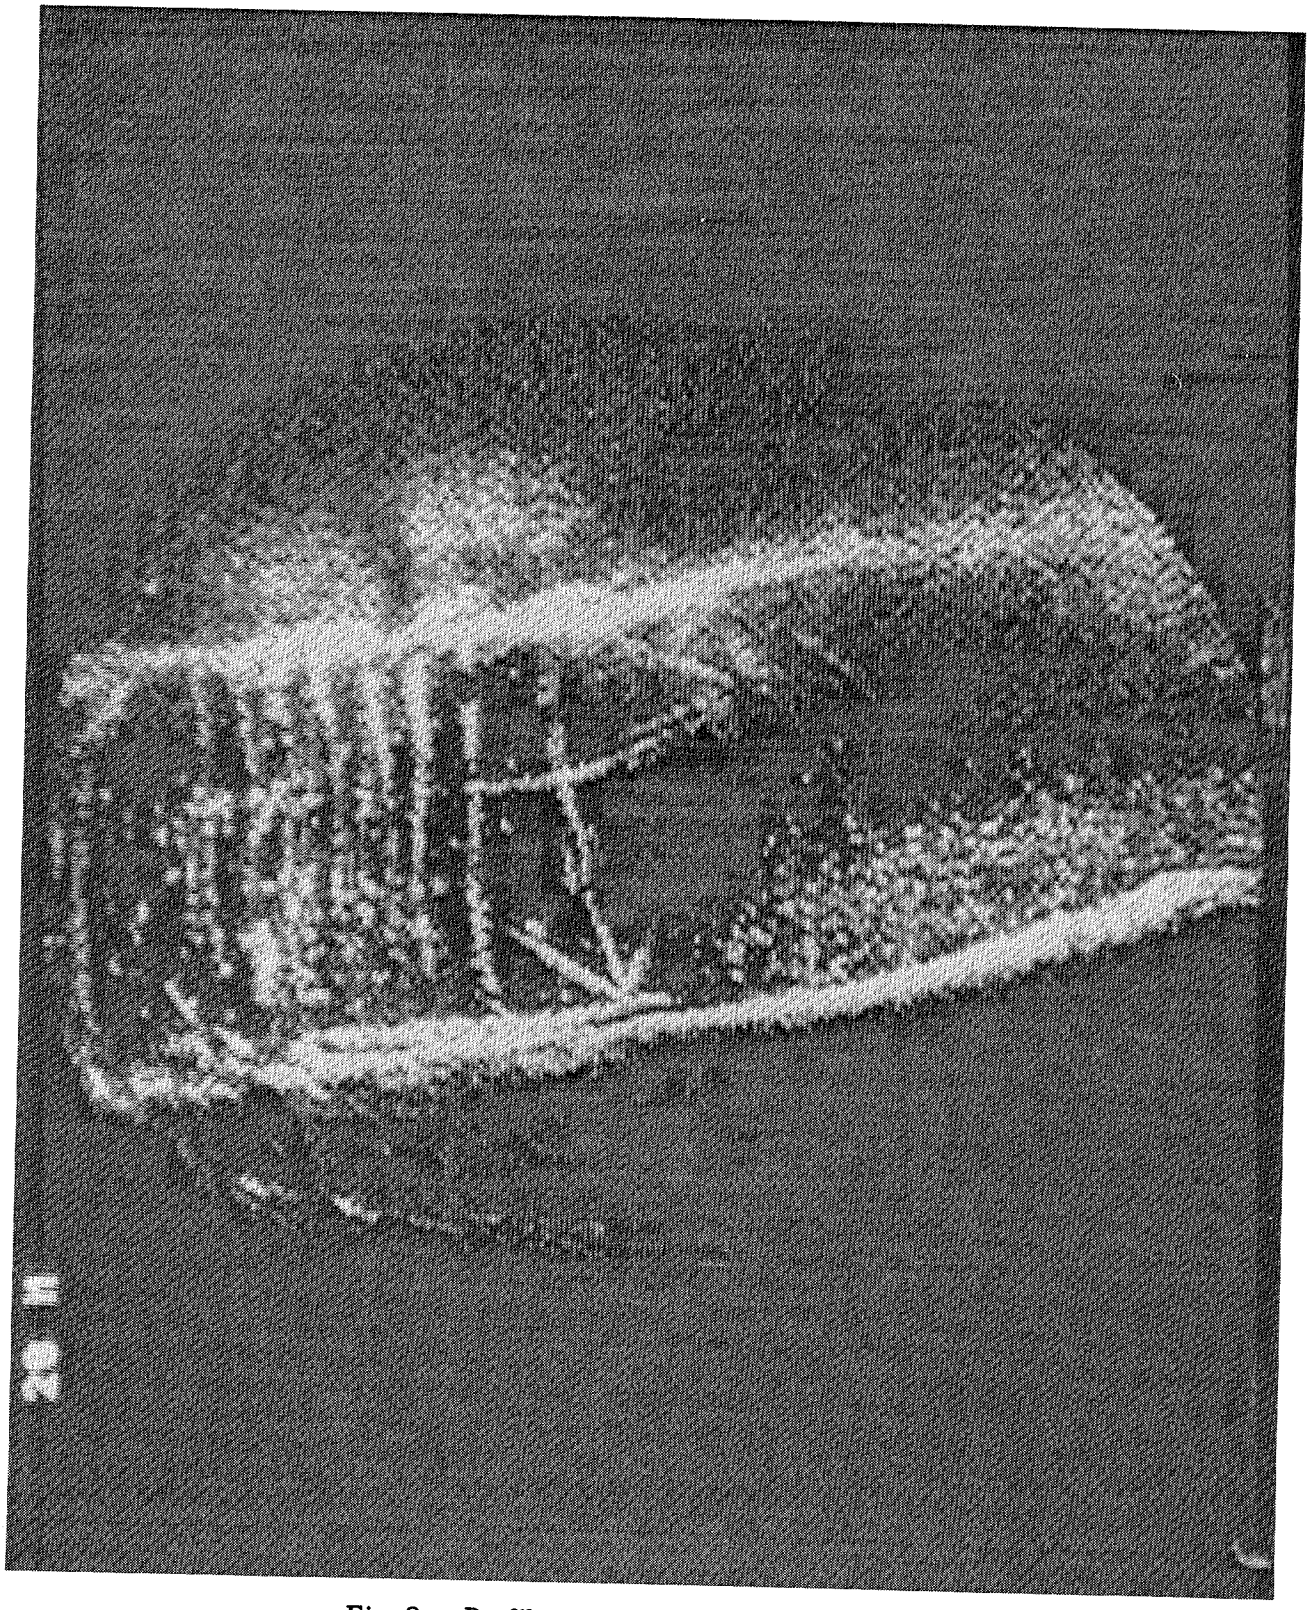
Fig. 8 — Profile view of production platform

Figures 8, 9, and 10 show a profile view of the platform with the sonar head located as illustrated in Fig. 4(b). The approximate distance of the platform from the sonar head is 5 m. Let us first examine Fig. 8. The upper and lower heavy, white, near horizontal lines in Fig. 8 are the surface and bottom returns. The series of vertical lines to the left center and between the surface and bottom returns are the vertical risers in the platform. As previously stated, the risers are 30 to 60 cm in diameter. The vertical line to the right of the risers is the corner of the platform, and the diagonal lines emanating from the corner leg are also structural members. Note the short parallel lines on either side of the corner leg (near center of Fig. 8). These are anodes. The range setting in Fig. 8 is 20 m, and the scan angle is 360 deg. The origin of the scan line is in the center of the display. Note the increase in surface boundary noise is caused by a supply

boat which moored to the platform with its prop wash directed through it. Compare this with Fig. 5. Note also that the vertical members appear to bend. This effect is due to sensor motion.

4. Sensor Motion - Distortion caused by sensor motion (straight members appear curved) is evident in several photographs. An operational system using sonar scanning techniques would require that the sensor be rigidly anchored to eliminate ocean current-induced sensor motion.

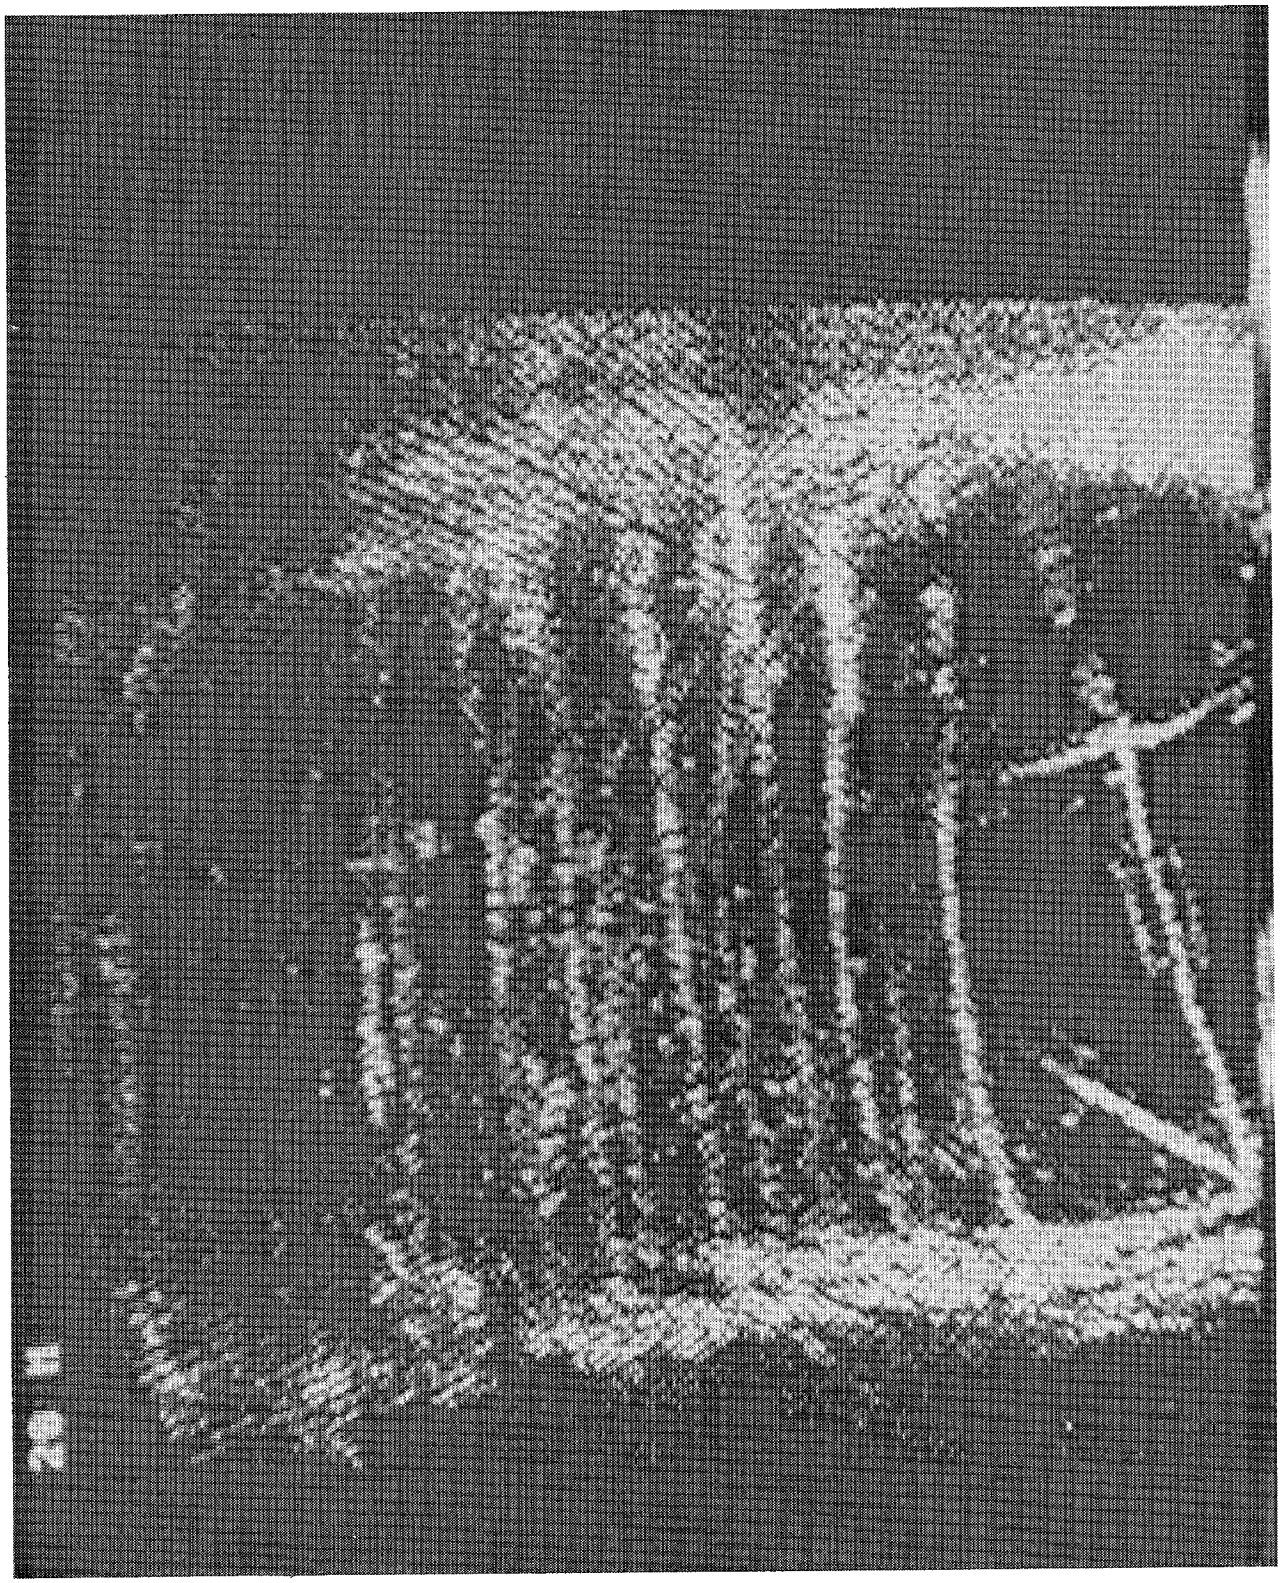
Fig. 9 — Profile view of production platform

In Fig. 9, only the presentation on the display is changed. Here the origin of the scan line is to the right center of Fig. 9, and only 180 deg of the scan is shown. This provides a blow-up of the target.

The near-vertical white line to the far left is the corner member. Note the clearly visible anodes on this member. The remaining vertical lines to the left of the corner member are the vertical risers.

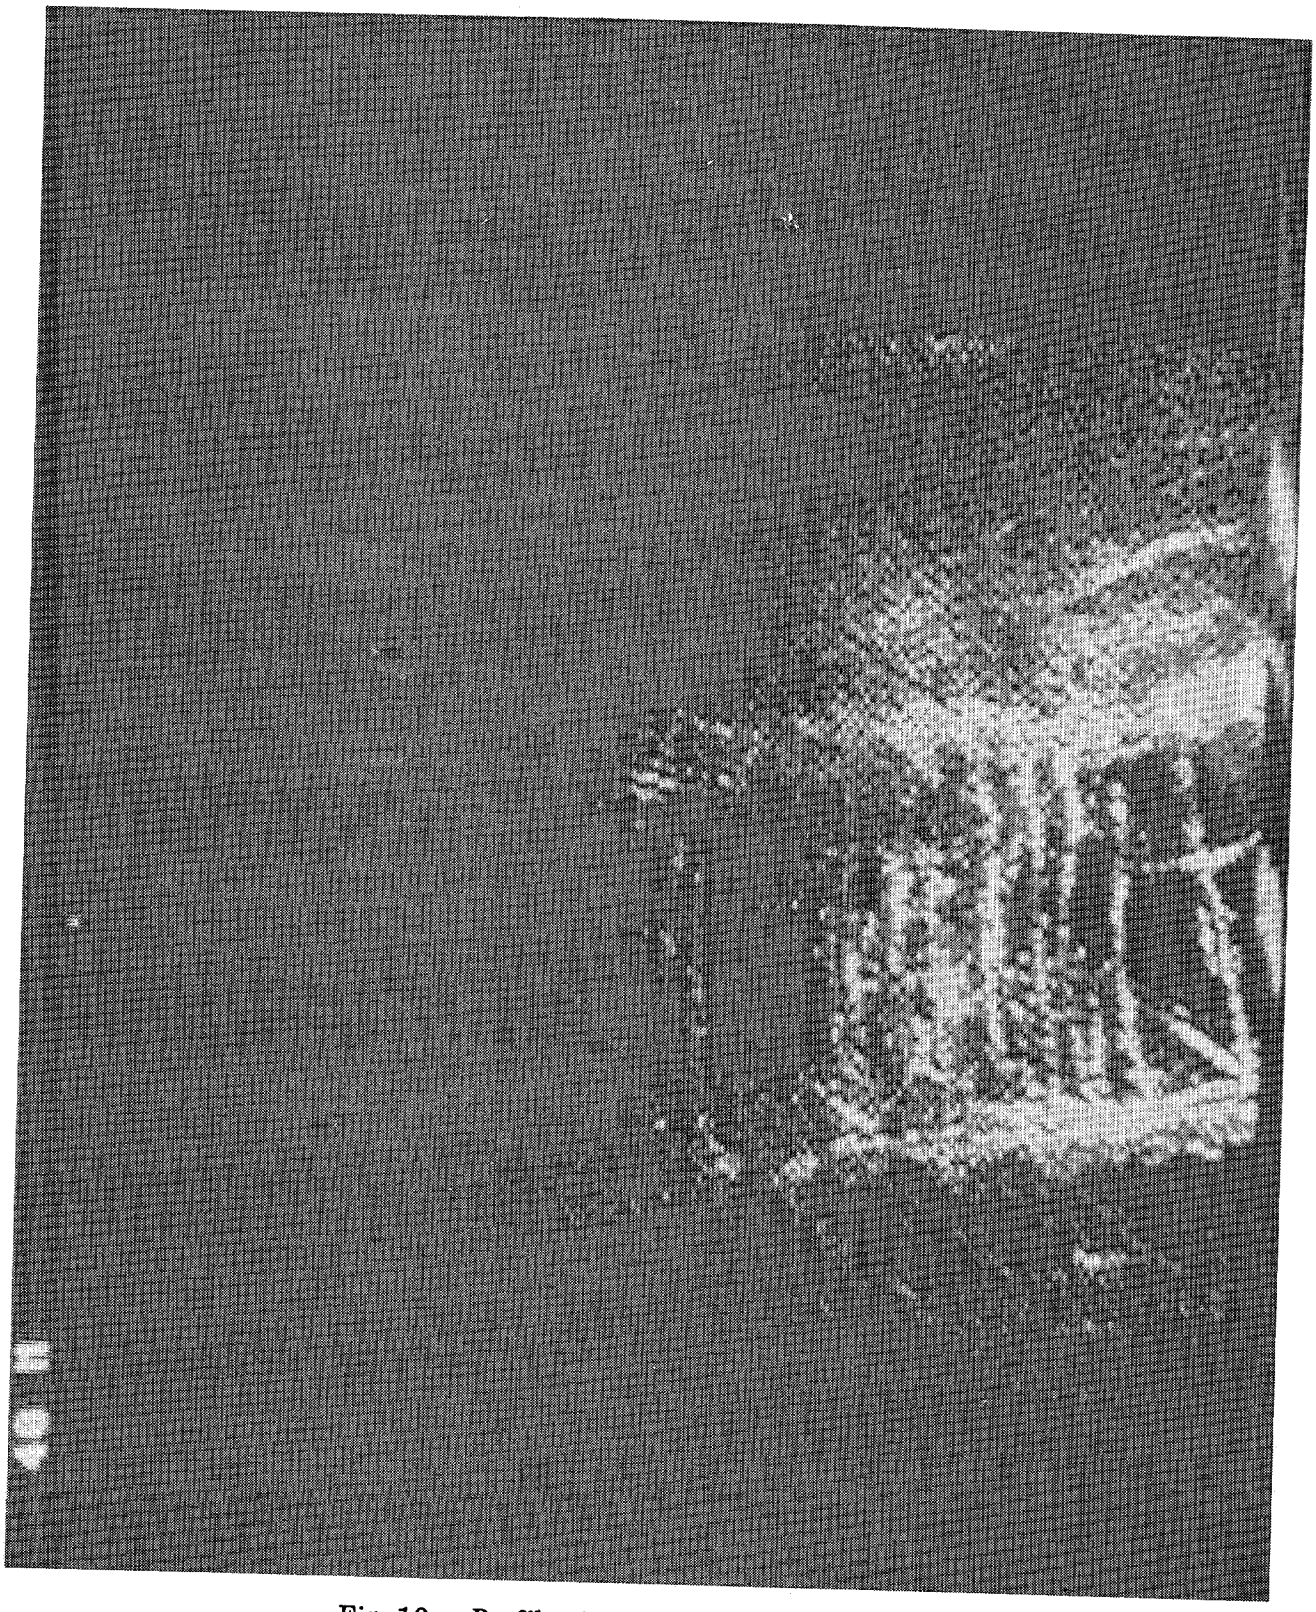
Fig. 10 — Profile view of production platform

In Fig. 10 the range was changed to 40 m, and the sector viewed in 180 deg. Thus it is 40 m across the screen. Note again the anodes on the corner member to the left center of Fig. 10.

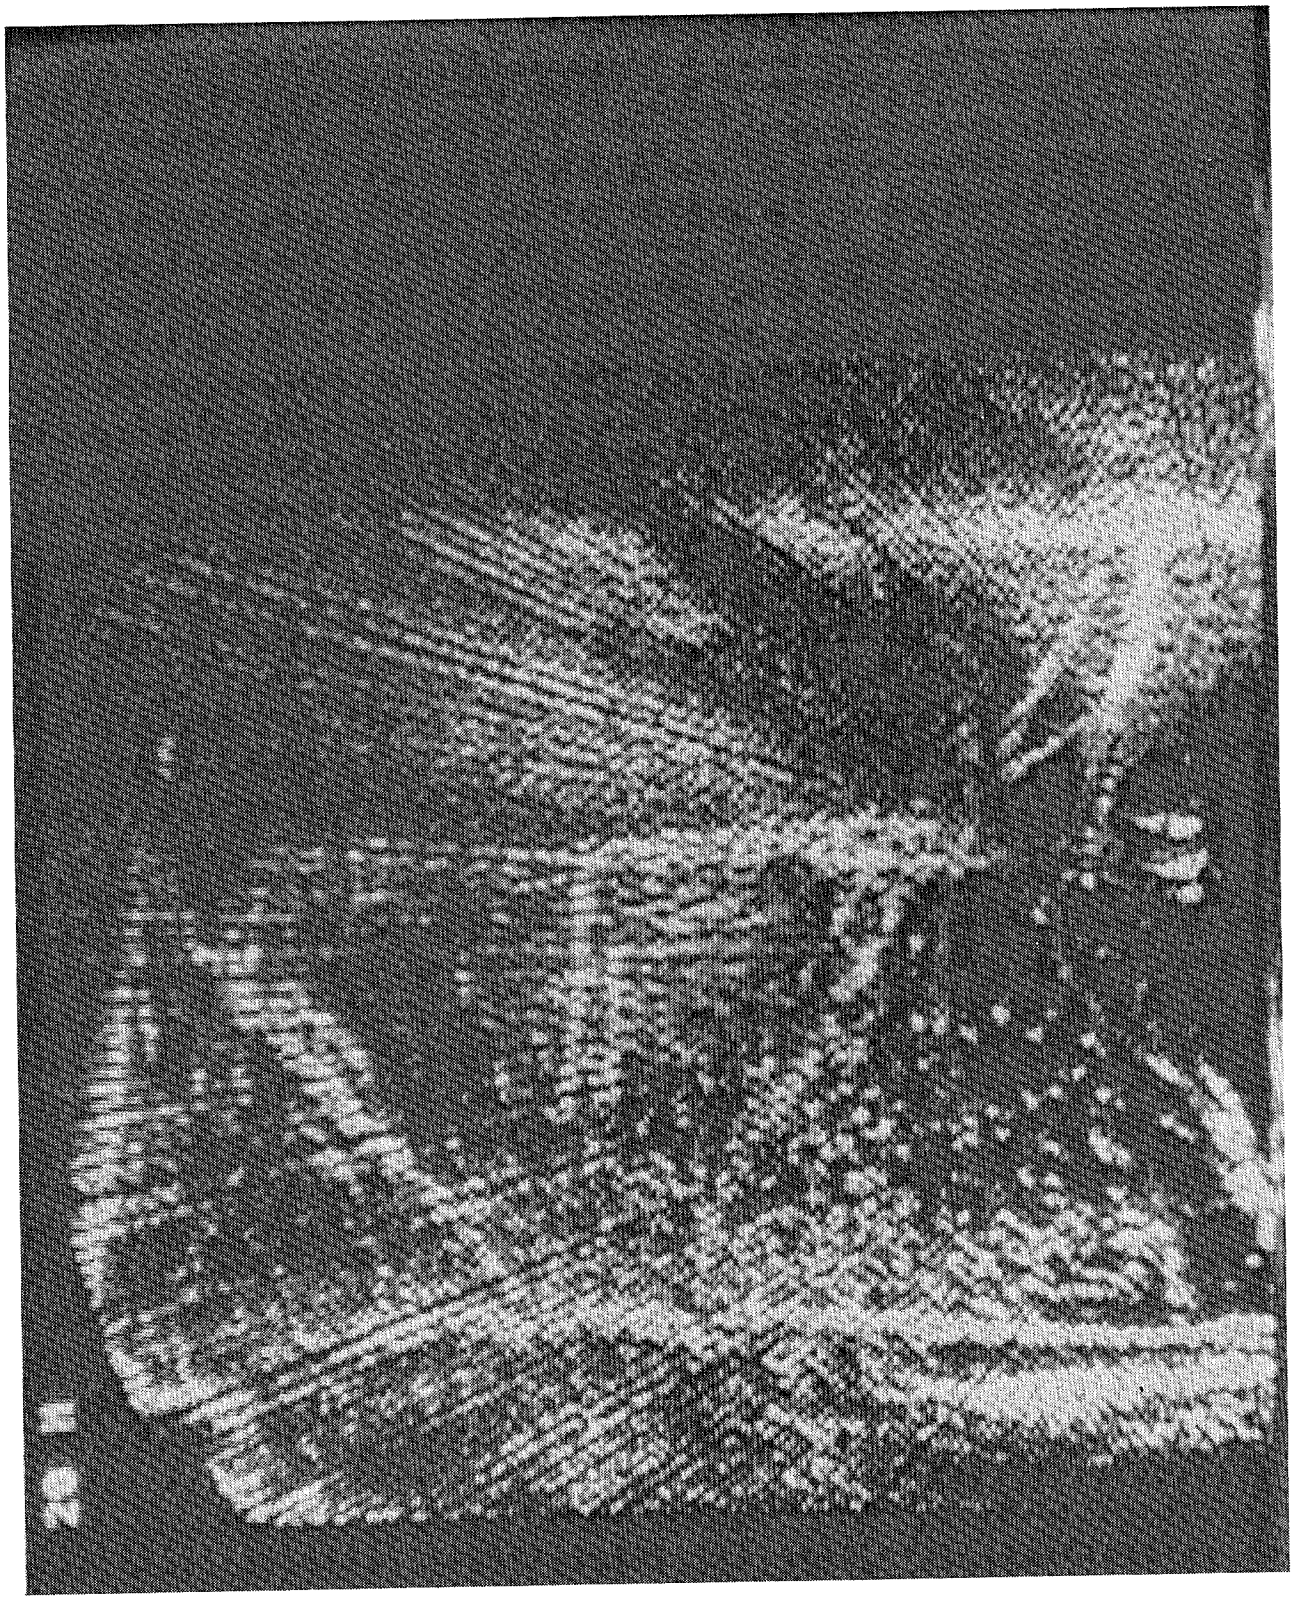
Fig. 11 — Profile view of platform structure

Fig. 11 shows another profile view of the platform structure with the sonar head moved closer in to the structure. The range setting is 20 m and the scan angle is 270 deg. The corner member appears as a vertical line near the lower center of Fig. 11. Again, what appears to be an anode is barely visible on the corner leg.

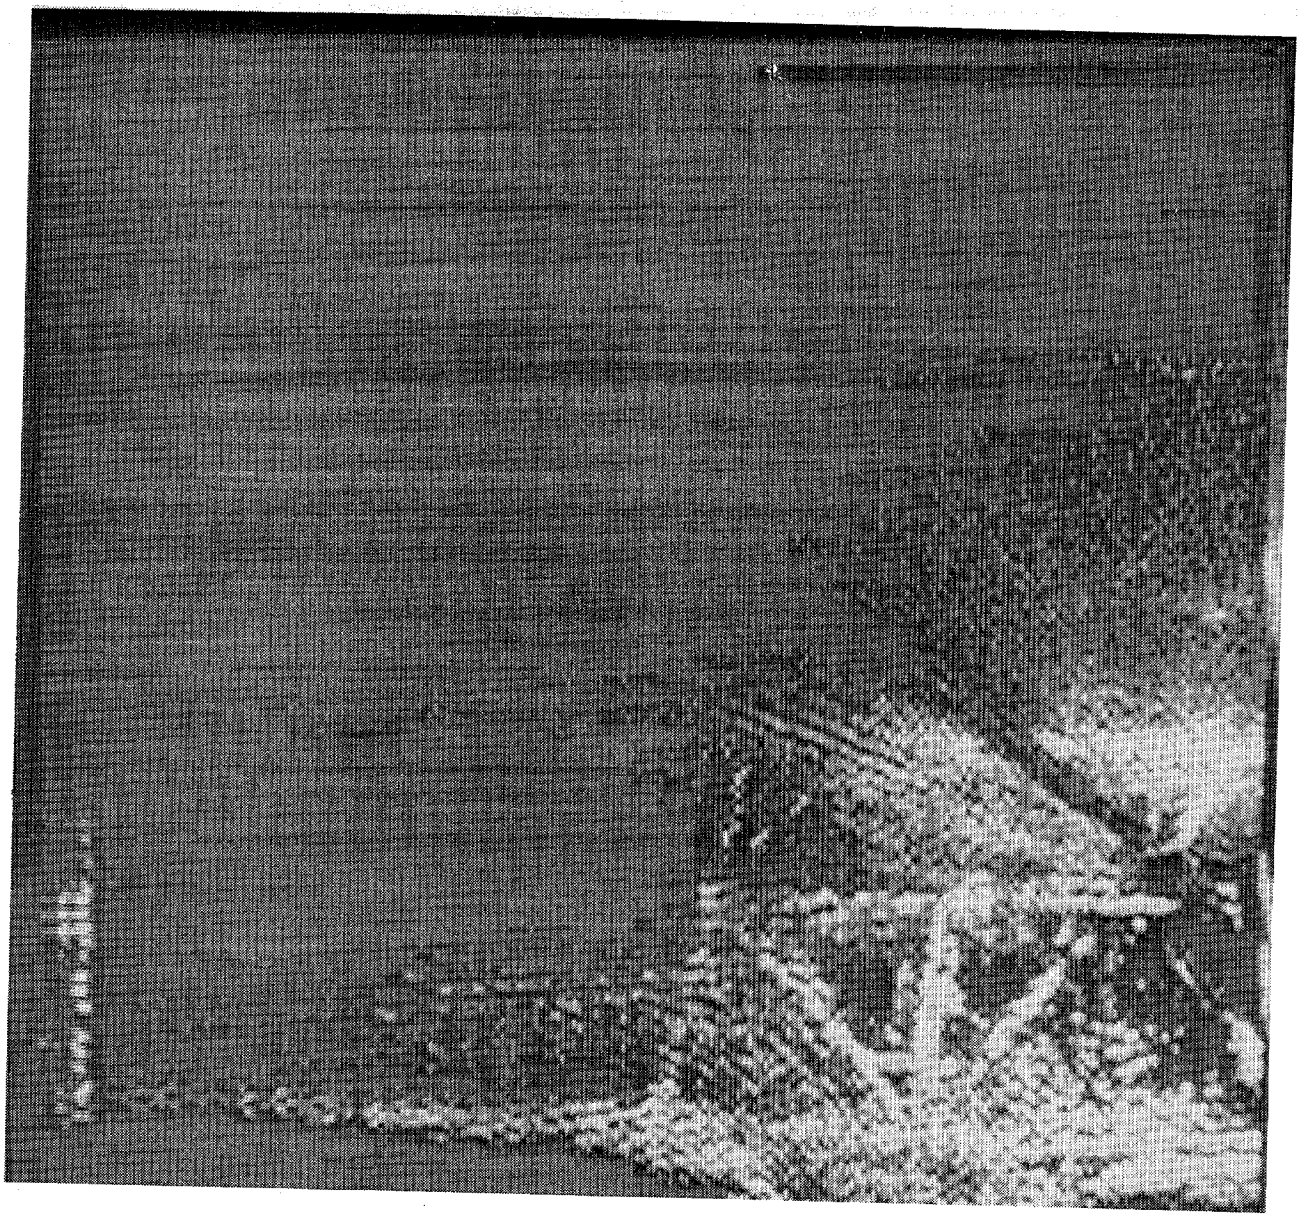
Fig. 12 — Profile view of platform structure

Fig. 12 shows a profile view of the same corner, with a range setting of 40 m. Fig. 4(c) shows the approximate location of the sonar head with respect to the corner of the platform.
