EXPERIMENTAL STUDY OF THE EROSIONAL/CORROSIONAL VELOCITY CRITERION FOR SIZING MULTIPHASE FLOW LINES

PHASE II - EXPERIMENTAL RESULTS

FINAL REPORT
SwRI Project 04-4008-002

American Petroleum Institute
2535 One Main Place
Dallas, Texas 75202-3904

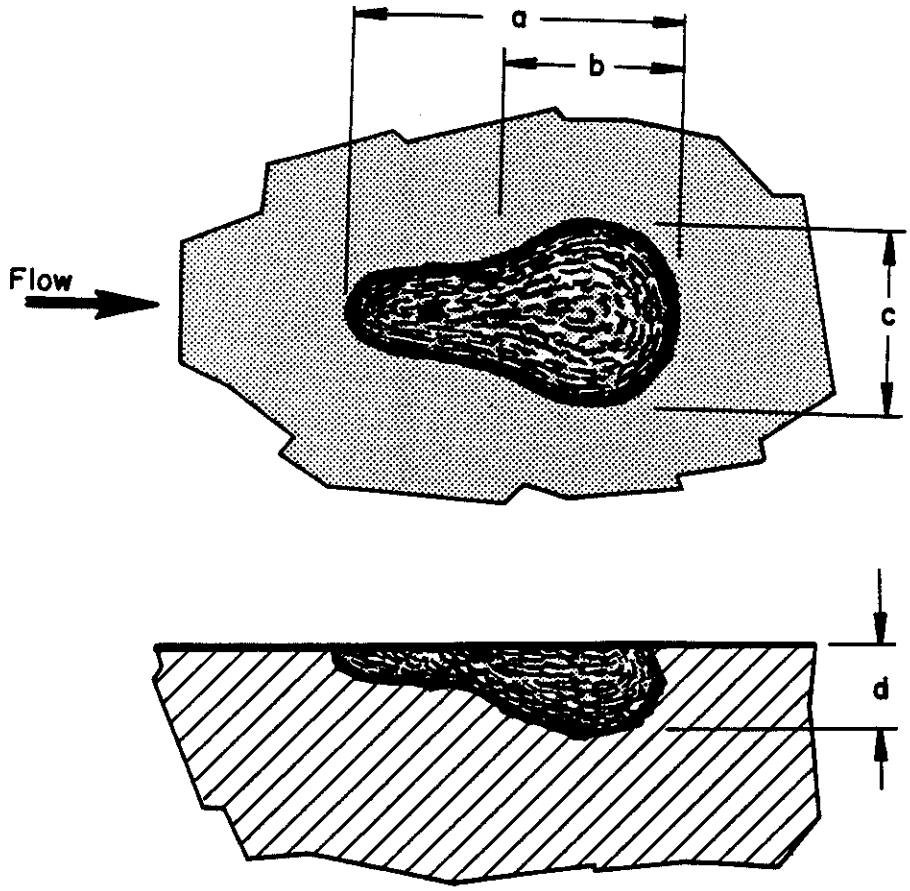
All four of the 90° elbows experienced localized pitting wear that was confined to a one-inch-wide band that ran along the outside portion of the bend. The pits were elongated in the direction of flow. The sketch in the Figure 4.5 presents the general shape of the pits. It appears the pits grew in the downstream direction and widened and deepened as time passed. Table 4.4 summarizes the average pit size, maximum pit size, and the approximate total number of pits for each of the four test fittings. The average and maximum pit sizes were determined by measuring individual pits that were selected as representative by visually inspecting each test fitting. With a maximum pit depth of 0.023" achieved in 60 days of testing, the maximum wear rate for the test was about 138 MPY.

Figure 4.5 Typical Erosion/Corrosion Pit Geometry.
