**MINERALS MANAGEMENT SERVICE**

**POST MORTEM PLATFORM  
FAILURE EVALUATION STUDY**

**FINAL REPORT**

**PMB ENGINEERING INC.  
SAN FRANCISCO, CALIFORNIA**

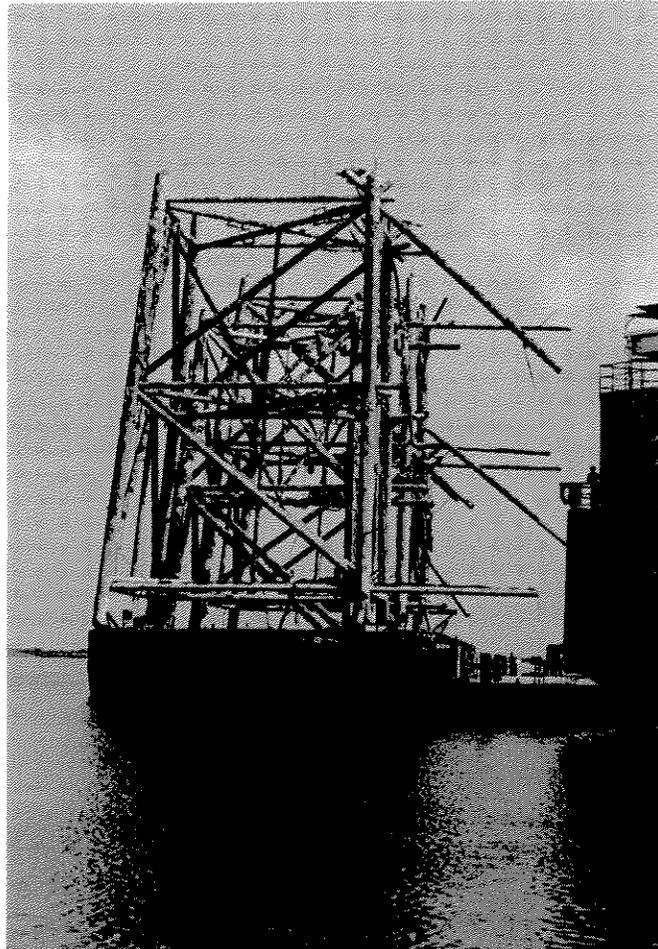
**Photo 2-3** End-On View of Platform Sections

The platform was severely damaged but did not topple in Andrew, and was inspected onshore after the platform had been cut into several large pieces for salvage (see Section 2, Photos 2-2 and 2-3). The platform had suffered significant joint damage including cracked X joints, complete sever of several K joints, and damaged KT joints. There were no joint cans at any of the damaged joints. There was also a noticeable curvature in the platform legs.

Photos 2-2 and 2-3 show broadside and end-on views of three jacket sections from ST 177 B resting on one of the transport barges. This is the set of jacket components that served as a basis for most of the inspections. As described later, some components of the ST 177 B AUX platform in the process of being scrapped nearby where also investigated.

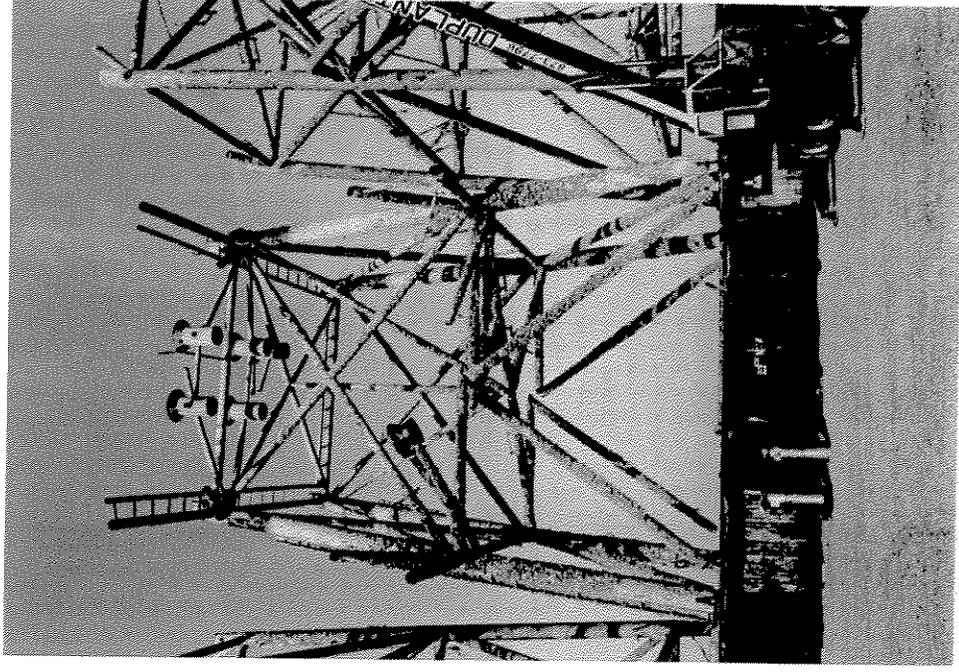
**Photo 2-5 Closeup View of Section TN (Top North)**

Photo 2-4 shows a closeup of BN, Photo 2-5 shows a closeup of TN and Photo 2-6 shows a closeup of BS. The following sections describe the findings of the inspections.

The X joints were located in the upperbays of the platform just below the water line of TN (Photo 2-5). Photo 2-7 shows a closeup of the BN X joint in the transverse frame Row 2. The through brace (and coincidentally the tension brace) extends from the bottom right side to the upper left side. The most severe Andrew waves moved basically from right to left of the photo. A crack is clearly seen at the intersection of the braces along the tension brace.

K joints were located in the middle two elevations. The uppermost K (closest to the waterline) is located on the lower section of TN (Photo 2-5). A closeup of the K joint on ROW 2 is shown in Photo 2-12. Andrew waves moved basically from right to left in the photo. The failure occurred due to complete shear through the chord. The shear plane is in a plane directly along the bottom of the compression brace. Note that the right hand side of the K brace has dropped downward approximately 1 foot. This is due to the portal action of the legs as discussed in Section 2-6.

The longitudinal diagonal bracing extending between each major horizontal frame showed no signs of damage. These braces can be seen in Photos 2-2 through 2-5 and are the diagonal braces that are in the plane that is perpendicular to the paper.

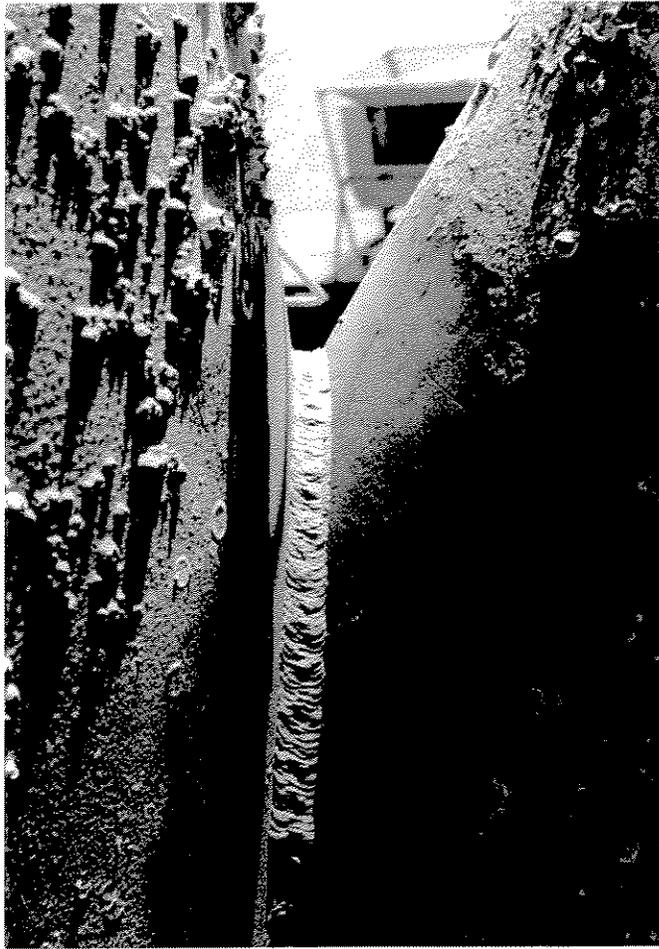
Several of the platform joints near the mudline were sandblasted clean to allow for close visual inspection of the joints for cracks caused by high stresses during Andrew or by long term fatigue. All of the cleaned joints (which included both tension and compression braces) showed no signs of cracks or other damage.

**Photo 2-18 Cleaned Joint at B1 - Tension Brace**

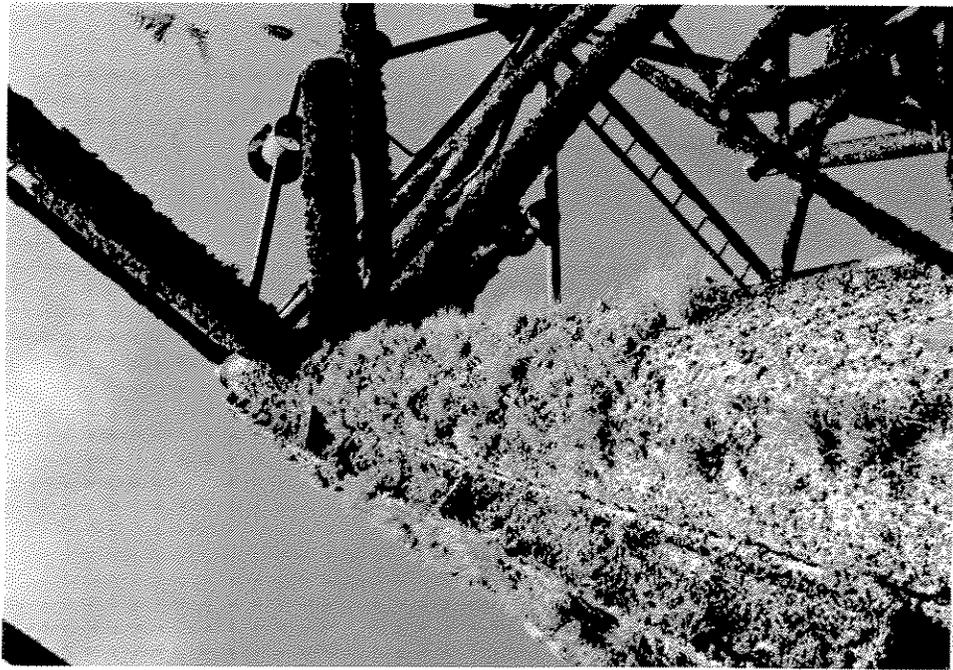
Photo 2-22 View of Leg B2 (TN)

The platform legs in the lower elevations where the K bracing had completely failed had a slight curvature in the direction of the Andrew waves (Photos 2-20 and 2-21). This curvature was possible since the complete loss of the K joints allowed for the formation of large deformations in the legs.

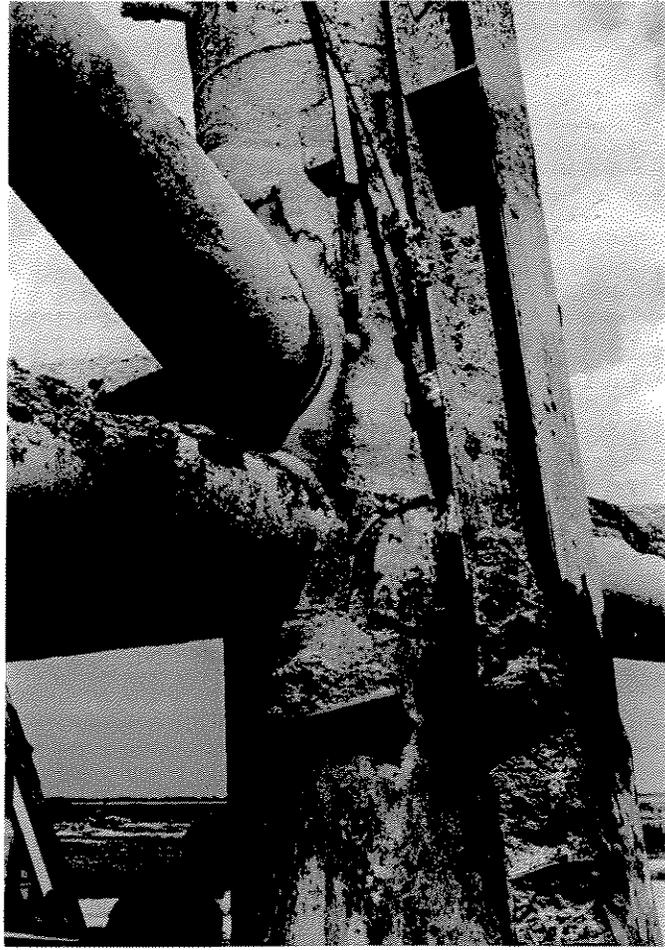
**Photo 2-26 Cleaned Compression Joint at Mudline**

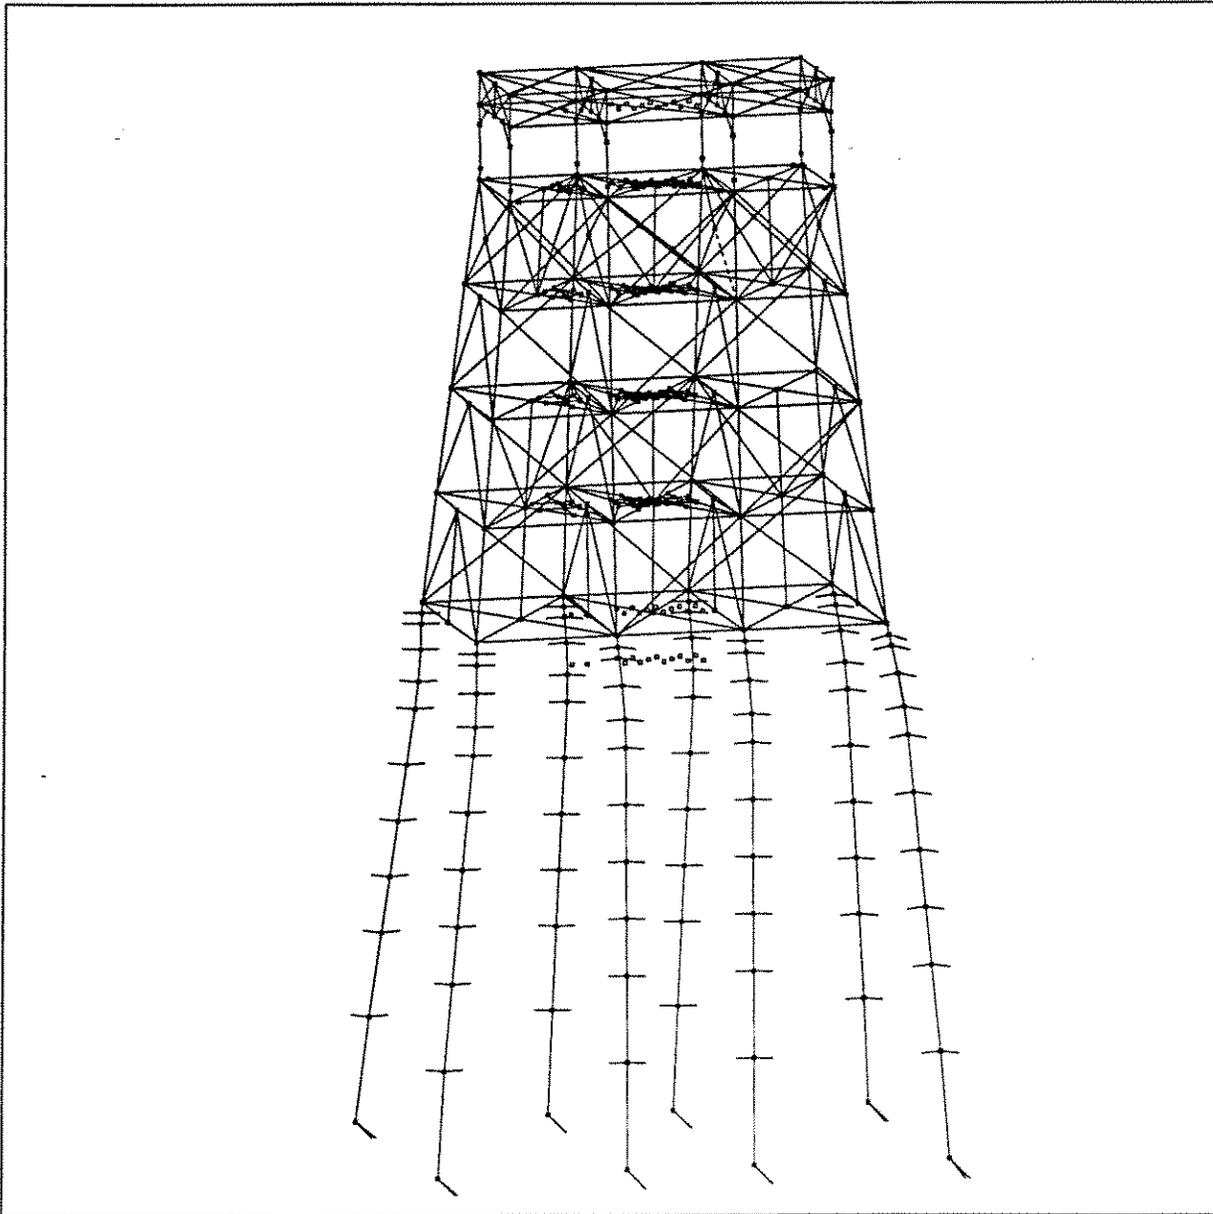
**Figure 3-4 Basic Model - Initial Member Failure**

This corresponds to the actual behavior of the structure, where the K-braces had sheared and the jacket's load bearing capacity was reduced to the bending strength of its legs. The legs had begun to yield but had not completely failed at the Andrew loading, which would correspond with the observed "lean" in the jacket after the storm. Thus, the analytical model that combined the increased strength foundation with the brittle joints, appears to provide a reasonable "recipe" for evaluation of the ST 177 B platform during Andrew.

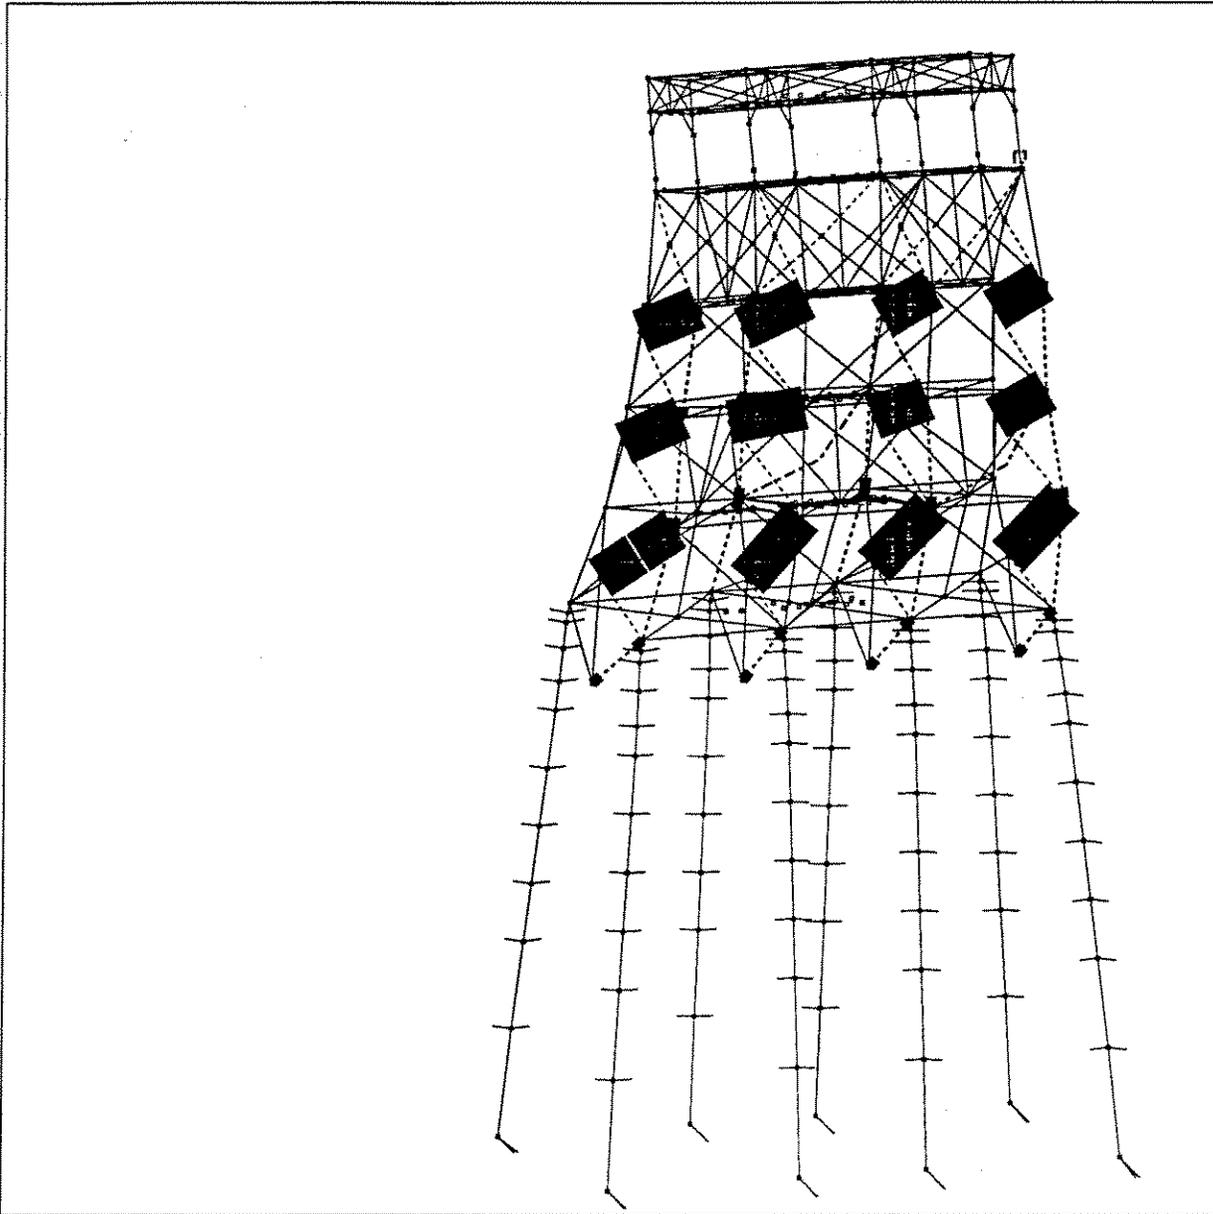
**Figure 3-15 Brittle K Joints - Intermediate Load Step**

Figure 3-15 shows the displaced shape at an intermediate load step. All of the upper X braces have now yielded. The first elevation KT joints and the second elevation K joints have failed in a brittle mode, forcing the load back into the legs for redistribution to other members. There is also some initial yielding due to bending at the two corner legs downstream from the wave direction. Recall that in the platform inspection there was a noticeable curvature to the platform legs in the same direction as indicated by the analysis. There is no indication of yielding in the piles.

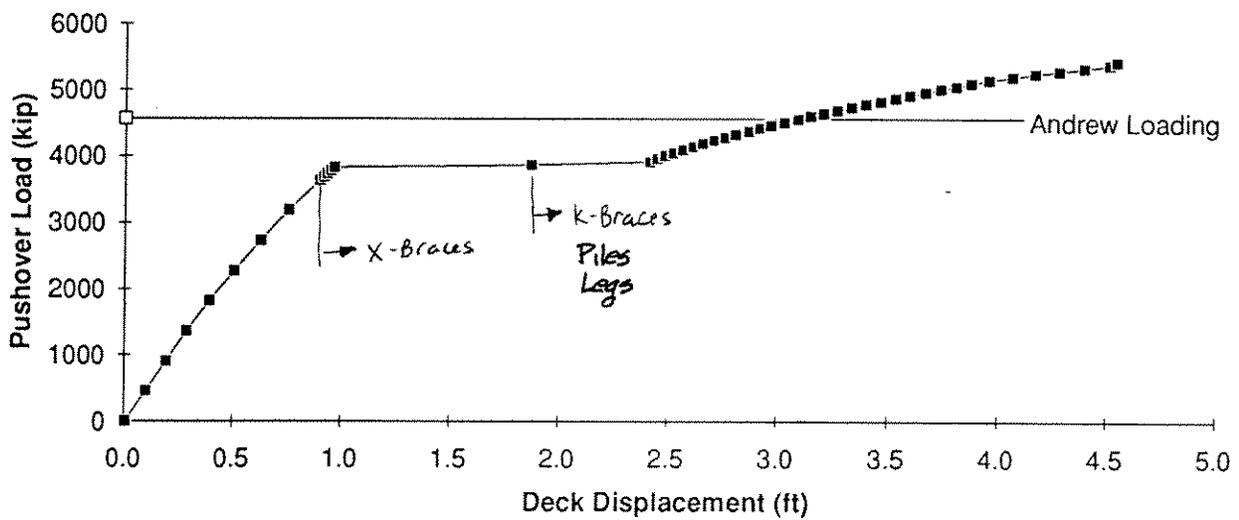
**Figure 3-16 Brittle Joints - Final Load Step**

Figure 3-16 shows the displaced shape just prior to failure which was controlled by bending failure in the platform legs. The last row of K joints have now failed. There is continued yielding of the corner legs, with yielding indicated along the entire leg length in the K and K region. The leg is still linear in the X brace region.
