Testing Fire Resistant Boom in Waves and Flames

James McCourt and Ian Buist
SL Ross Environmental Research Ltd.
Ottawa, Ontario, Canada

Abstract

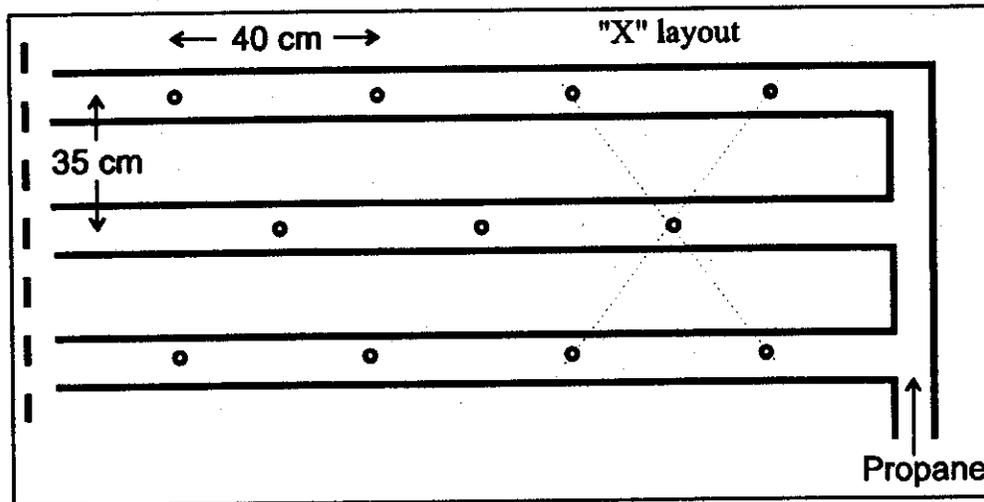
Figure 1: Hole Spacing for Full-Scale Bubbler

A mathematical flow analysis was used to determine the sizing of the bubbler system. The basis for this analysis was the need to provide 2 g/s of gaseous propane from a series of holes, in an "X" configuration, submerged about 50 cm. The flames

generated were to cover an area approximately 1 m wide directly against an 8-m length of boom.

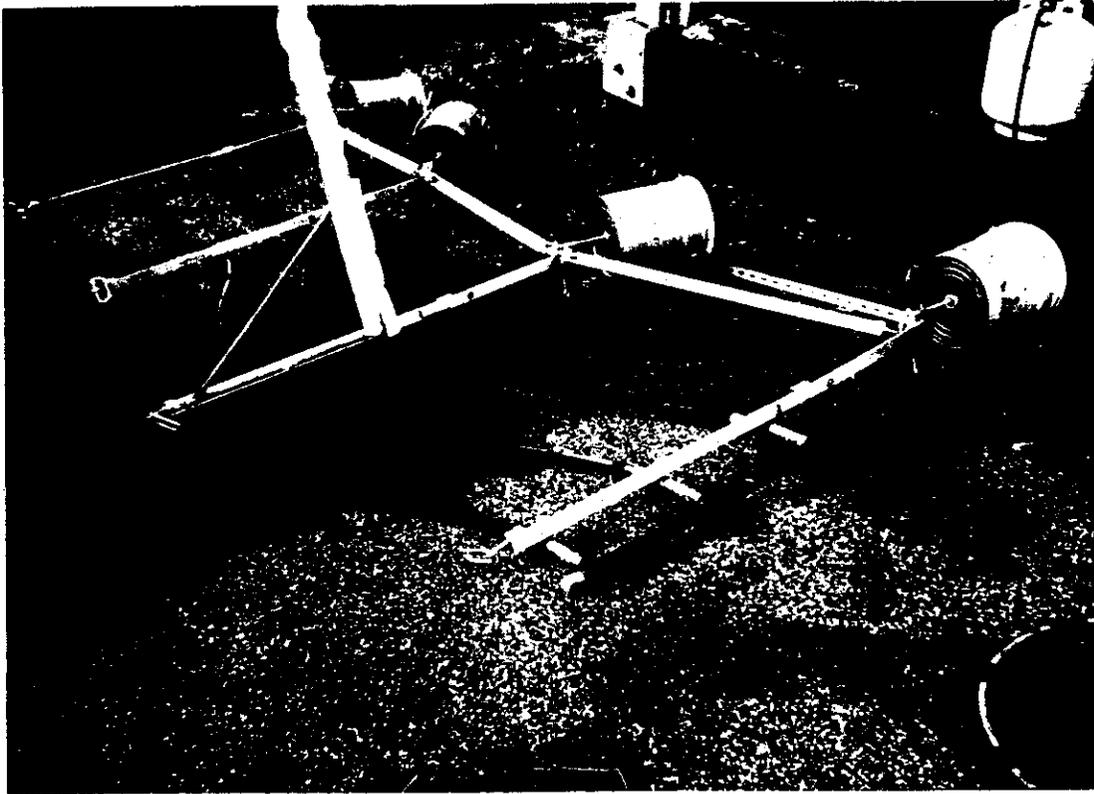
Figure 2: Photo of One Bubbler Unit

A flexible, underwater propane bubbler, consisting of two independently fed units, was designed (see Figure 2). Each unit was made of three 4.1-m long sections of 2-cm i.d. hose. The hoses were connected at one end to a 2.5-cm i.d. header pipe and capped at the other. The three hoses were held parallel by a framework of four aluminum cross-bars. The hoses were clamped to the bars, 35 cm apart, using U-bolts. The hoses had 3-mm holes in their underside, spaced 40 cm apart, with the centre holes offset 20 cm from the other two to create the "X" configuration. One end of the aluminum bars was connected with a carabiner to the ballast/tension chain at the bottom of the skirt of the boom. This allowed the frame to pivot while connected to the boom. The other end of each bar was supported by a metal float connected to the boom. The other end of each bar was supported by a metal float connected by rings and snaps so that it would freely follow the waves. The spacing between floats was maintained by braces between adjacent bars.

One of the units was designed such that the other could be added to it to make a 2-m wide flame over a 4-m length of boom. Also, the two bubbler units were designed as mirror images so that, when deployed, the header pipes at the end of each unit would be next to each other in the centre of the bubbler system. This simplified the deployment of the two 25-m long, 2.5-cm i.d. feed hoses that supplied propane from the tank-side vaporizers. Each feed hose was ballasted with short lengths of steel reinforcing bar so that they remained underwater.

An ignition pilot light was mounted on each bubbler unit. These consisted of 1 m of 1.3-cm copper pipe in an L-shape clamped to one of the aluminum cross-bars such that the end of the copper pipe extended above the water surface. The copper pipe had many small (1.6-mm) holes drilled in it, both above and below the waterline, to ensure a steady flow of propane in all wave conditions. The copper pipe was wrapped in Fibrefrax refractory batting to diffuse the propane and provide a large, stable flame in wind. Each igniter was independently fed propane from a 9-kg propane

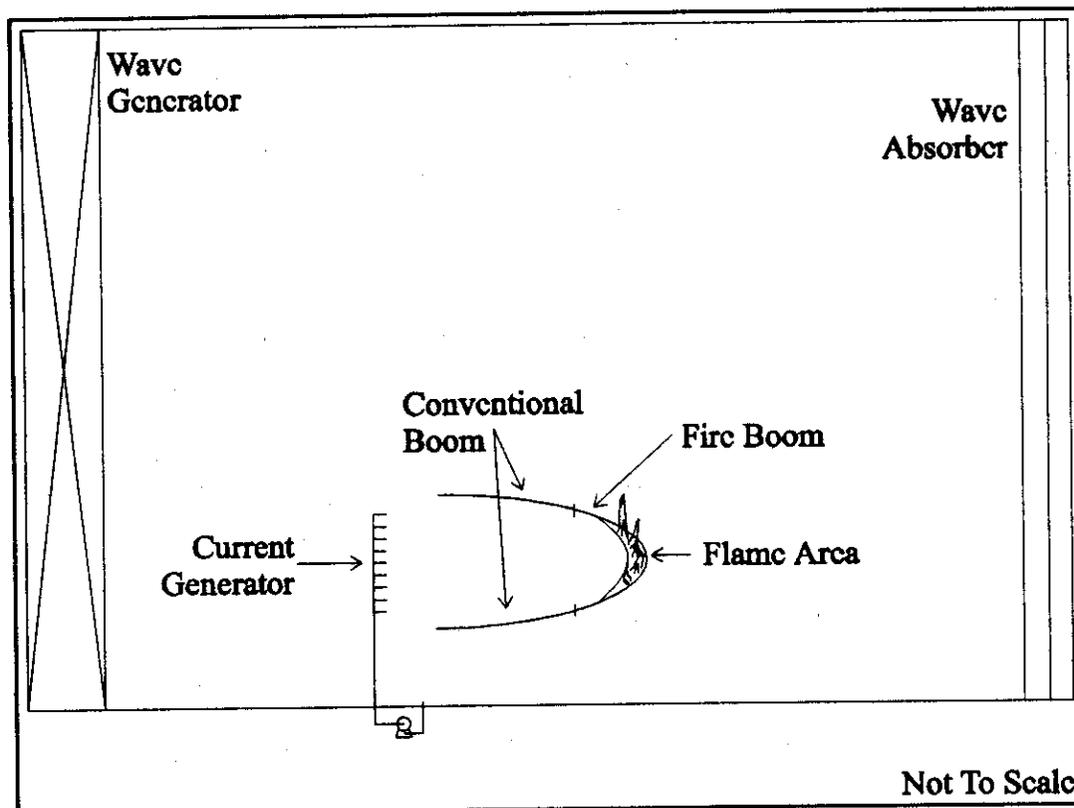
Figure 3: Schematic Diagram of OSMB

The test was conducted in the OSMB, which measures 122 x 61 x 3.3 m (L x W x H). Figure 3 is a schematic representation of the layout of equipment in the basin. A pneumatic wave machine on one end can produce sinusoidal waves of varying amplitude and period. The wave absorber at the opposite end of the basin is ineffective with large waves and allows most of their wave energy to be reflected back into the tank. A standing wave pattern sets up a few minutes after the waves are started. The waves can easily reach 1 m in height at the locations of the nodes. A capacitance wave probe was mounted 33 m from the wave generator, and 6 m upstream of the 16.5-m wide opening to the boom to record the wave characteristics; however, at any one position along the length of the tank, there may be small waves, intermediate waves, or waves with slowly varying amplitude. This means that the wave measurements reported are only an approximate indication of the conditions in the basin.

The propane bubbler units were attached to the chain in the skirt along the middle 8 m of the fire boom. The fire boom was then connected in the middle of two 16.5-m sections of conventional boom and the entire unit deployed in a catenary formation. Each end of the boom was attached to a 22,000 N (5000 pound) model 1110-AF Interface load cell and float, and a 1-cm diameter wire rope was used to moor the boom to the end wall of the basin. As well, a 3-mm diameter cable was stretched across the basin at right angles to the current and used to keep the boom ends from wandering laterally, but free to move longitudinally in the basin under the action of waves and current. A test showed negligible effect of this cable on the forces measured by the load cells.
